*The Regalia Room Mural  
Paintings Conservation Project,  
Trondheim, Norway*

**Conservation Measures and  
Monitoring of Salt Weathering  
2001-2002**

18.12.2002

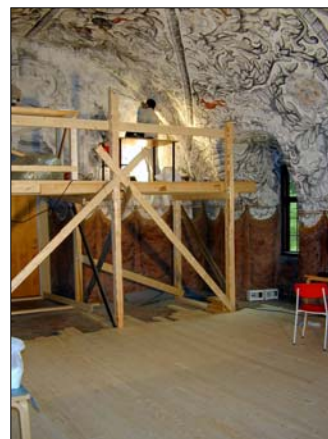
*Figure 1: From the 2001 conservation campaign at the west wall. Note the preliminary wooden floor – a measure undertaken in order to check its buffering capacity on the indoor climate*

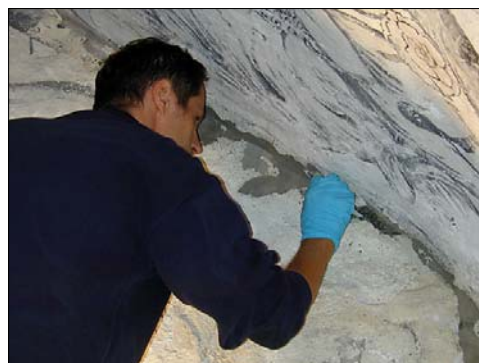
*Figure 2: Closing cracks with lime mortar on the west wall in August 2001*

The actual conservation work carried out in August 2001 involved mainly closing cracks and gaps, which borders had been secured in 2000, by various types of lime mortars. The final finishing of the mortar repairs (toning etc.) was not undertaken (fig. 3-7).

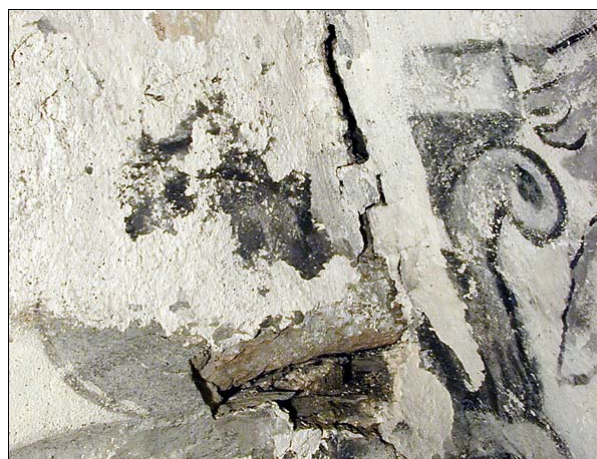
*Figure 3: After removal of cement mortar from the 1966 restoration. NW-corner.*

Prior to some of the repairs, gypsum and cement mortars from the restoration in 1966, and not removed in 2000, were taken away (fig. 3). Originally, it was intended to remove much more cement, but as its removal in many cases poses a larger strain to the wall than leaving it, it was decided to refrain from treatment in most cases.

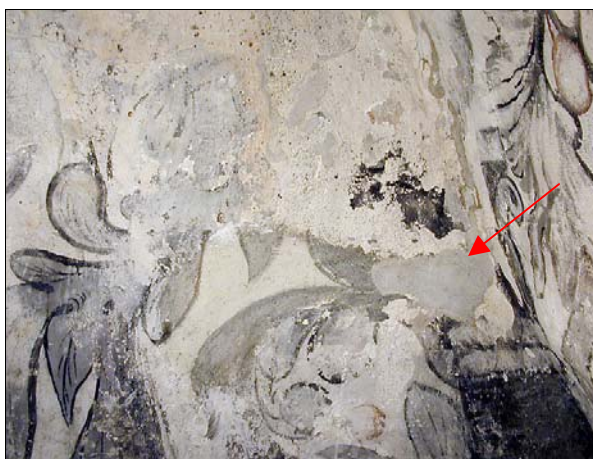
*Figure 4: Same area as in fig.3 after application of new lime mortar*

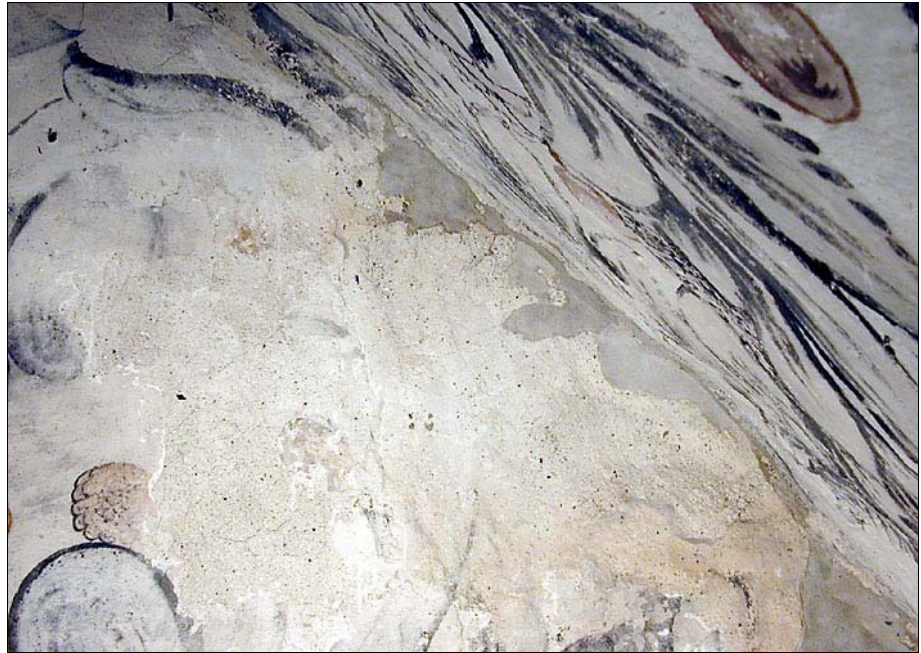
*Figure 5: After application of lime mortar repair in the NW-corner*

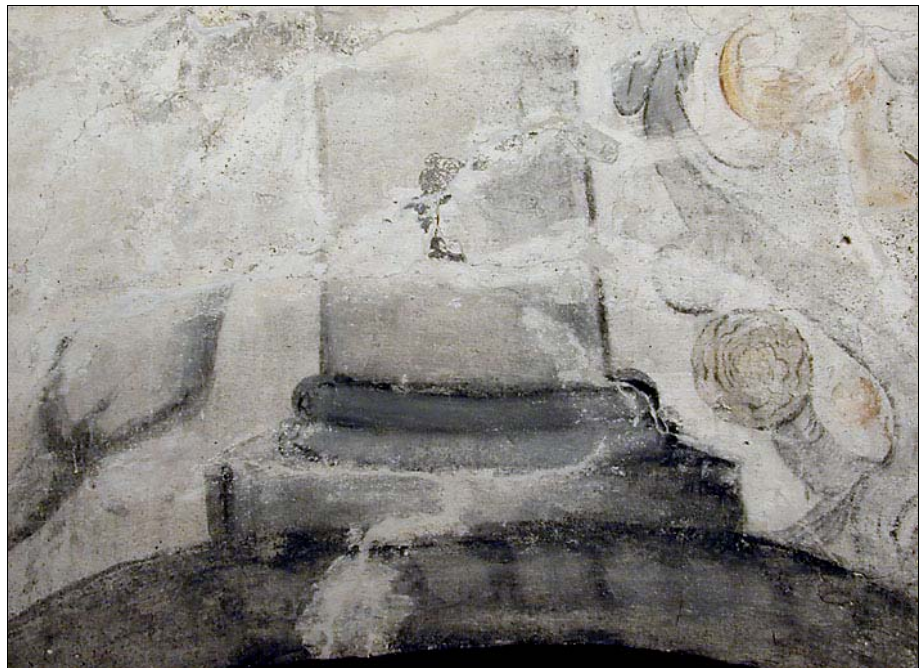
*Figure 6: After removal of gypsum from 1966 and application of lime mortar repairs just above the west door*

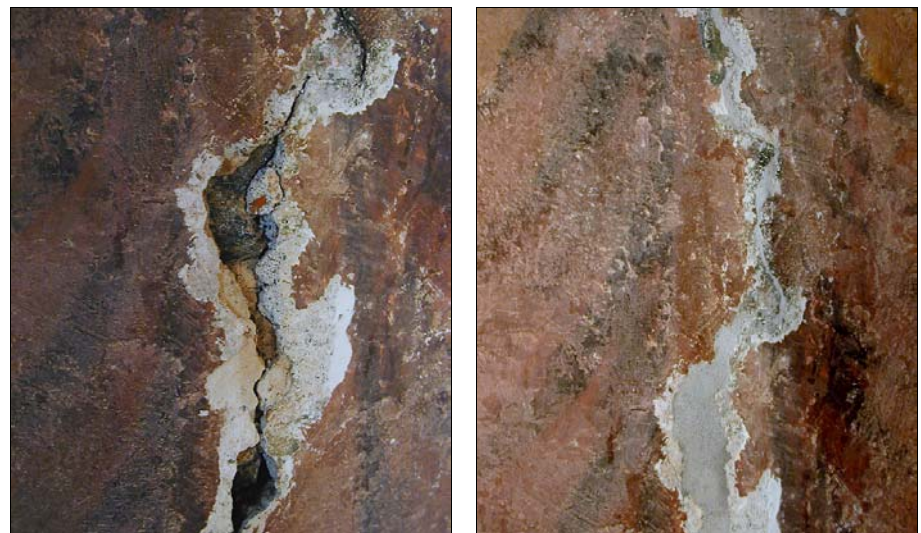
*Figure 7: After removal of gypsum from 1966 and application of lime mortar repairs in a crack on the south side*

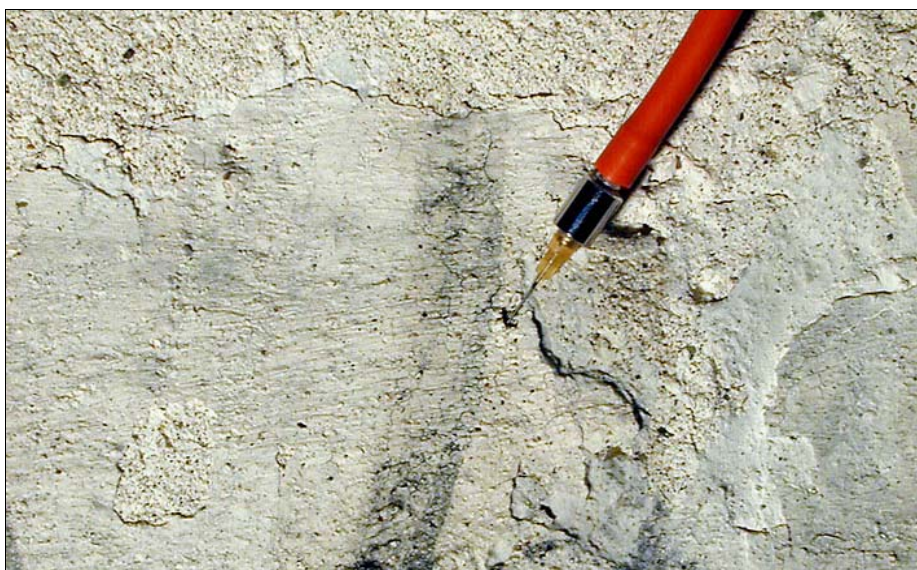
On large part of the west wall, especially connected to the porous, so-called “chimney plaster” on the north side, the brittle limewash applied in 1826 strongly exfoliates. One reason for its poor adhesion might be that the limewash was applied on dry plaster [2,4]. The borders of most exfoliating limewash was secured by fine lime mortars mixed at high speed in 2000 [5]. However, at that time it was not possible to properly bring in very fine lime mortars / lime injection mortars behind the brittle flakes and thus securing them more permanently. The fine lime injection mortars were usually too viscous, thus not being able to enter the narrow space between limewash and plaster. Another problem was that, if the plaster was too dry, the finest injection mortar dried out too quickly upon injection.

*Figure 10: Applying drops of limewater over a longer period of time with an injection needle in order to moisten the plaster before application of consolidants.*

In order to deal with this problem, limewater was applied in order to try to properly moisten small, selected test areas (fig. 10). Subsequently, “lime paint” (very liquid injection mortars as described in [4]) were injected behind the exfoliating limewash / flakes. Even though several hundred millilitres of limewater was used, it was not possible to properly saturate the underlying porous plaster and thus the injection mortars were unfortunately absorbed by the plaster or dried out too quickly. In other tests pre-hydrolysed ethyl silicate were injected after properly moistening the test areas with limewater. The alkaline limewater was used in order to quickly start the gel-forming reaction of ethyl silicate. Flakes were gently pressed to the plaster after the procedure. Unfortunately, this procedure was also unsuccessful. It would seem that the gel-forming reaction took place very quickly, but the plaster nevertheless absorbed the consolidating agent. Thus, the flakes of limewash loosened from the plaster after the drying of the liquid.

Obviously, further experiments with various consolidants will have to be carried out in order to find a good method for fixing the brittle, exfoliating limewash to the porous plaster.

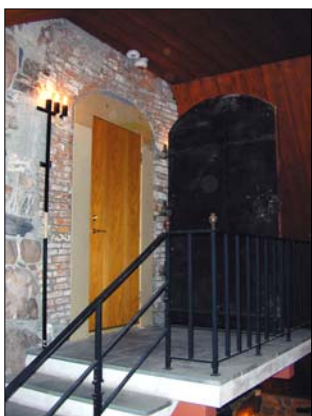
*Figure 13: Temporary (reversible) door installed in the door-opening in the west wall of the Regalia room in February 2001*

The most important measure was the installation of a temporary (reversible), extra door in the west wall (fig. 13,14). This was undertaken in February 2001, and simultaneously wooden planks (untreated spruce) were laid on the floor in order to buffer the indoor climate as much as possible (fig. 14). Moreover, the door leading from the courtyard of the Archbishop's Palace to the staircase was insulated. The results of these measures can be seen on the climate diagrams in chapter 4 and appendix 1. The relative humidity drastically stabilised after February 2001, and has generally been in the range of 60 to 75% in the Regalia room since then. This is a very significant improvement. However, as the relative humidity drops to 60% over long periods of time, this still causes problems with salt crystallisation (see chapter 6).

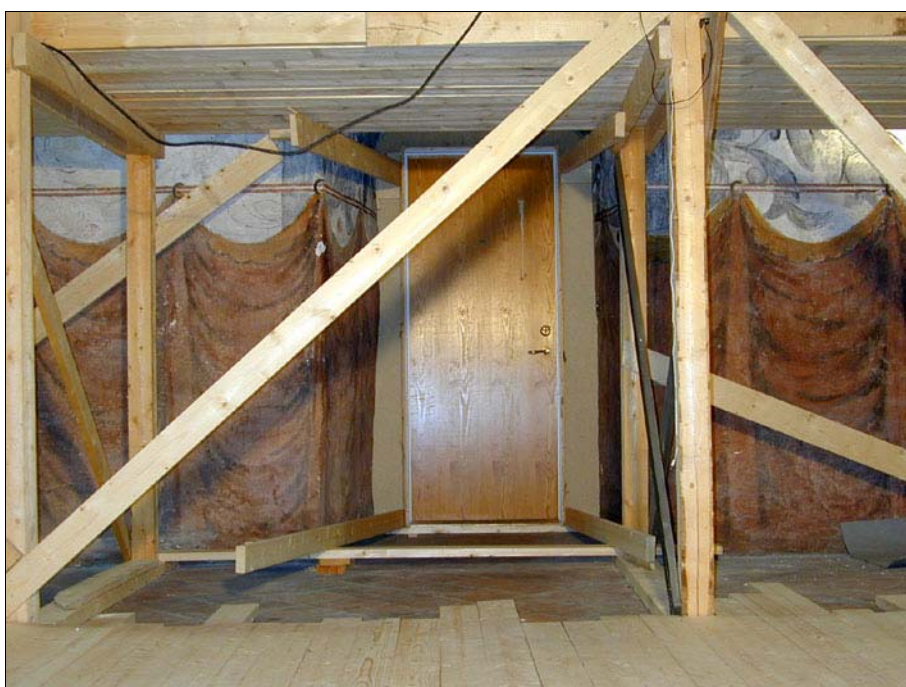
*Figure 14: The temporary door as seen from the Regalia room. Note the wooden planks on the floor. A permanent door should be installed as soon as the effect of the temporary one is properly confirmed.*

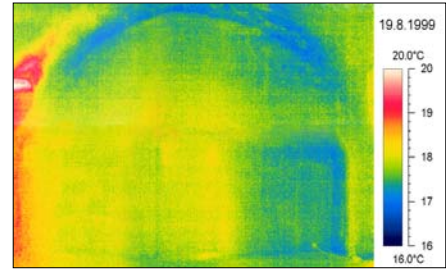
Figure 16: IR-Thermography of the west wall from August 1999 (cf. [2]). Note the cold spots (c.  $17^{\circ}\text{C}$ ) along the border to the vault and in the NW-corner. Room temperature c.  $18^{\circ}\text{C}$

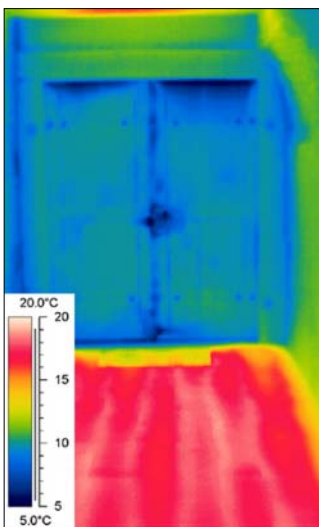
1. The floor in the staircase (by the entrance) has electric heating, which is the reason why the staircase is relatively warm (fig. 17).
2. There are no great temperature gradients on the west wall in the room, except for the door, which is influenced by the heated staircase (fig. 18). The border between the wall and the vault had a temperature of c.  $1^{\circ}\text{C}$ , the rest of the wall was 1 to  $1.5^{\circ}\text{C}$  warmer by a room temperature of  $1.5\text{--}2.0^{\circ}\text{C}$ . The largest cold area is in the NW-corner, like in the summer time (fig. 16). The east wall of the room was also recorded; temperature gradients could hardly be found here (general temperature of c.  $2^{\circ}\text{C}$ )

Figure 17: IR-Thermography, entrance to staircase from the outside.

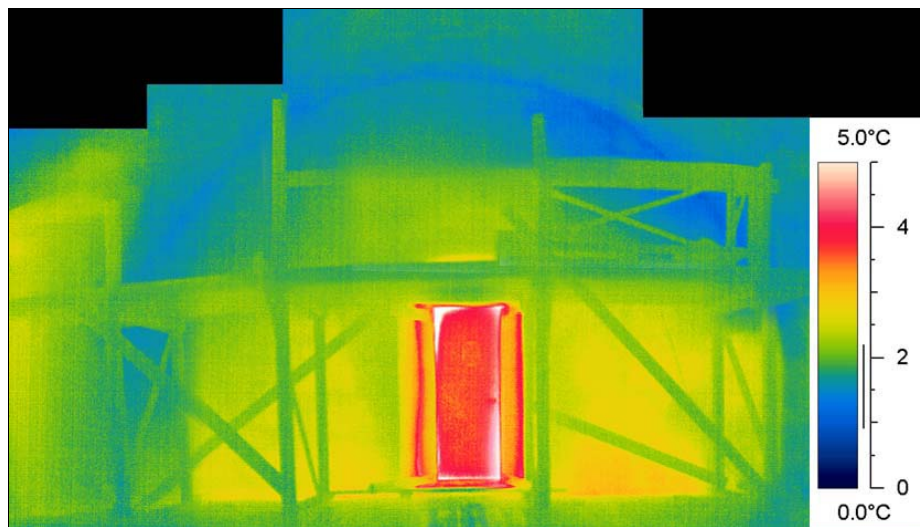
Figure 18: IR-Thermography recordings from the west wall of the Regalia room.

The cold border between the wall and the vault can be explained by the fact that the only part of the wall that is directly exposed from the outside is located here (cf. fig. 20). Moreover, there is an old, large crack between the vault and the wall, enabling cold air to enter. It is also possible that the many hollow areas along the border play a role [2].

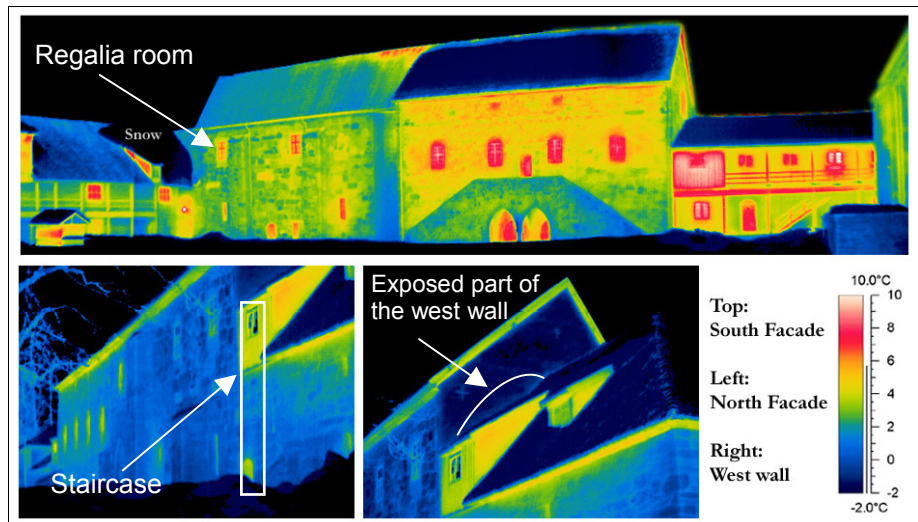
4. IR-Thermography was also undertaken on the exterior facades of the Archbishop's palace. The images in fig. 20 do not reveal anything new, but the differences between heated and unheated building parts can clearly be seen (compare fig. 20 and 21). The south façade had temperatures between 3°C (unheated) and c. 6°C (heated), whereas the north facades showed values below the freezing point (minimum -2°C). The ambient temperature was in the range between -4°C to +4°C in the actual period (overcast weather).

Figure 20: IR-Thermography on outside facades of the Archbishop's Palace. Top: South façade. Bottom: North façade.

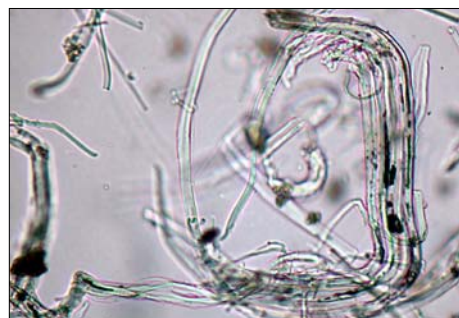
Figure 22: Halite (sodium chloride) whiskers on the west wall in September 2002. Sample RE130903\_4, microphoto, width of field c. 0.5 mm

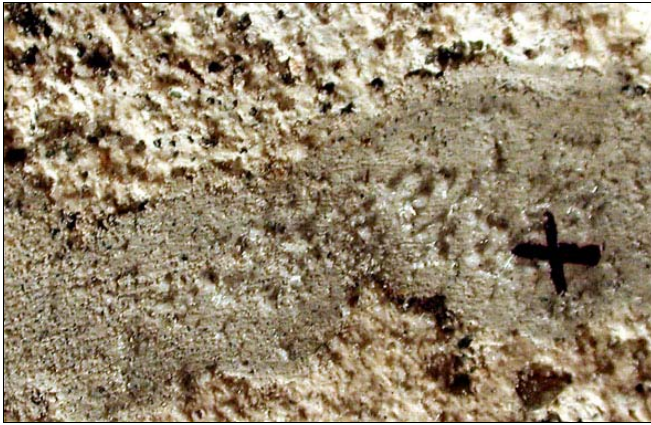
Figure 26: Salt whiskers on a new lime mortar repair. Salt has a tendency to effloresce on such material because of its finer pores, which keeps moisture longer, as compared to the adjacent old lime plaster. The area was not sampled in order to be able to follow the evolution of the whiskers in the future. Width of photo c. 5 cm. Photo no. RE02\_002.

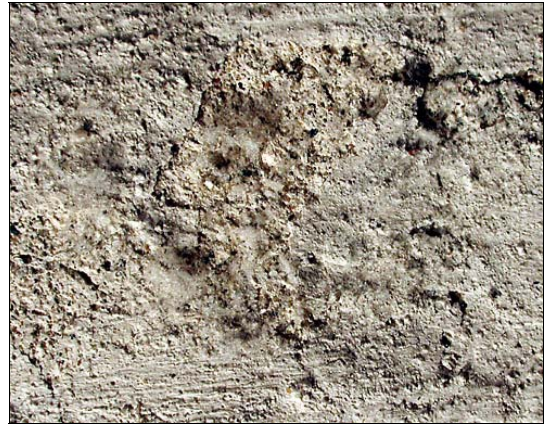
Figure 27: Long needles and whiskers of mainly halite and a little nitratine (sodium nitrate) forming cotton-like bundles. Width of photo: c. 8 cm. Photo no. RE02\_003, sample no. RE130902\_04. Microphoto no. RE02\_010 (see fig. 22)

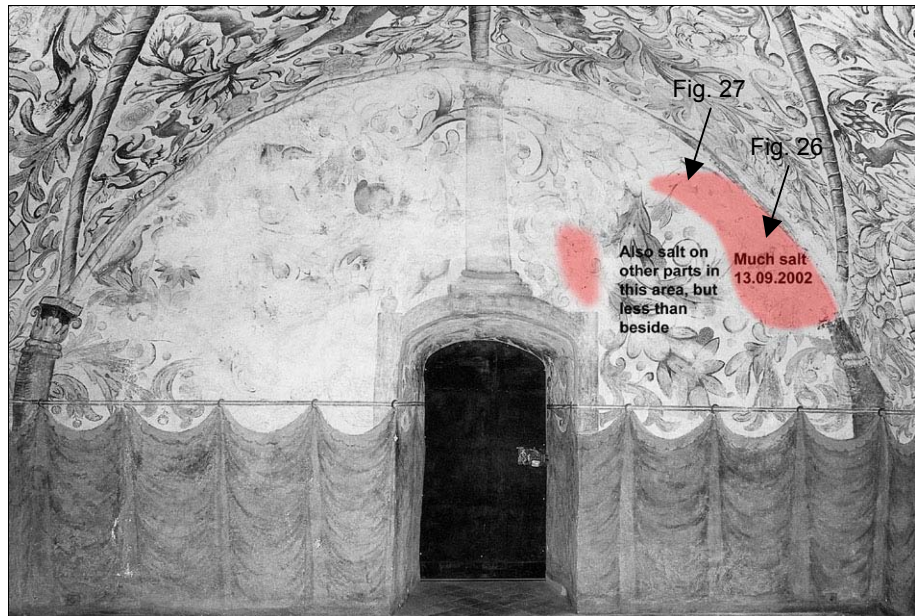
Figure 28: Areas with much salt in the middle of September 2002. Salts included mainly halite and nitratine.

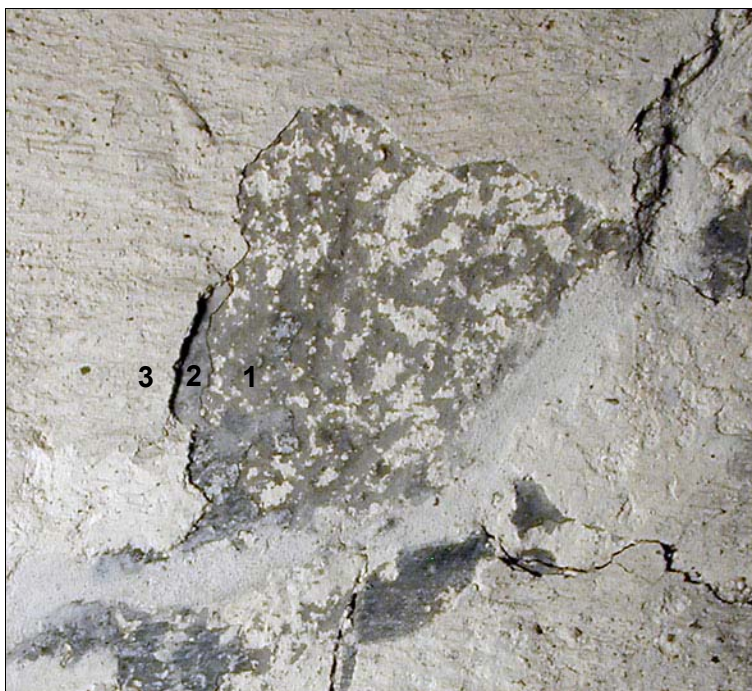
Upon removing 1966 gypsum repairs from the “column” above the door (fig. 9), it was possible to get a new view of the stratigraphy of the limewash and paint layers of the wall. Surprisingly, a formerly unknown layer (no. 2, fig. 32) turned up between the original grey paint from 1616 (no. 1) and the 1826 limewash (no. 3). It is possible that this layer corresponds to the what has been called the 2<sup>nd</sup> limewash/paint, supposedly applied in the periods between 1672 and 1826 and earlier found on the north side of the wall. However, only tiny fragments have been found earlier [2].

*Figure 32: Layer of paint (2) found between the 1616 paint (1) and 1826 limewash (3) on the “column” right above the door opening.*
