Andreas Franz and Per Storemyr

The 17th Century Mural Paintings in the Regalia Room, Archbishop's Palace, Trondheim, Norway

History, Paint Technology and Weathering of the West Wall

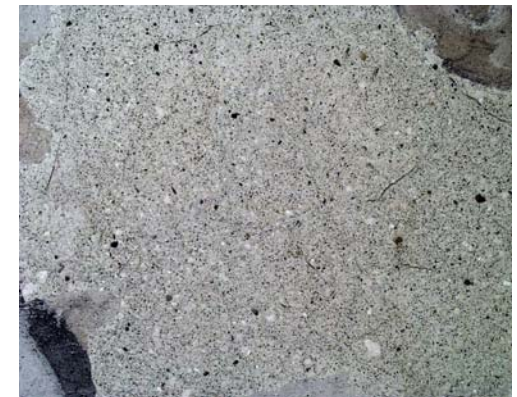
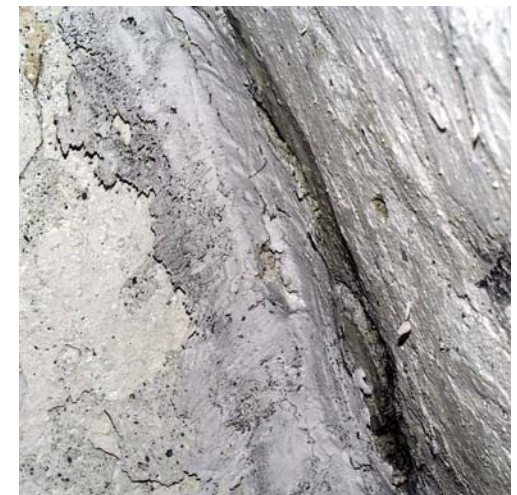
Plaster stratigraphy on the west wall. The pictures show the fine-grained plaster in the chimney area (above) and exfoliating gypsum repairs from 1966 (below)

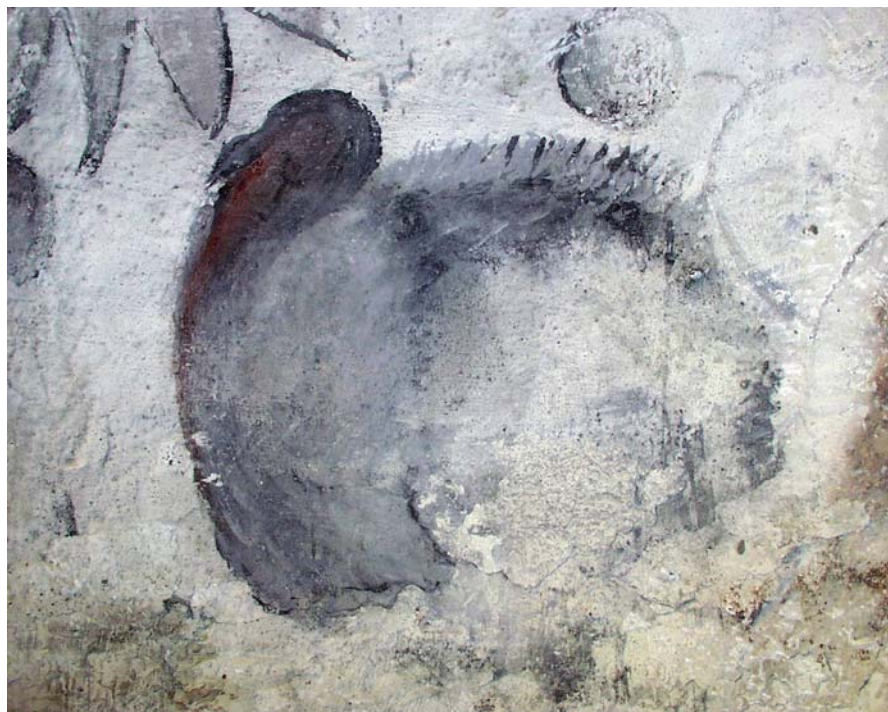
*The turkey in Q1 was probably overpainted by an inexperienced painter after 1826
(4th paint layer)*

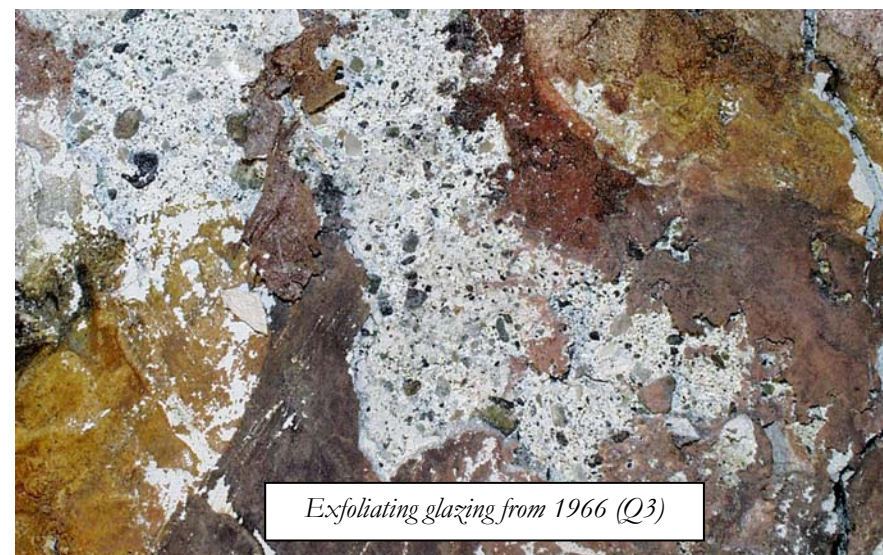
Exfoliating glazing from 1966 (Q3)

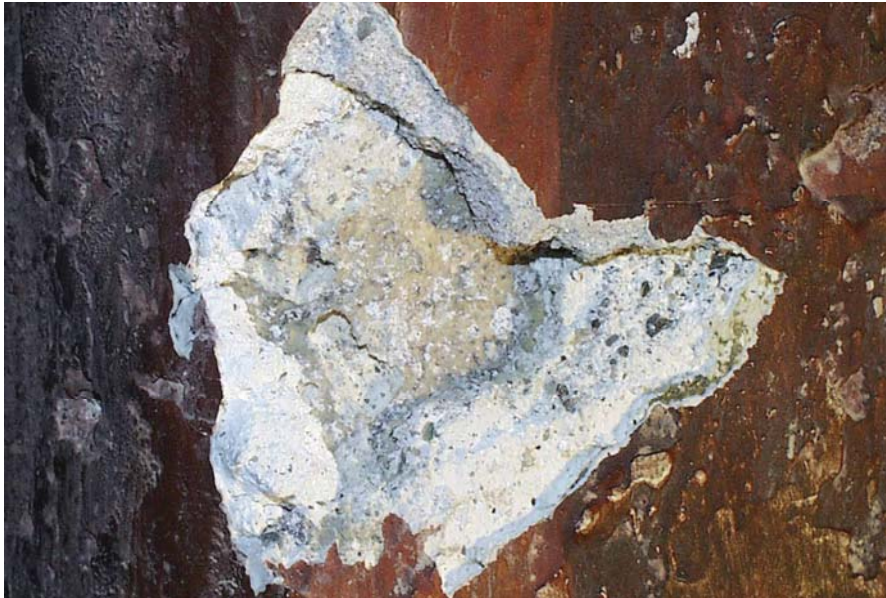
Mechanical damage at the south edge of the main door opening. On the "bottom" it is possible to observe a plaster from before 1616. The uppermost paint stratigraphy can be seen on the picture to the right.

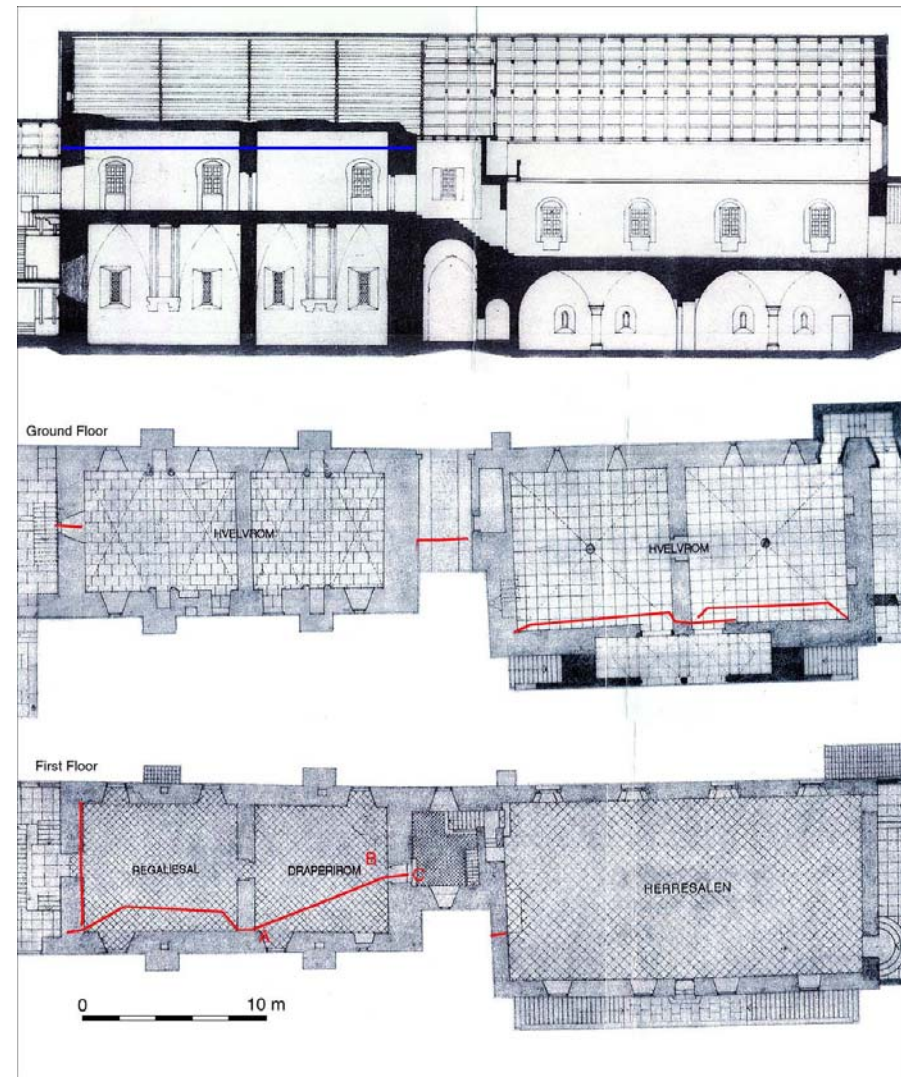
The longitudinal cracks were discovered before the last restoration (Krafft 1952), but they apparently widened during and after all the interventions between 1962 and 1975. The cracks run in the southern part of the vaults and walls in the east house, continue through masonry in the tower room, and become especially wide in the vault of the Drapery room. In the Regalia room they are difficult to observe, but there is nevertheless a distinctive crack pattern in the south side of the vault. Obviously these features have caused some loosening of plaster and paint in this area - also close to the west wall.

Plans and section showing the location of cracks in the Archbishop's Palace (straight red lines), as well as supporting steel beams (blue)

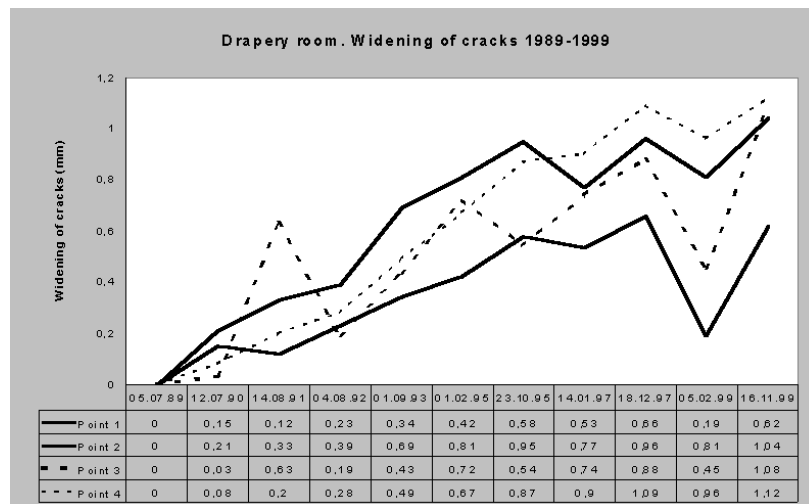
Diagram showing the widening of cracks in the Drapery room 1989-99

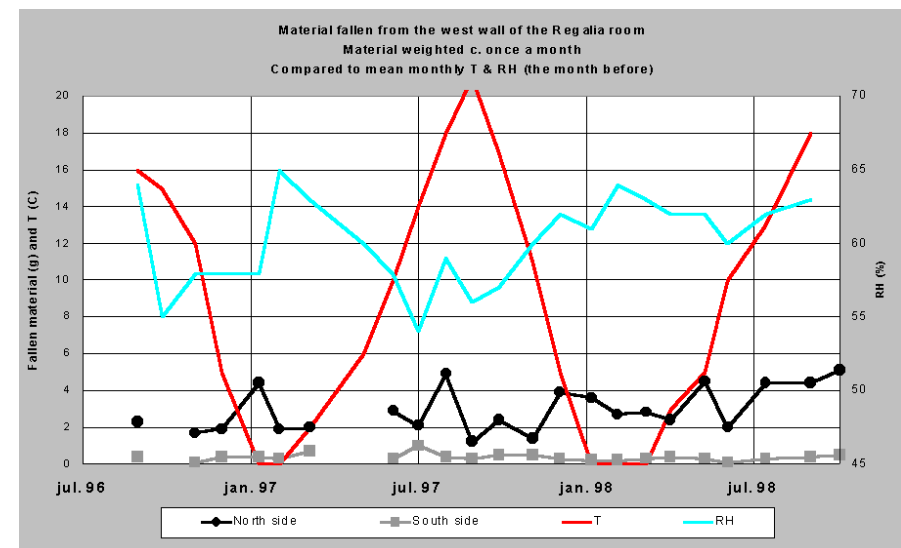
Material fallen from the west wall between July 1996 and October 1998, compared with the indoor climate (mean monthly values)

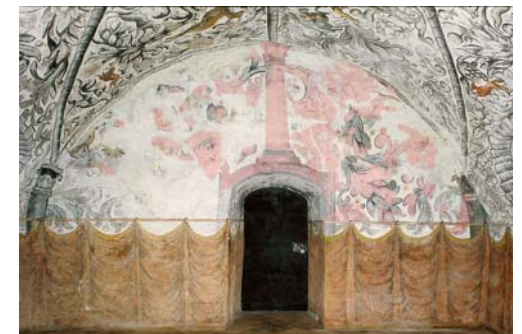
*Mapped weathering forms on the west wall.
The small picture shows the widespread
distribution of areas with powdering of
paint (or granular disintegration of paint)*

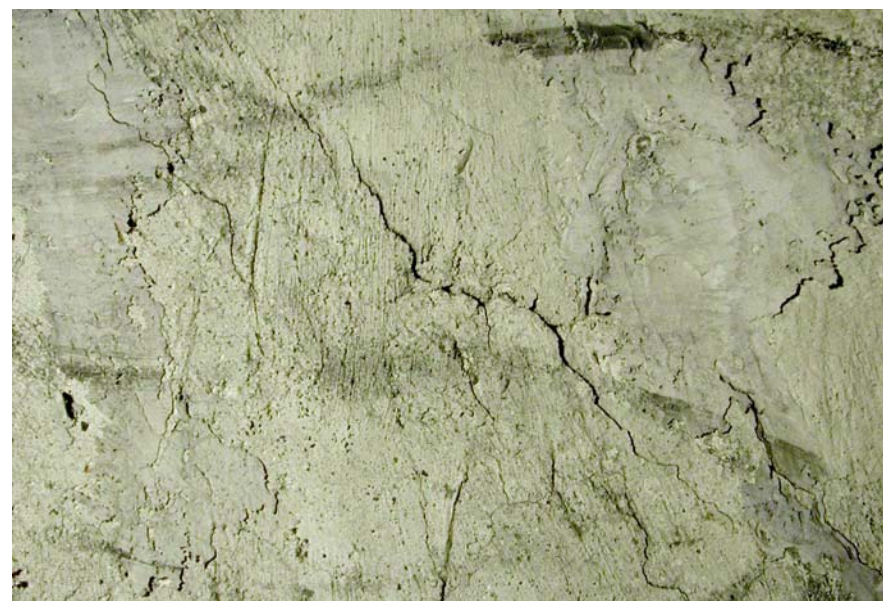
3. The extensive crack pattern above the main door opening. This seems to be a combination of shrinkage fissures in the plaster, and "real" cracks caused by either vibrations when the opening was enlarged or other kinds of stability problems in the west house (these cracks may continue in the west wall of the vaulted room below the Regalia room).
4. Cracks along the border between the wall and masonry inserted in order to block the niche in the northwest corner. These cracks are not dangerous.
5. Shrinkage fissures in the plaster, especially above the main door opening. Some of these fissures have caused the plaster to become unstable and should be repaired.

Crack pattern in the area above the door (type 3)

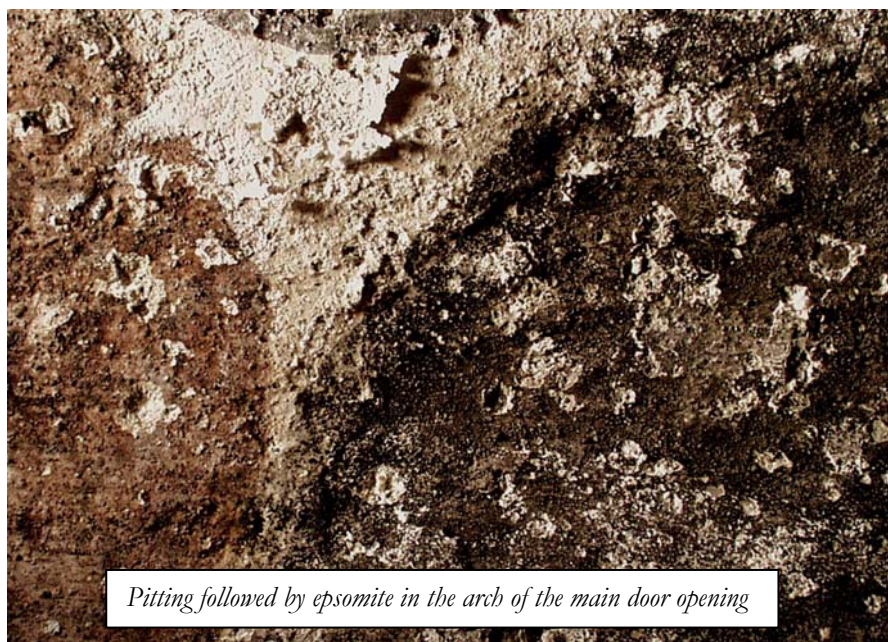
Pitting is a specific weathering form that mainly occurs underneath the arch in the main door opening. It takes the form of small "volcanic craters", or

Pitting followed by epsomite in the arch of the main door opening

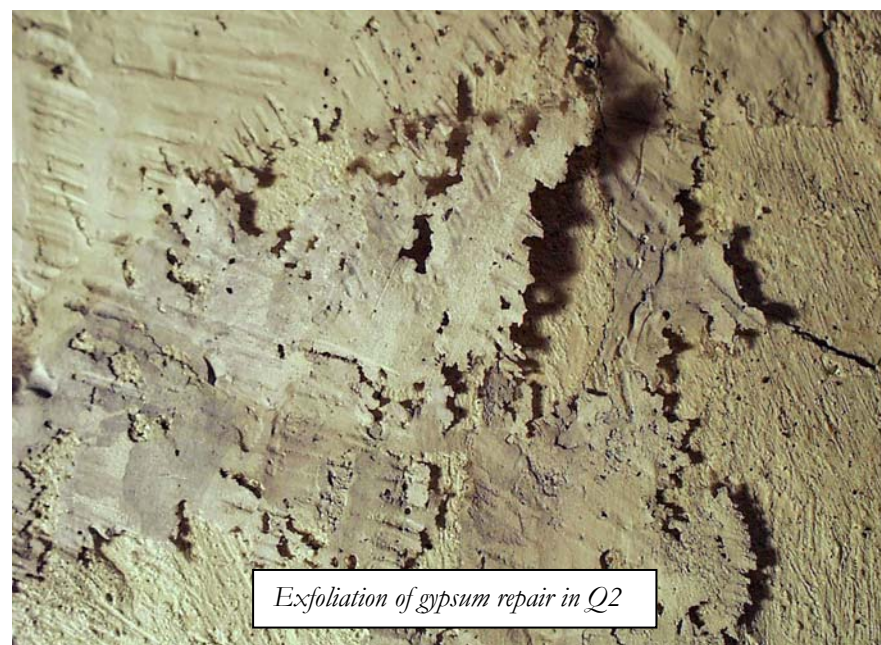
Exfoliating gypsum repairs from 1966 is probably the most *apparent* weathering phenomenon on the west wall. One reason is that gypsum repairs are very widespread, another is that large proportions of the repairs are

Exfoliation of gypsum repair in Q2

damaged. Most of the exfoliation takes place where the gypsum has been used to fix cracks and fissures, or the boundaries between exfoliating limewash/paint and sound surfaces. There are often salts below exfoliating gypsum layers on the northwestern part of the wall, mostly powdery efflorescences of thenardite. Thus, there must be multiple causes for the severe exfoliation. In addition to *salts* and the *location* of gypsum repairs in areas with very active weathering, the material properties of the repairs themselves must be considered. Gypsum often shows high *thermal dilatation*, implying that temperature differences in the room might affect the weathering. Also *hygric dilatation* should be considered. Moreover, possible organic additives (animal glue) in the gypsum mixture might increase the extent/rate of swelling/shrinking of the repairs. A very important reason why all *exfoliating* gypsum repairs should be removed is that during

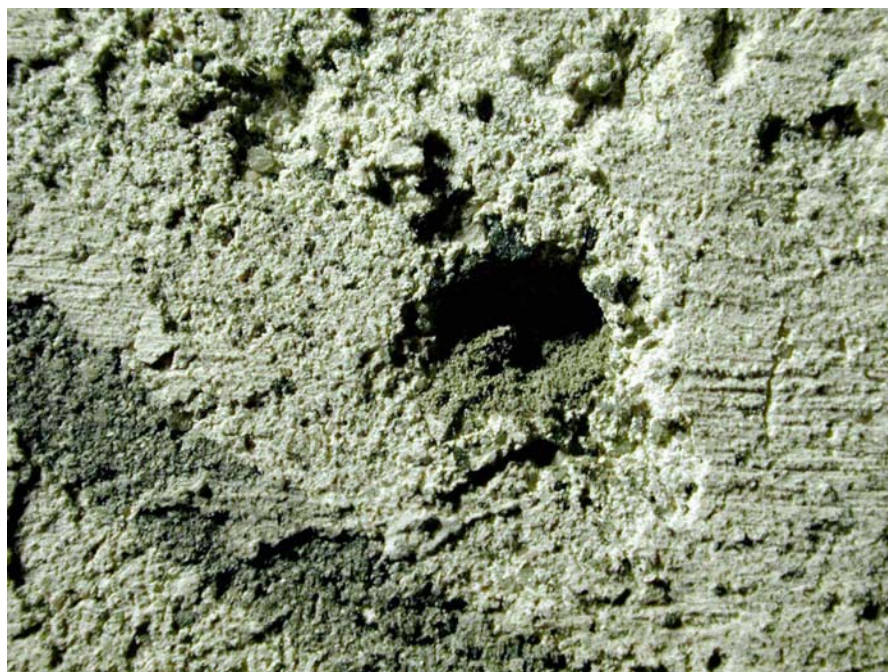
*Another weathering form: Granular disintegration of aggregates (greenstone) in mortar.
Width of field c. 10 mm*

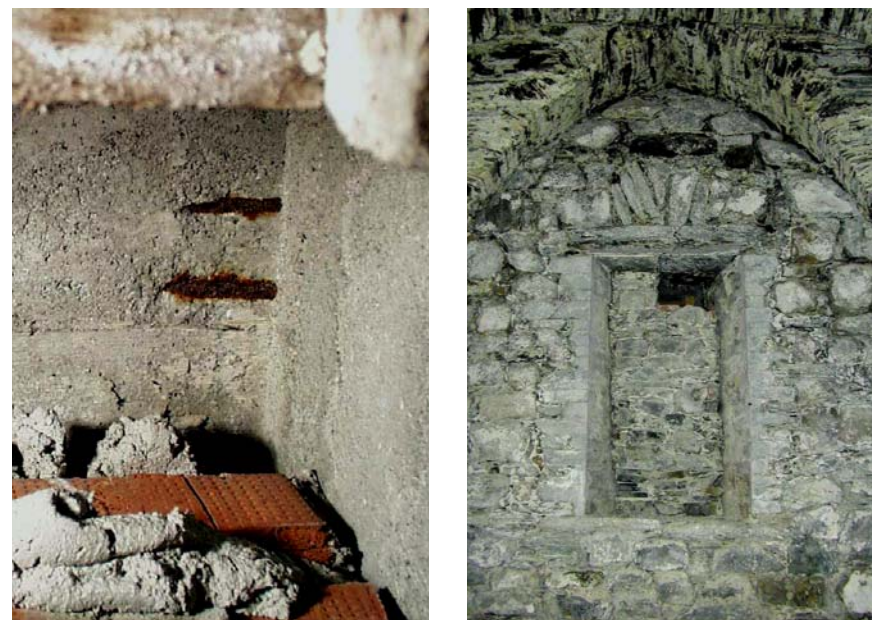
Two places where clues to the weathering in the Regalia room can be found. Left:: (Rusting) reinforced concrete inserted during the last restoration in the upper part of the opening at the rear of the northwest corner of the west wall. Right: The west wall of the vaulted room below the Regalia room. This room was used as gun powder store until 1826. Today there are massive amounts of alkaline salts of unknown origin on the walls

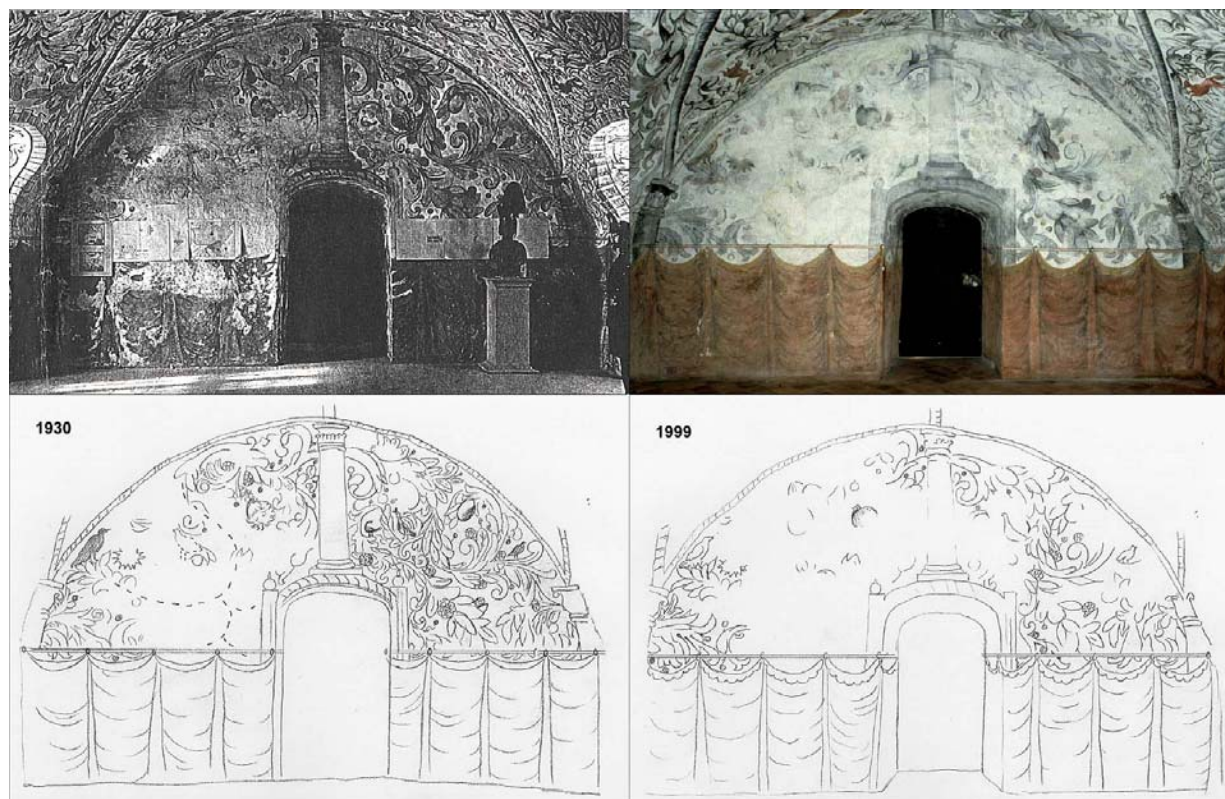
Comparison of the state of the west wall in 1930 and today. Drawings by Birgitta Odén, left photo from Schröder, right photo by Kjartan Proven Hanglid

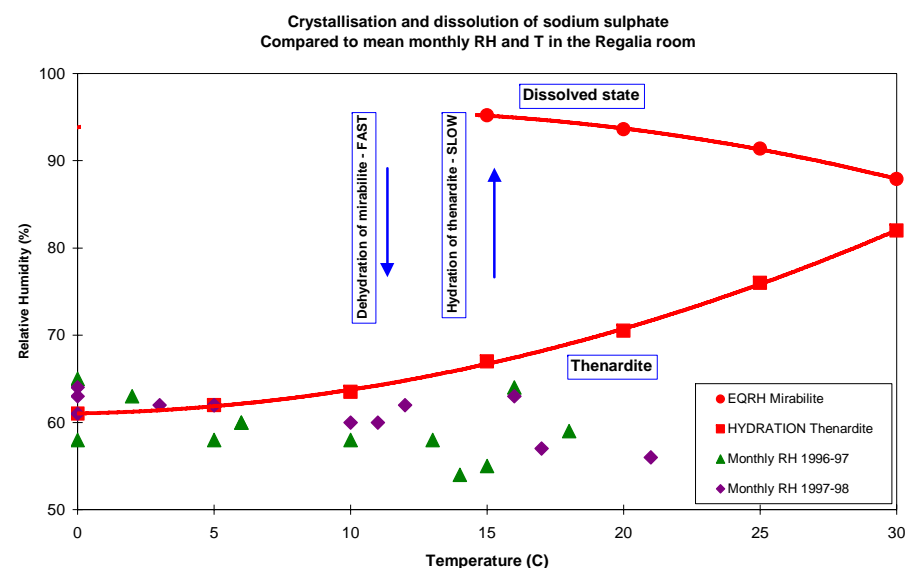
Diagram showing theoretical EQRH/hydration curve of two forms of sodium sulphate (thenardite and mirabilite) and mean monthly T and RH in the Regalia room 96-98
