The Restoration Workshop of Nidaros Cathedral

**CONSERVATION OF  
MURAL PAINTINGS IN THE  
REGALIA ROOM,  
ARCHBISHOP'S PALACE,  
TRONDHEIM, NORWAY  
1999-2005**

**Emergency Conservation of the West Wall  
and Scientific Investigations 2000**

*NDR 1/2001*

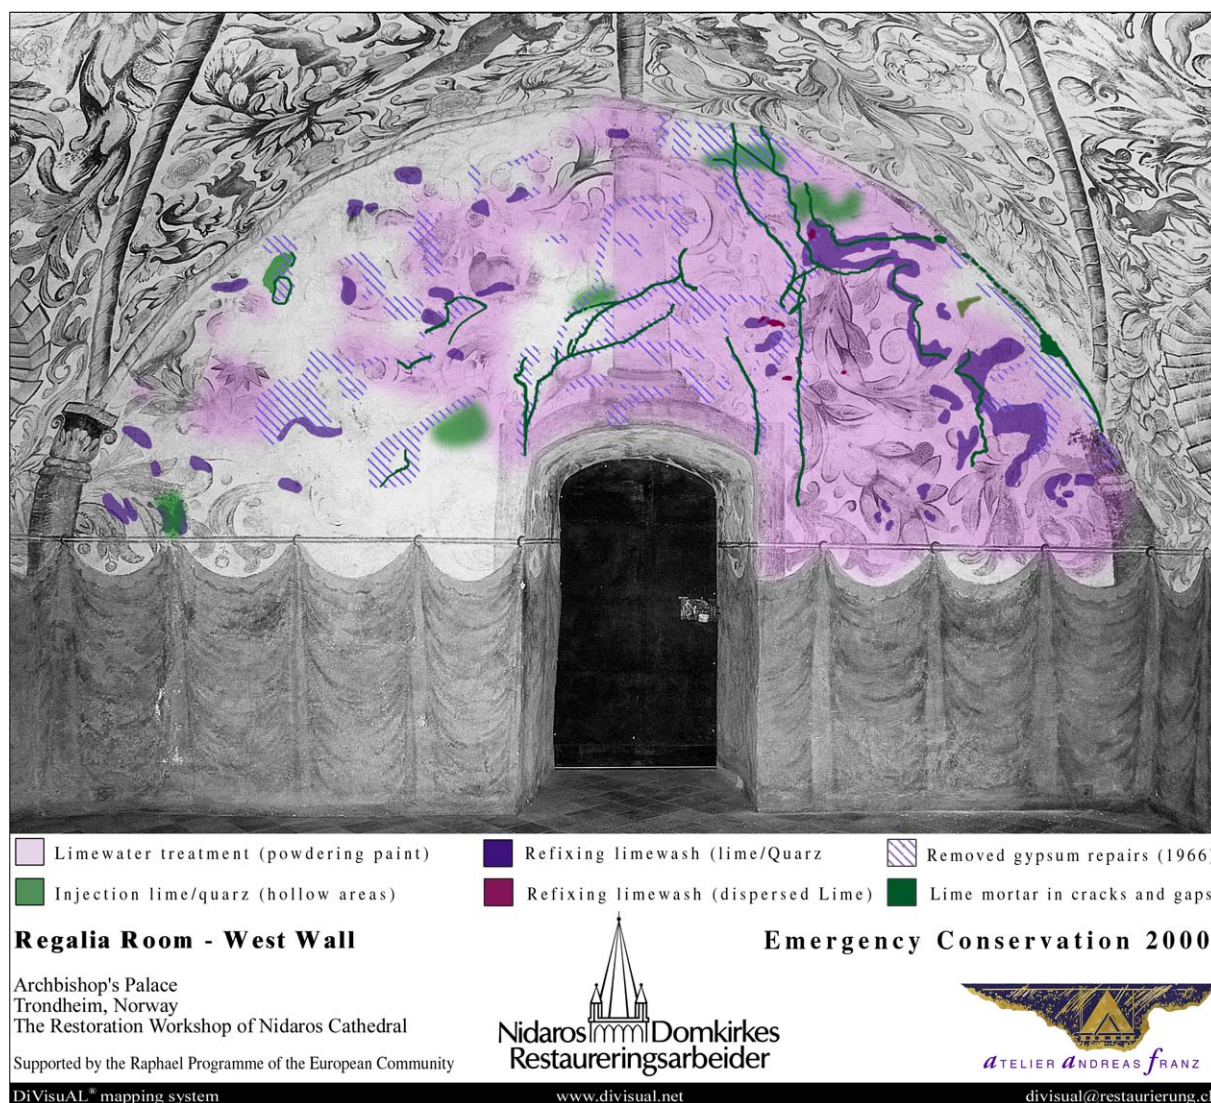
*Map of measures carried out during the emergency conservation in June 2000*

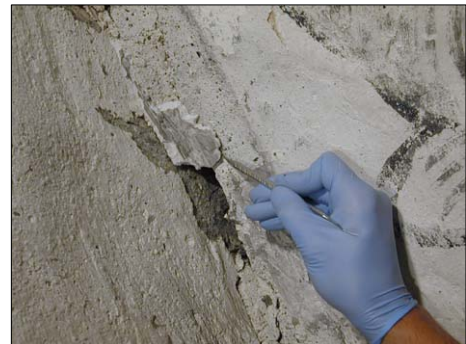
*Removal of gypsum repair mortar from 1966 (in Q2)*

We removed all the loose and exfoliated gypsum repairs, as well as many of those apparently affecting adjacent plaster and lime negatively. We also removed most gypsum in cracks. The work was undertaken mechanically using various sized scalpels only. Gypsum was not, or only partly, removed at places where it covered large areas and apparently did not give rise to any damage (especially in the lower part of Q1).

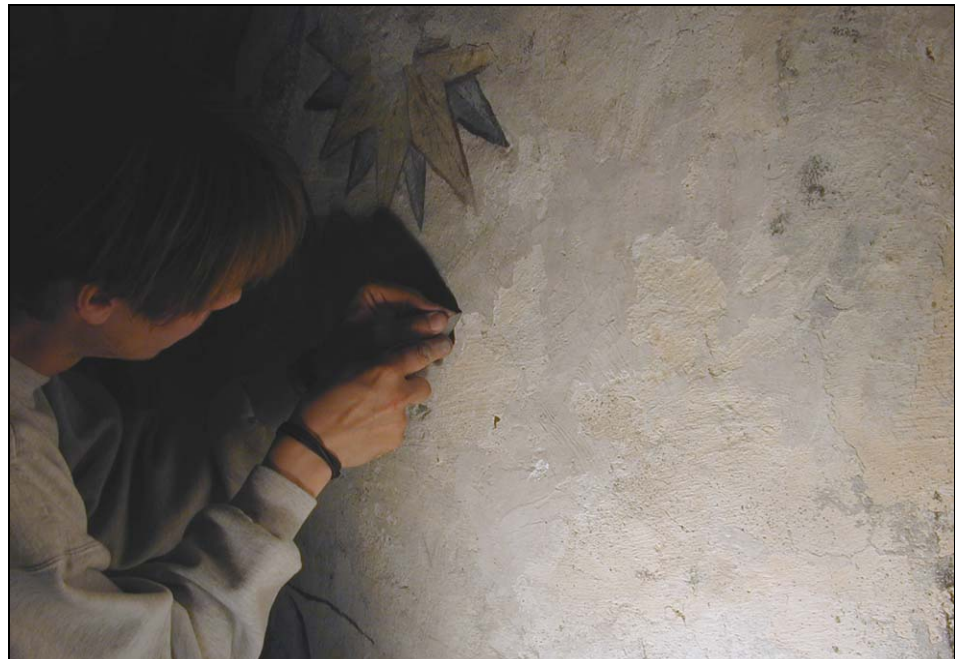
*Removal of gypsum repairs "smeared" over the surface in Q1*

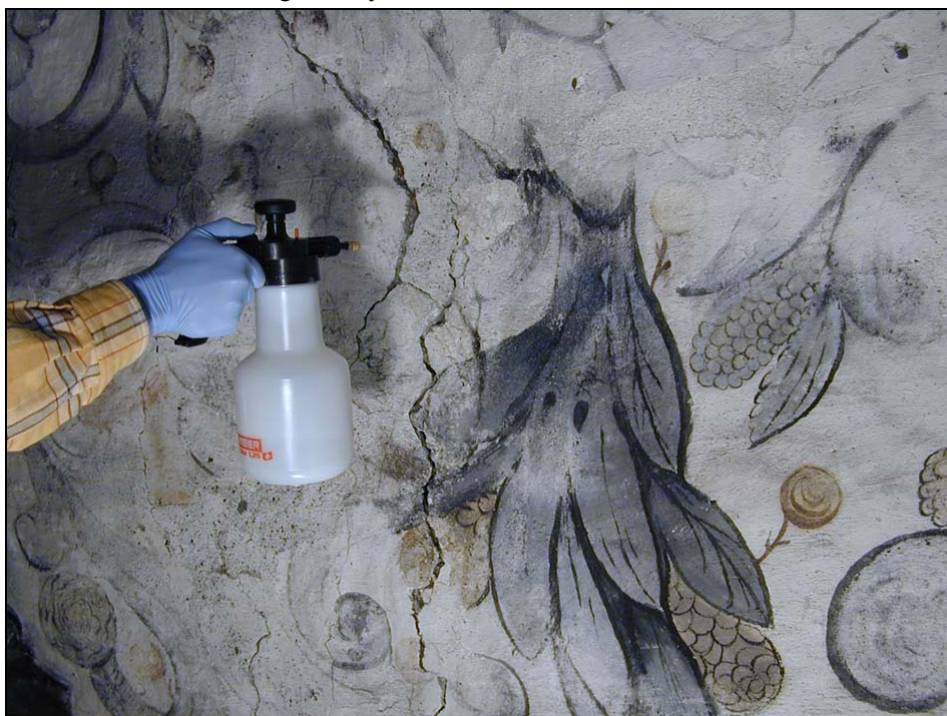
*Spraying limewater on the wall in order to consolidate the surface (in Q2). Note also the extensive cracks, which appeared after the removal of gypsum repairs from 1966*

There are several ways to treat powdering of paint on murals, but since we wanted to “stay in the system”, impregnation by limewater was chosen as the best option. Another option, impregnation by ethyl silicate, was considered very problematic, not least since other measures on the wall was to be undertaken by lime mortar. Lime mortar will introduce water to the wall, which negatively influences the hardening of ethyl silicate.

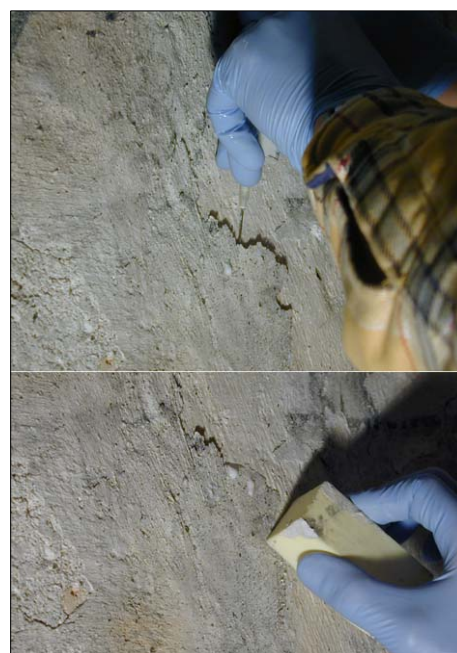
On the uppermost parts of the wall, especially on the so-called "chimney plaster" in Q2, intensive exfoliation of limewash and paint can be found. One reason seems to be that the limewash/paint from 1826 was applied on a very dry plaster. Another reason is the fact that large hollow areas and an extensive crack-pattern exists in these part (ibid.:35ff).

*Injecting lime behind limewash*

chapter 3.6). The lime mortar was applied using thin injection needles. Before injection the spot was pre-moistened with limewater (as used for impregnation; see above). After full absorption of the limewater the injection was performed and the flakes of limewash and paint were placed on the appropriate spot using slight pressure (manually with the hand). Very fine gaps between mortar and limewash were re-fixed using a thin soup of lime without any aggregates.

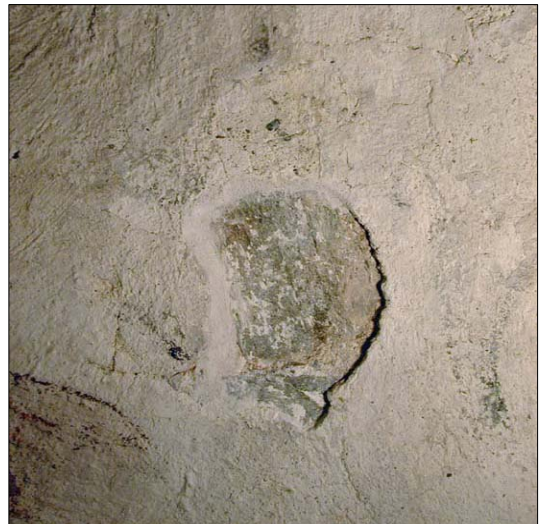
Shortly after filling some of the hollow areas, strong salt crystallisation (mirabilite) could be observed close to injection holes at one place in the upper left part of Q1 and one place in the lower right corner of Q1. We brushed away this salt, and it never recrystallised afterwards.

*Upper right part of Q1. After removing a large gypsum repair hollow areas around were filled with lime mortar, which was also use to close the gaps around the "open" area. Salt crystal-lisation were observed after the work, but after being brushed away they did not return.*

Apparently unstable and potentially dangerous hollow areas were filled with lime mortar with fine quartz-sand using injection needles (see prescription in chapter 3.6). Again, all places to be filled were pre-moistened with limewater in order to avoid shrinkage fissures in the new lime mortar.

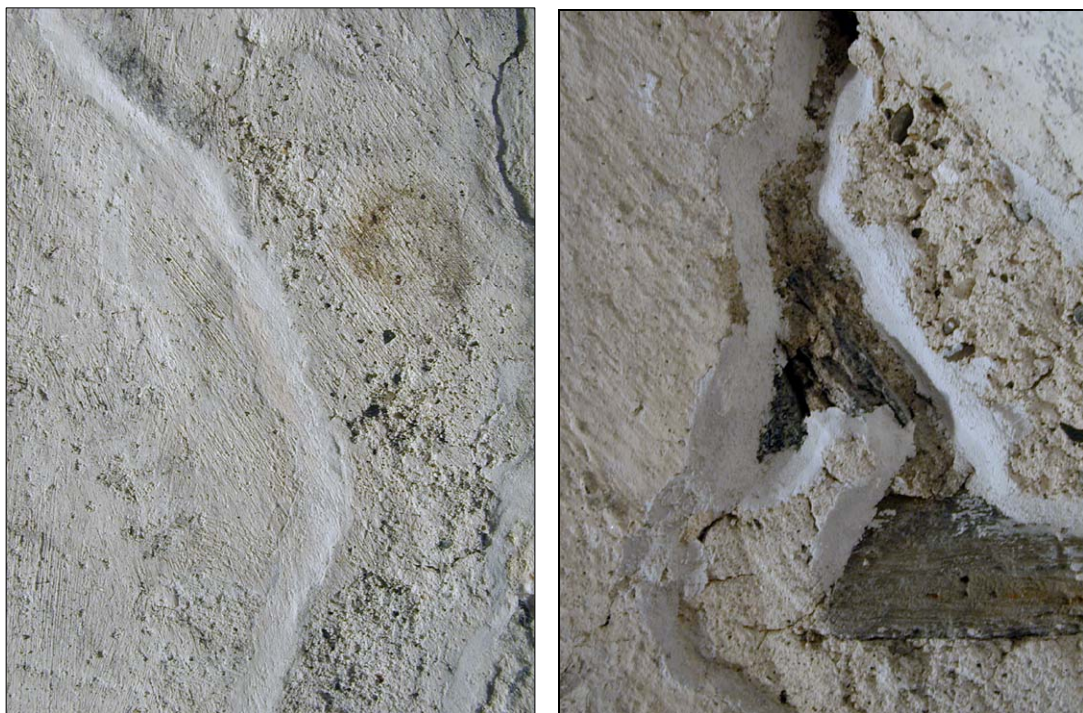
*Closing of cracks and gaps with lime mortar in Q2. Right: Final closing of crack. Left: temporary closing of edges and corners (Q2).*

In order to stabilise the plasters along the edges of cracks, they were filled using "regular" lime mortar (see prescription in chapter 3.6). According to the tests made in advance (see chapter 2), lime mortar with quartz sand was the best material for this purpose (few shrinkage fissures).

The same mortar was also used for closing many gaps on the wall, especially where the plasters had completely disappeared and masonry stones could be seen.

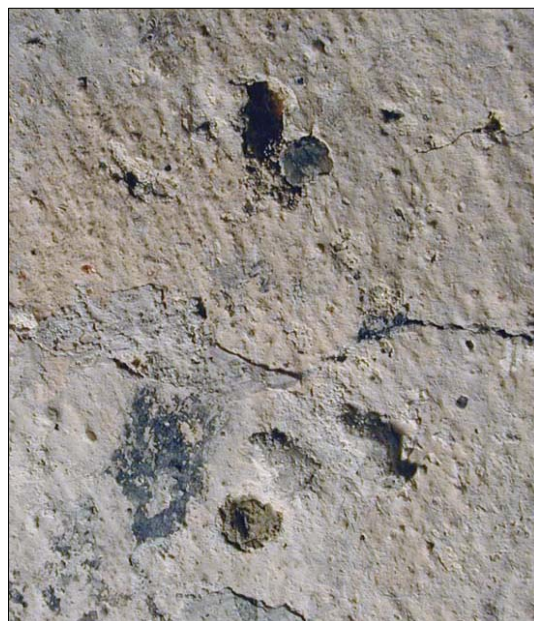
The injection mortar can especially be found in the lower right corner of Q1 and in the lower part of Q2. Although we have not seen it at other places, it is to be assumed that its use was more widespread. The mortar has apparently been used to fill hollow areas below plasters, and there are some clearly distinguishable holes in which the mortar must have been injected (see picture to the right). These holes were earlier incorrectly classified as strongly weathering aggregates (ibid.:42).

*Holes for injection mortar (Q2)*

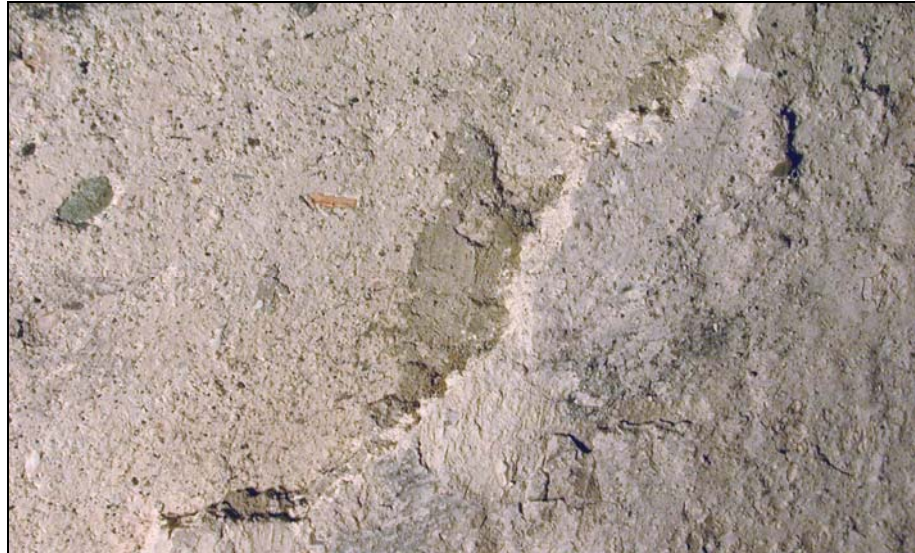
The mortars are medium to loosely bound and at places very soft and disintegrated. We classified the mortar as a weathered cement injection, but were not sure whether it could be a peculiar lime mortar. Since it was impossible for us to distinguish possible lime from other components in the very fine grained mortar by microscopy, we made a quick XRD in order to check for calcite. This analysis showed that there is no lime in the mortar whatsoever. We can thus rule out that it is a lime mortar, but in a cement one would also have expected some lime (calcite). This means that we are either dealing with a particular cement or with a different kind of mortar (cement paste cannot be accurately determined by XRD).

*Gray injection mortar behind plaster in Q1*

Since a main aim of the next conservation campaign is to fill in hollow areas, the injection mortar will have to be carefully analysed before the campaign starts in the summer of 2001.

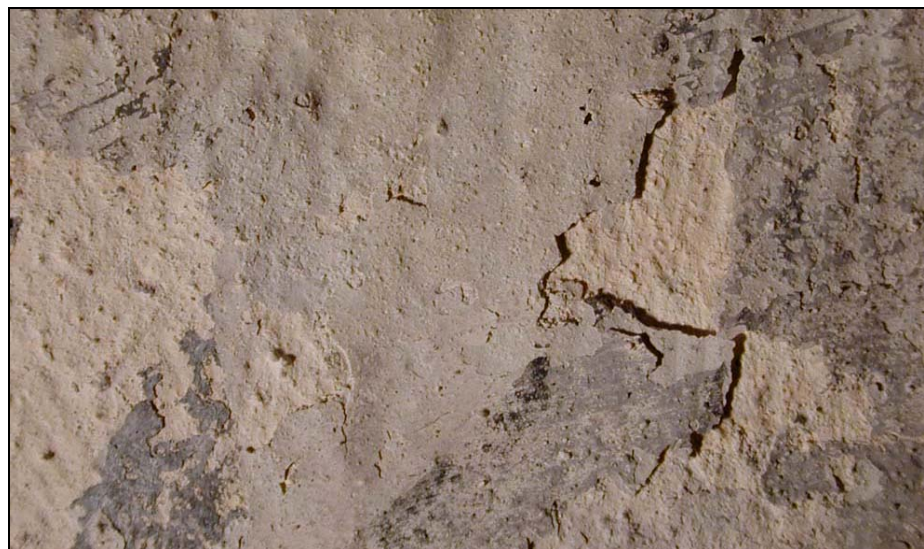
Discovered in 1999, but not reported in our previous report, a gray, intermediate paint layer was found to be quite extensive. It appears that it was applied above the original limewash from 1616, especially in the right corner of Q2. Perhaps it was applied in the intermediate, somewhat difficult-to-understand-period between 1672 and 1826. We did not analyse this layer properly in 2000, and further work will be undertaken later.

*Gray, intermediate paint layer (in the middle of the picture)*

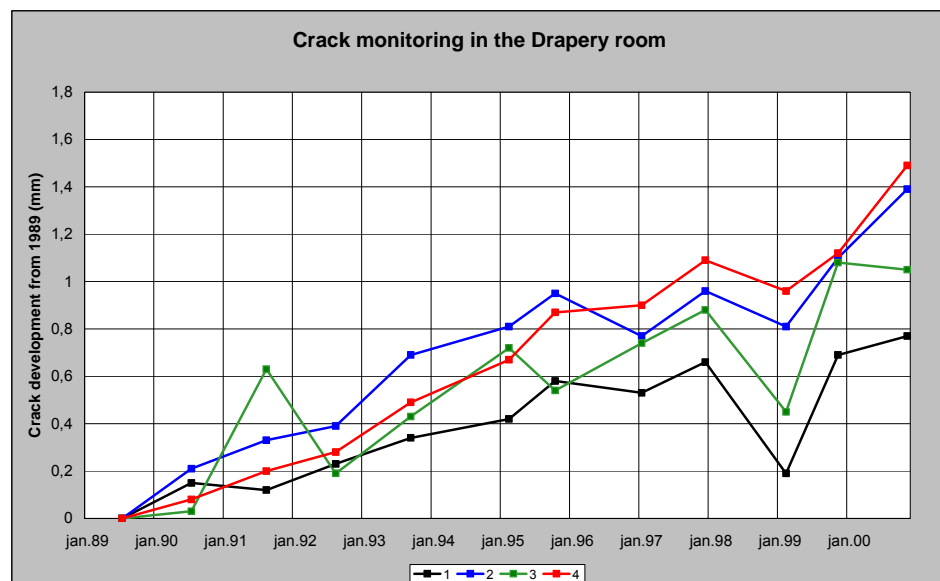
The new measurements show that the longitudinal (east-west) cracks generally widened little from 1999 to 2000. Maximum values were measured in the Drapery room close to the Regalia room, where the widening between November 1999 and November 2000 was in the order of 0,3 mm. This must be regarded as somewhat serious, especially since it seems clear that the widening does not represent seasonal variations.

*Crack monitoring in the Drapery room 1989-2000. No. 1-2 are measuring points on the west wall, and 3-4 on the east wall. The drop in the winter of 1999 was probably caused by heavy rain (see Franz & Storemyr 2000).*

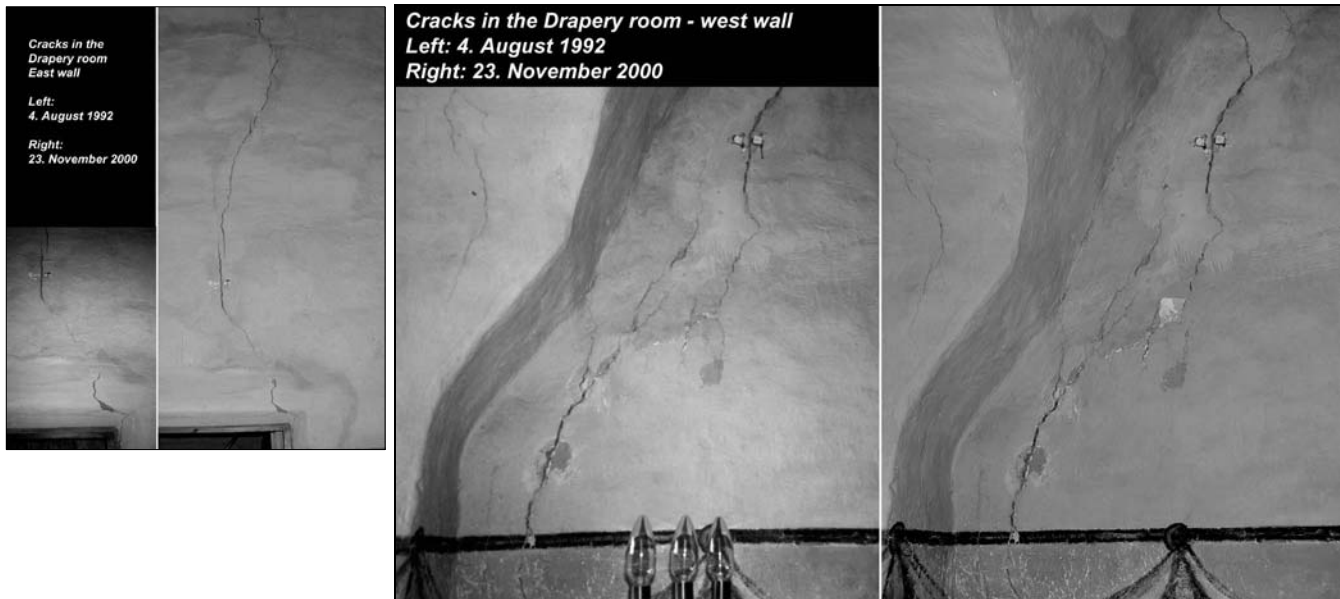
After finding photos of the cracks in the Drapery room taken in 1992, we have undertaken a comparison with the state in 2000 (see photos on next page). It is impossible to observe any widening of the cracks on the photos, but it seems that no *new* cracks have developed over these 8-9 years. It is on the other hand clear that a few flakes of exfoliating plaster and whitewash close to the cracks have been lost in the period (both on the west and east wall). This corresponds to what we have observed in the Regalia room (east and west wall).

*Cracks in the Drapery room. Comparison of state in 1992 and 2000 on the west wall (large photo, measuring points 1-2) and east wall (small photo, measuring points 3-4). Photos: Øystein Ekroll (1992) and Per Storemyr (2000)*

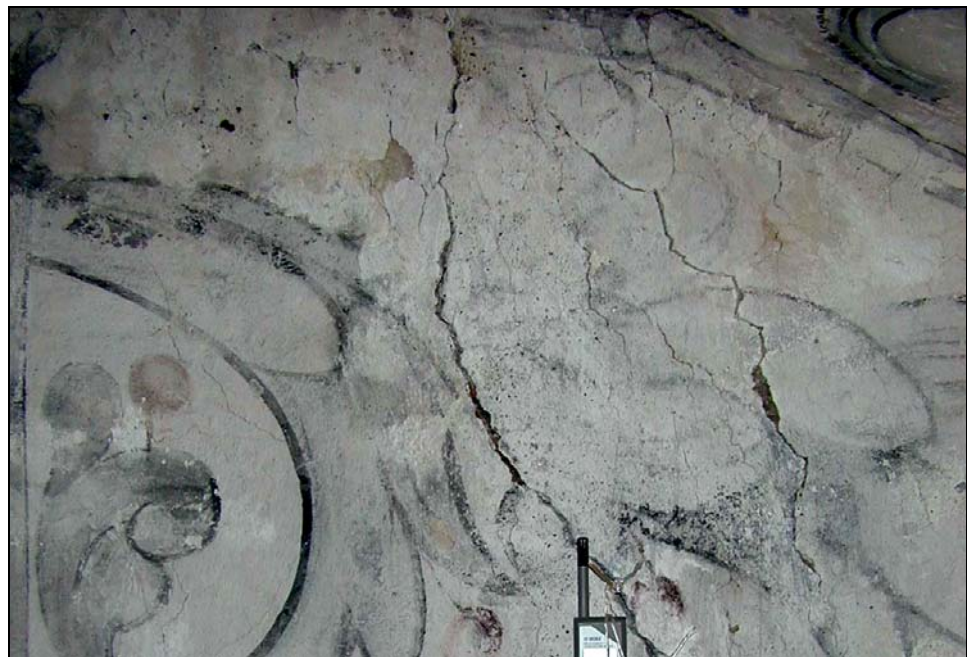
The removal of gypsum repairs from 1966 on the west wall in the Regalia room made it much easier to see the extent of the cracks. Although looking dramatic, we believe that the cracks are quite stable at the moment, and at least not widening more than cracks in the Drapery room. Since most of the cracks were closed by lime mortar repairs in 2000, it will be easier to follow possible widening in the future. We also plan to establish measuring points on the wall.

*Cracks on the west wall (Q1) after removal of gypsum repairs from 1966. The cracks were closed with lime mortar in 2000*

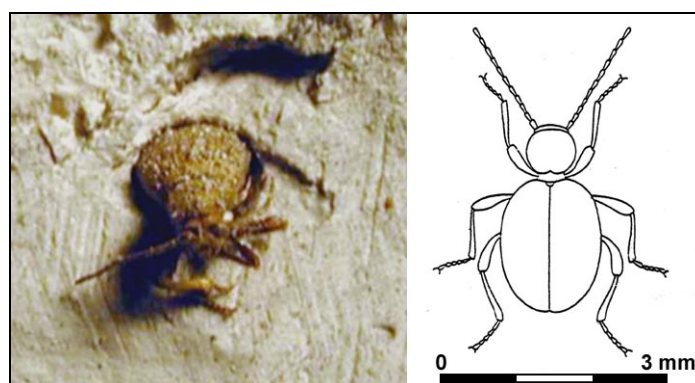
*Brass beetle (Niptus hololeucus) in the Regalia room.  
Drawing after Statens Institutt for Folkehelse,  
RM 1989, nr. 100*

Before the emergency conservation commenced in 2000, several more beetles were found on the floor close to the west wall. Some were alive, and some might have fallen from the wall or the openings between the wall and the vault. One was taken to professor in zoology, Jon Solem at the Museum of Natural History and Archaeology in Trondheim, who immediately determined it as a brass beetle (*Niptus hololeucus*), which belongs to a family of "theft beetles".

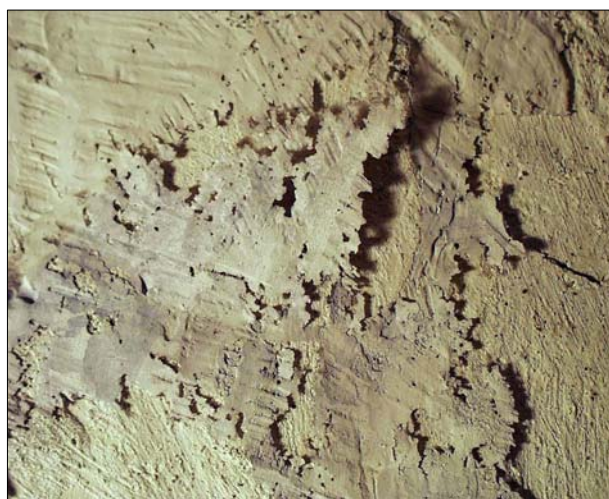
*Exfoliating gypsum repair from 1966  
(photo from 1999)*

used to seal most cracks in 1966. As reported in Franz & Storemyr (2000:39f), these gypsum repairs were in very bad condition before they were removed in June 2000 (see picture above). However, this suggestion has by no means been confirmed. Moreover, as the cracks are now sealed by lime mortar, we will have to observe the development over a longer period of time in order to find out whether these new sealings will weather faster than other parts of the wall.

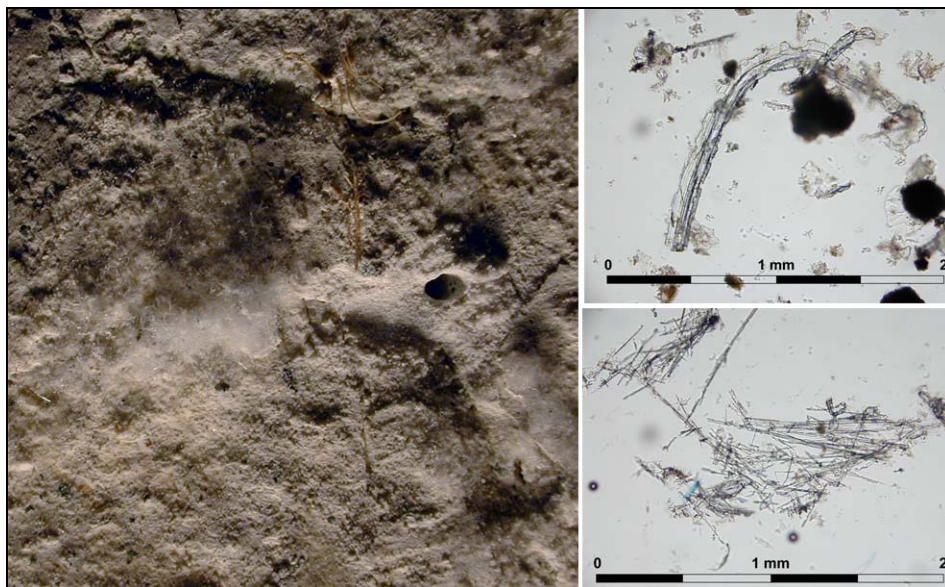
During the emergency conservation in June 2000, we also used lime mortar as an injection material for fixing scales etc. (see chapter 3.4). This implied that much moisture entered the wall at specific locations. At two such locations, both in Q1, mirabilite (hydrated sodium sulphate) appeared very soon (some hours) after injection (see picture below).

*Needles and whiskers of mirabilite formed soon after injecting lime mortar for consolidation purposes in Q1. Left: Cotton-like surface deposits of mirabilite. Right: Microphotos of needles (below) and whiskers (above). Microphotos taken in normal light.*

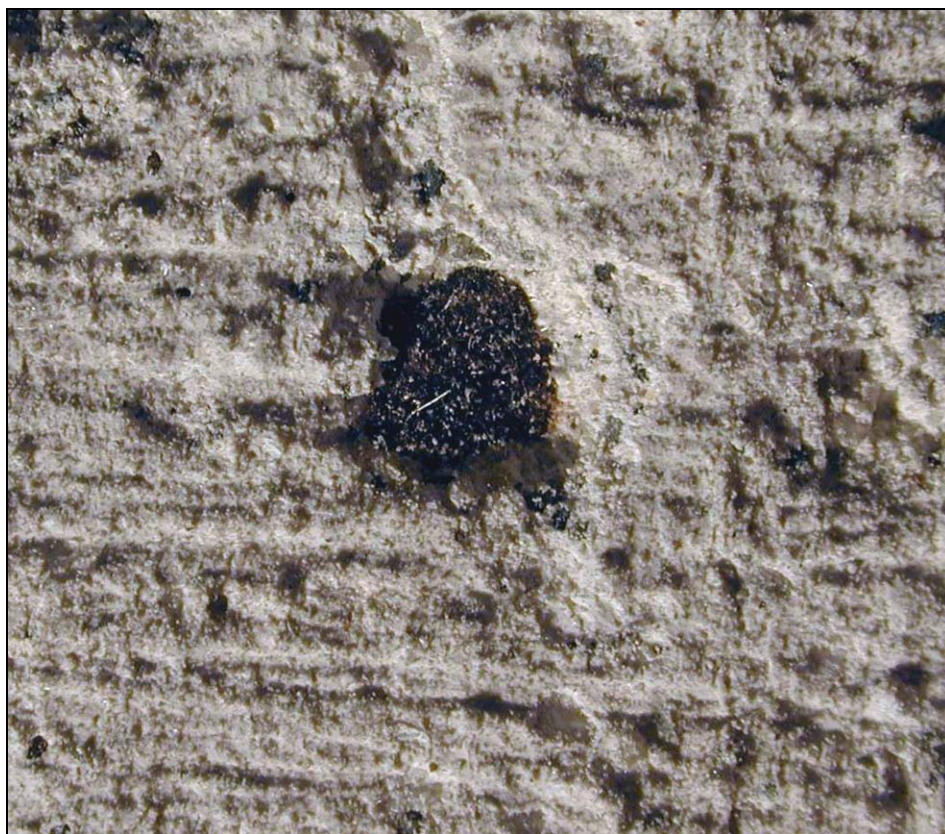
*Observation spot O.1 on a dark aggregate grain. Note the tiny, white salt needle in the middle. Width of field c. 10 mm*

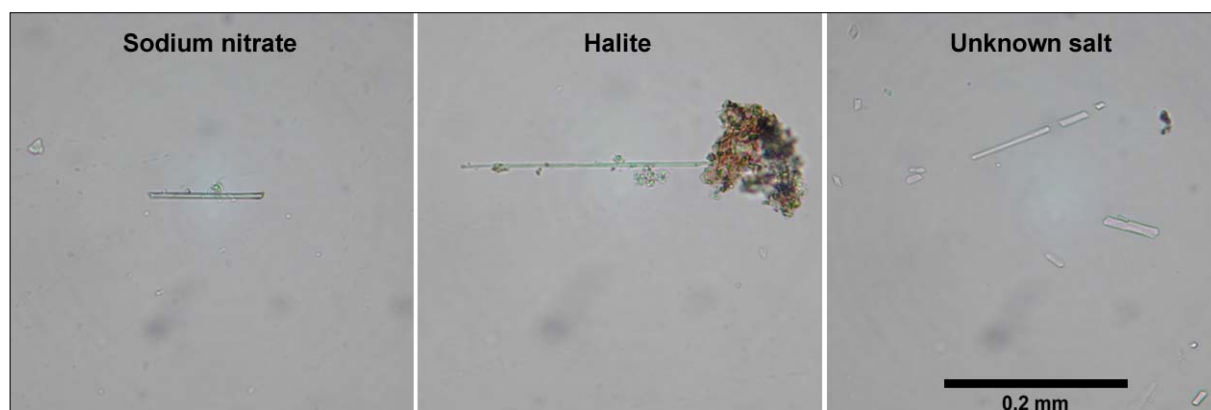
*Microphotos of salts found on observation spot O.1. Left: Needle of sodium nitrate. Middle: Needle of halite. Right: Unknown salt (possibly aphthitalite). Pictures taken in normal light. The scale to the right applies to all three microphotos. Sample taken/analysed 2. June 2000*

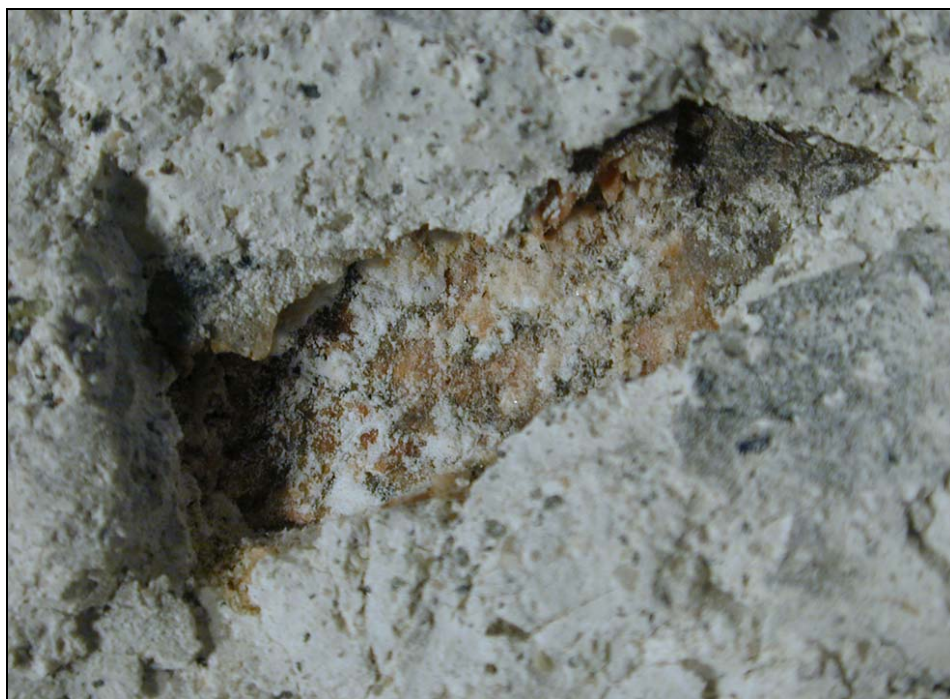
This spot is located in a "hole" in the limewash/mortar, on granite in Q2. There are much powdery efflorescences of thenardite both on the spot itself and below adjacent scales of mortar and limewash. After spraying the wall with limewater in June 2000 all the salts went into solution, and when the last observation was made in December 2000, they had not re-appeared. It should be noted that the spot is now covered with a very thin layer of lime mortar.

*Observation spot O.2. Powdery efflorescences of thenardite.  
Width of field c. 5 cm.*

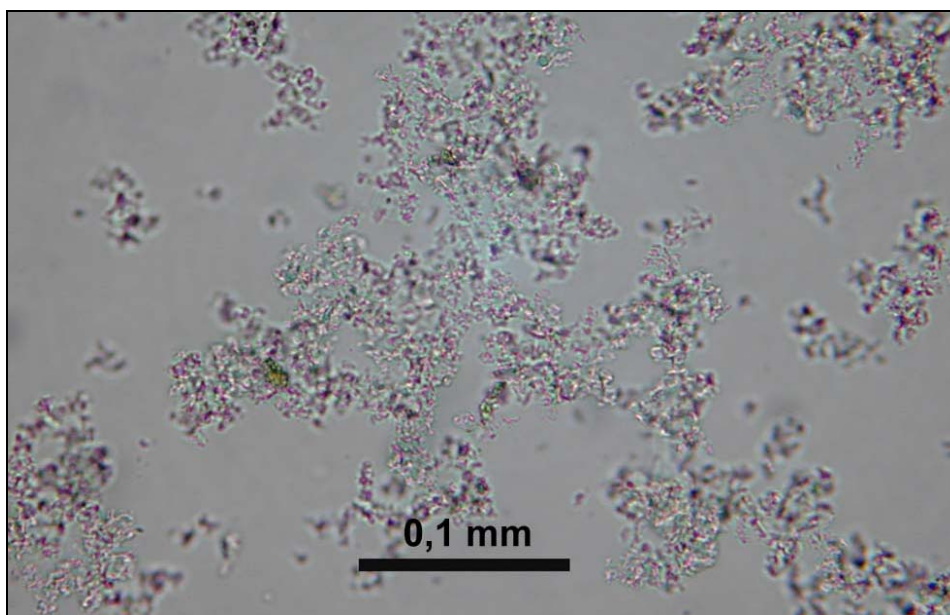
*Microphoto of thenardite in O.2. The dehydrated morphology indicates that the salt formed from mirabilite. Sample taken/analysed 2. June 2000*

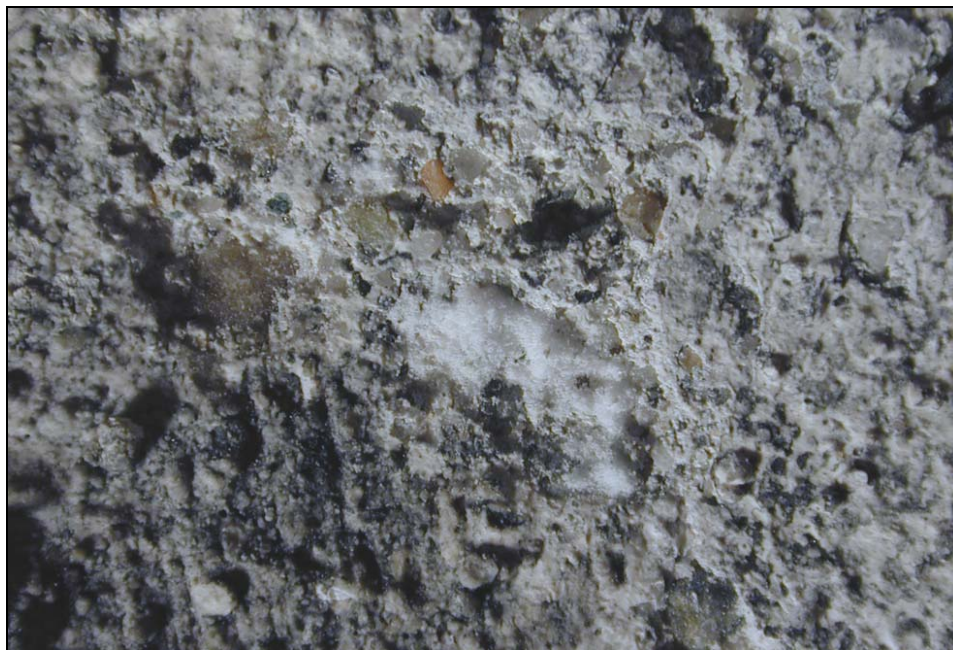
This spot is located within the "vault" of the door opening, and is the only place on the wall that has got epsomite as the main salt species. Epsomite occurs in its "normal" way, as "skeleton-like" whiskers with rounded edges. This area was not sprayed with lime water, and no morphological changes has been observed during the fall of 2000.

*Powdery efflorescences and whiskers of epsomite in O.3. Width of field c. 5 cm*

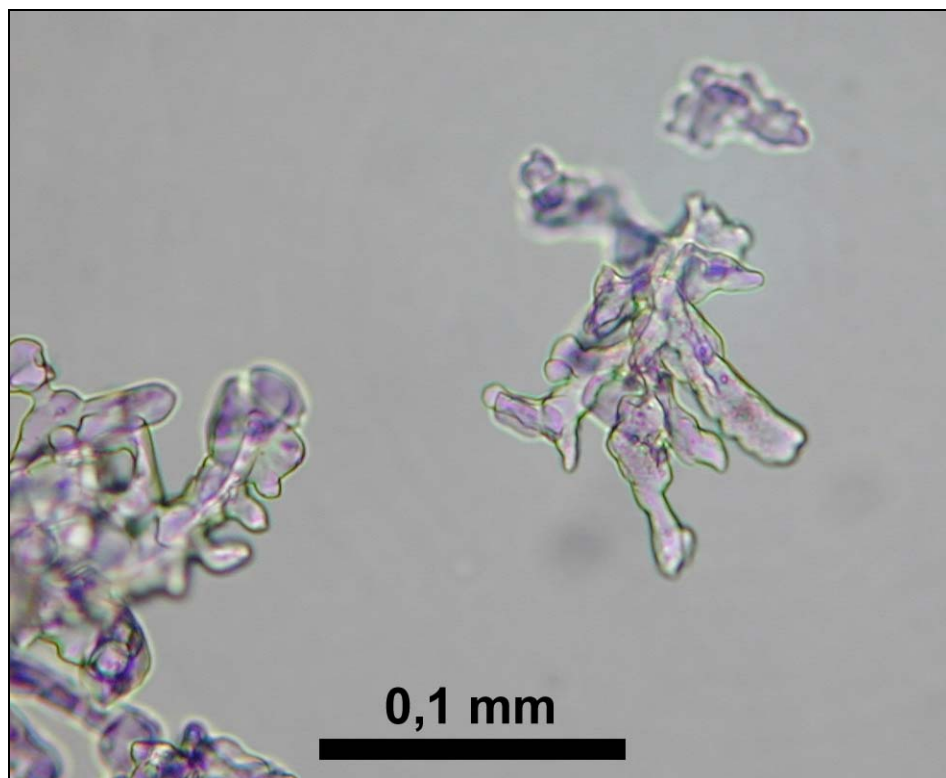
*Microphoto of epsomite in O.3. Sample taken/analysed 2. June 2000*
