Weathering and Conservation of Soapstone and Greenschist used at Nidaros Cathedral

Brief Summary of Investigations 1999-2000

May 2000

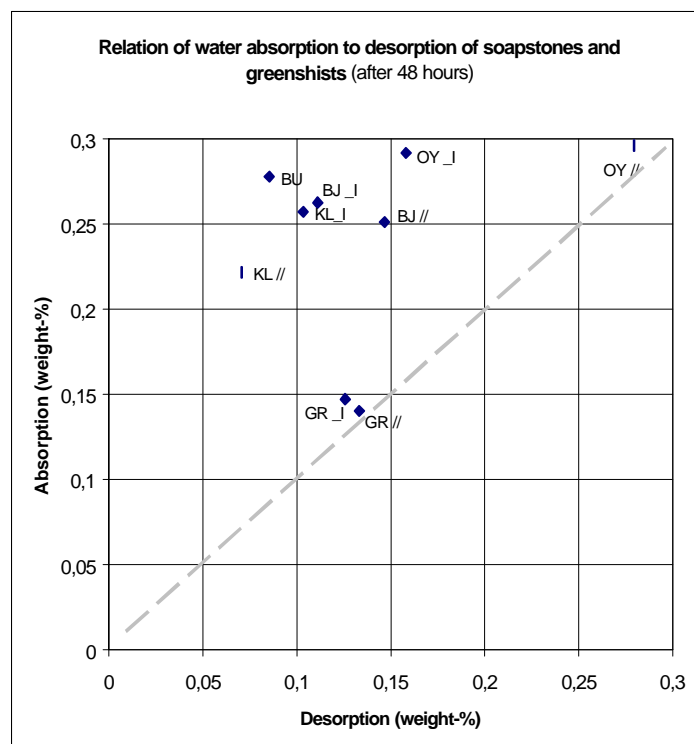
Capillary water absorption is usually very slow (see figure below). As usual, the *desorption* (or evaporation) is slower than the absorption, and dependent on the orientation of the stones, i.e. water is more rapidly desorbed parallel to the distinct foliation in some stones. This means that once filled with water, the stones keep it for a long time. This is for instance relevant for the frost resistance of the stones.

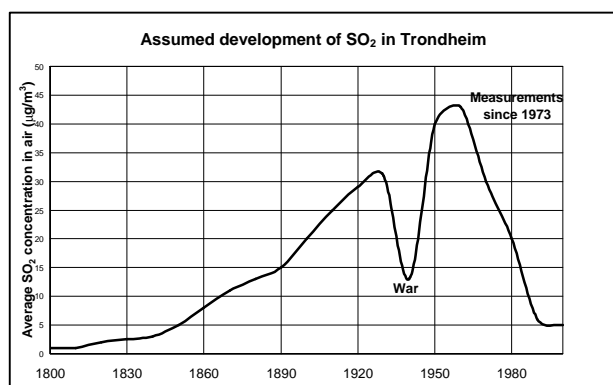
Fig. 3: Assumed development of SO₂ in Trondheim (from Storemyr 1997)

The history of local air pollution in Trondheim goes back to the beginning of the 19th century when heating with coal became normal and small industrial enterprises were established in the city. SO₂-concentrations increased towards the turn of the century, and it has been assumed that average concentrations in the cold season rarely exceeded some 40 µg/m³ between 1920 and the late 1970s (Storemyr 1997). Since then there has been a drastic decrease to some five µg/m³ at present (fig. 3). Emissions of NO_x from traffic have been increasing during the last decades and lays at present in the range of 40-60 µg/m³ (cold season) (Hagen 1994).

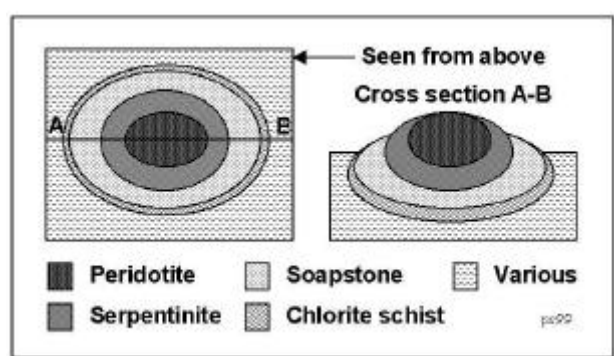
Fig. 4: Geology of a typical soapstone deposit derived from alteration of peridotite. Tectonic movements may have rendered the structure much more complex than shown on the picture

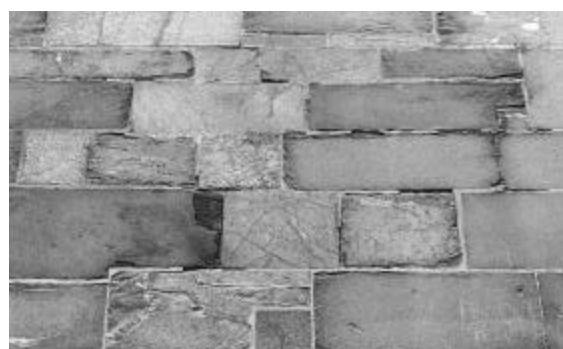
Fig. 5: Ashlars of Øye chlorite schist (dark) and Bakkaunet soapstone (light) side by side in the Octagon of Nidaros Cathedral. Note slight weathering along repointed cement joints.

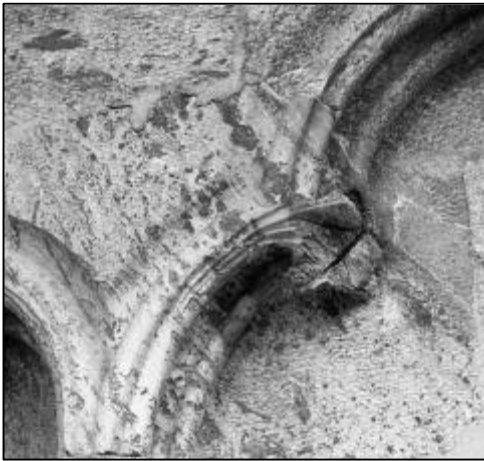
Fig. 6: Stavanger soapstone

The various soapstones at Stavanger cathedral have not been included in tables 1-2. Contrary to most of the “soapstones” at Nidaros Cathedral, the quarries from where the stones at Stavanger were extracted in the Middle Ages are not properly known, although it may be assumed that the quarries are local ones of Caledonian age. The most common stone at the High-Gothic choir is a soapstone proper (hereafter named “Stavanger soapstone”, fig. 6). It is a very soft, slightly foliated stone with a matrix of relatively fine-grained talc and chlorite, and very large aggregates and intersecting veins of carbonate minerals (mostly dolomite). Carbonate minerals may also occur as well-developed, millimetre-large crystals within the matrix. Many stones contain characteristic “pockets” of very compact and soft green talc/chlorite. Pyrite is a common trace mineral.

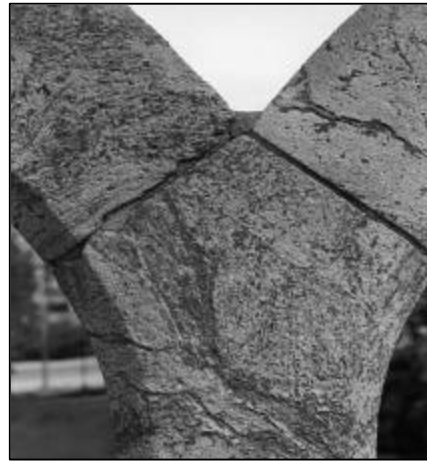
Fig. 7: Bergen soapstone

Several soapstone deposits can be found in various altered ophiolite fragments around Bergen. One of these stones, perhaps originating from a quarry called Kvernes, has been used at the 17th century north portal of the Church of the Holy Cross in the city centre (hereafter named “Bergen soapstone”, fig. 7). It is a foliated soapstone proper, very much like the Stavanger soapstone, with intersecting veins of dolomite and magnesite. However, contrary to Stavanger, Bergen soapstone contains no sulphides at all, but large amounts of magnetite (Storemyr and Bredal-Jørgensen in Moe 1998).

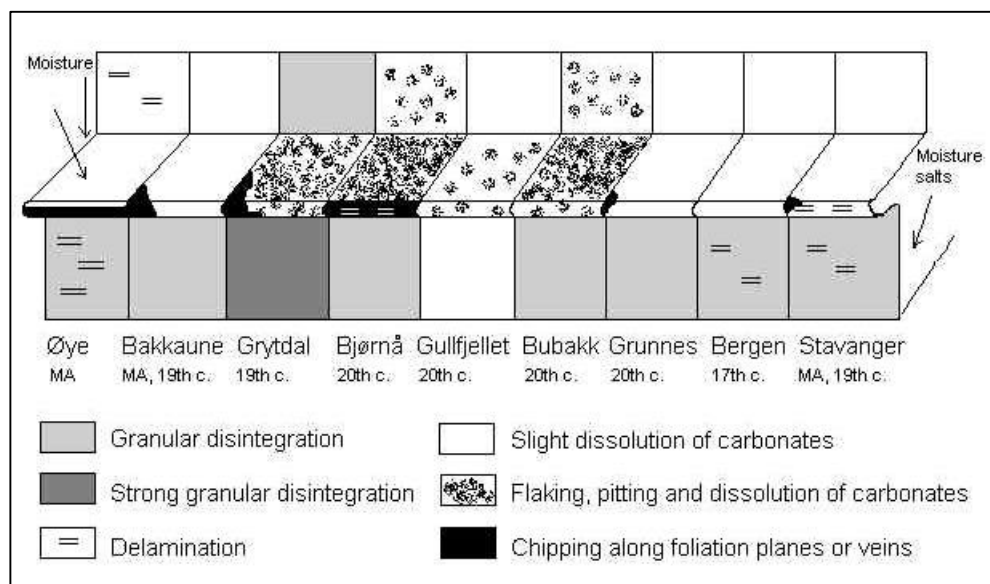
Fig. 8: Behaviour of the investigated stones under typical exposure conditions. Observations have been made both at buildings and relevant quarry faces.

Depending on the actual stone type and the time it has been in service, the typical weathering forms are (fig. 8): 1) Slight to heavy crumbling of the upper surface, usually combined with growth of lichens. 2) Loss of mouldings (or other projecting details). 3) Thinner or thicker black crusts underneath, often combined with various forms of flaking and delamination. It must be noted that the foliated stones usually are horizontally bedded - and not face-bedded - when used in such situation.

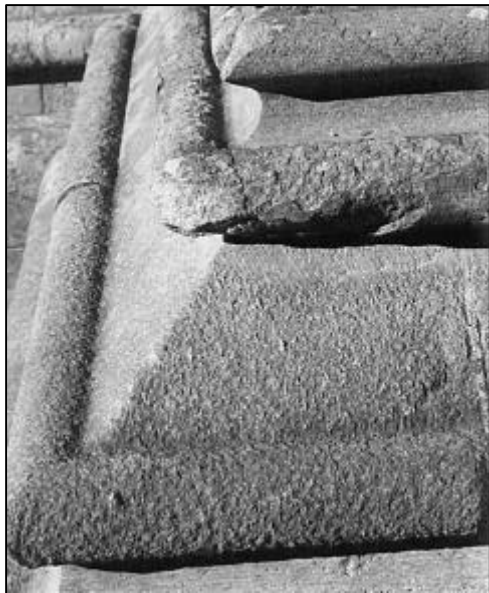
Fig. 9: Crumbling of exposed Bjørnå stone at Nidaros Cathedral

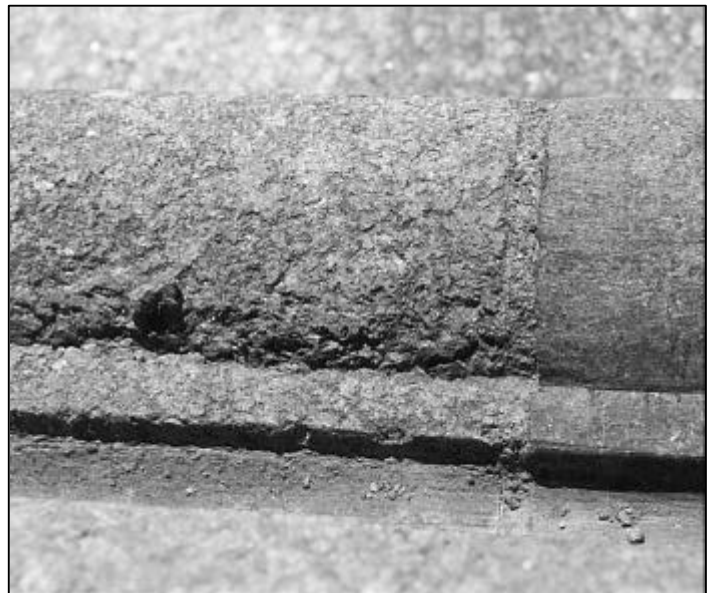
Fig. 10: Crumbling of exposed Bubakk stone at Nidaros Cathedral. The stone to the right is a serpentine

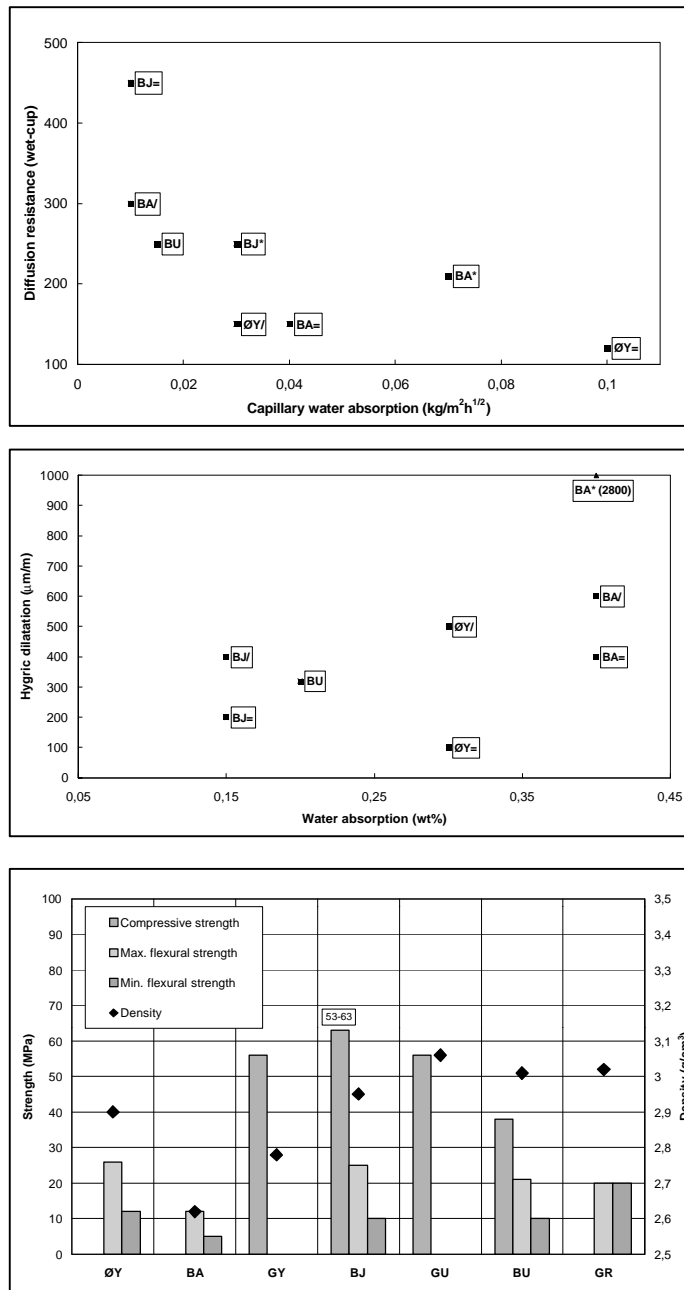
Fig. 11: Water vapour diffusion resistance (top), hygric dilatation (middle) and mechanical properties (bottom) of investigated stones. ØY=Øye, BA=Bakkaunet, GY=Grytdal, BJ=Bjørnå, GU=Gullfjellet, BU=Bubakk, GR=Grunnnes.

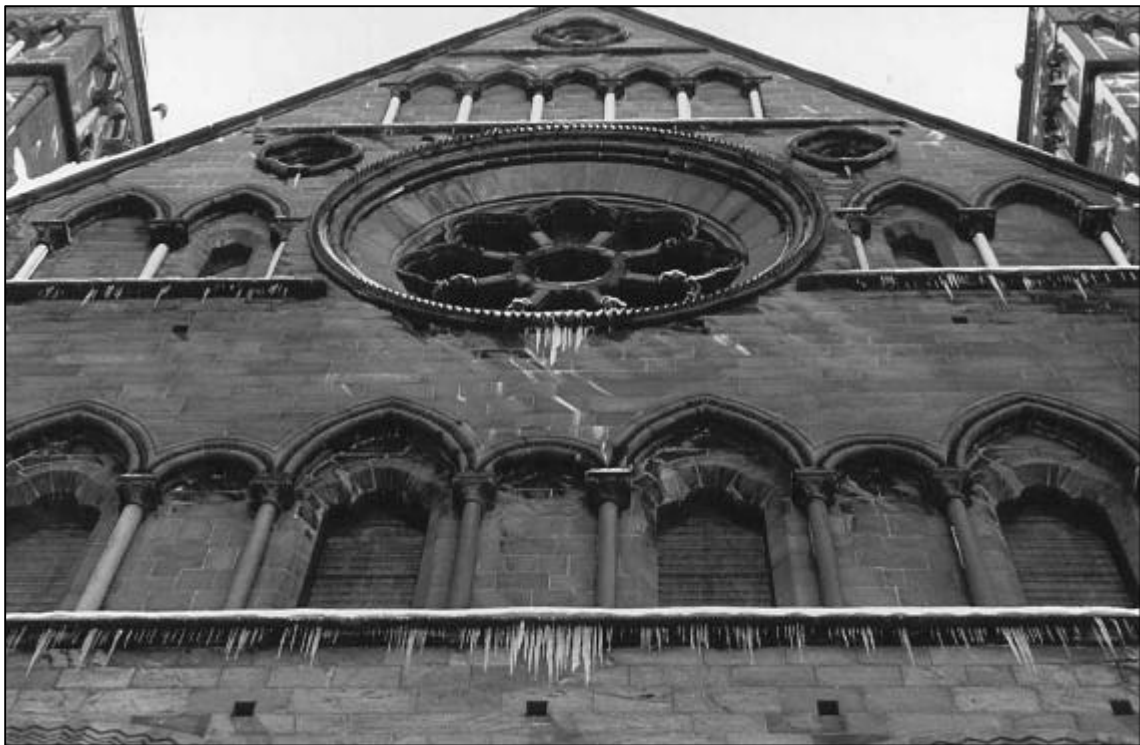
Fig. 12: Icicles forming from string courses made of Bjørnå stone, Nidaros Cathedral. The mouldings had recently to be removed due to dangerous cracks along foliation planes.

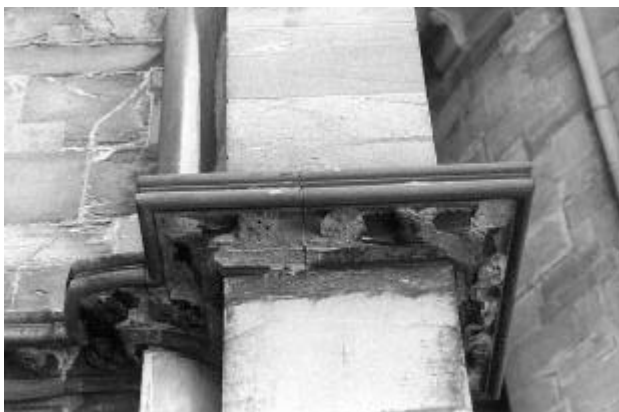
Fig. 13: Loss of carved detail underneath string course made of Øye stone, probably mainly due to the formation of black crusts.

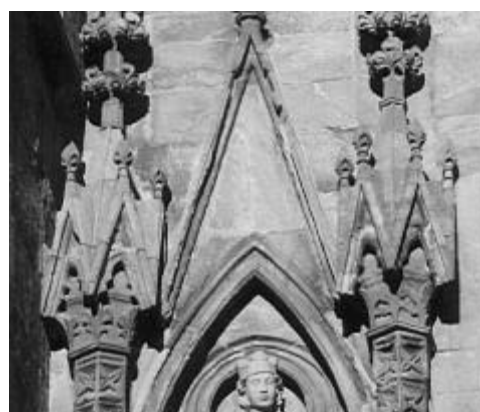
Fig. 14: Weathering at niches on the east front of Stavanger cathedral. Parts of mouldings are lost in the blind gable

Black crust formation is a greater problem at parts of Stavanger Cathedral. Typically, the lower parts of mouldings are lost along foliation planes or in a very disintegrated state (fig. 14). In the latter case, relatively "hard" gypsum crusts might conceal a completely disintegrated stone, making it very difficult to remove the crusts without causing a lot of damage. Formerly, such areas were simply removed and replaced by new stone (piecing in). The reason why this problem is so pronounced in Stavanger is manifold, but particularly related to the fact that the actual mouldings are sloping, as they are part of wall niches or other architectural features. This implies that moisture have easier access to the underside of the mouldings where black crusts can accumulate.

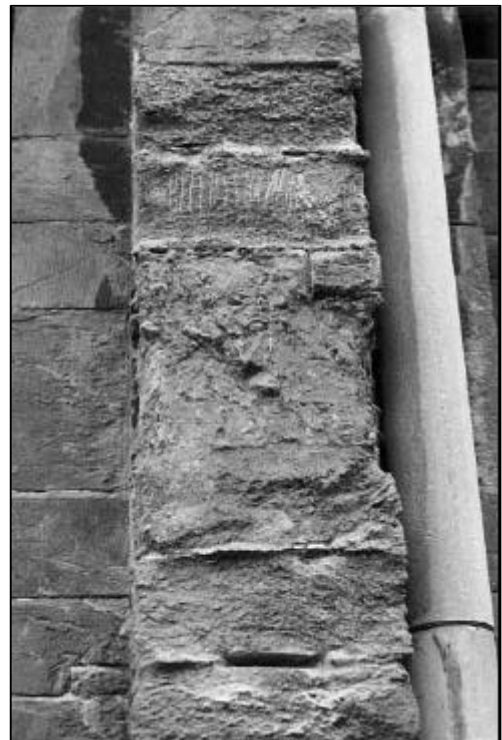
Fig. 15: Typical appearance of the worst damaged Grytdal stone.

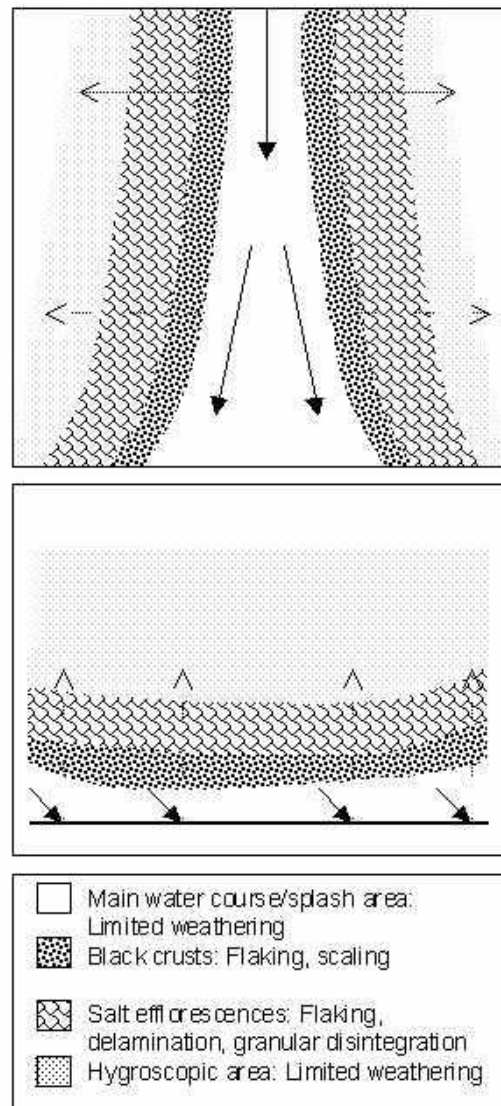
Fig. 16: Idealised representation of weathering in transition zones between exposed (run-off, water splash) and sheltered stonework. In actual cases two or more transition zones may be absent or overlap, creating a more complex picture

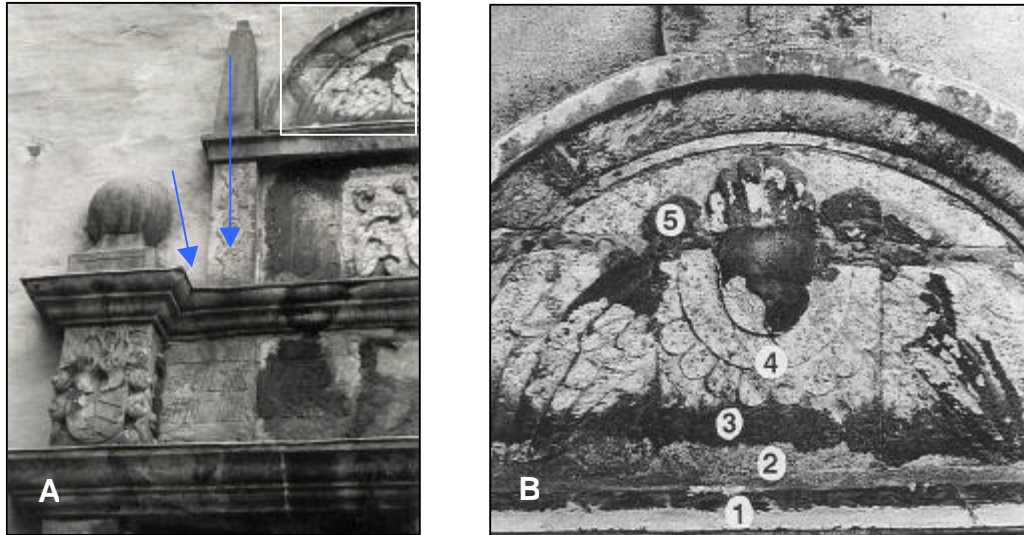
Fig. 17: Weathering at the north portal of the Church of the Holy Cross in Bergen. A) Black crusts accumulate beside water course (arrows), B) Weathering in splash zone; 1) Sill, 2) Washed part, 3) Accumulating black crusts, 4) Areas with salts (gypsum/chlorides) and delamination, 5) Slightly projecting details with black crusts. Black crusts have probably accumulated here because the details are projecting, but not completely exposed. (Photo B from Moe 1998)

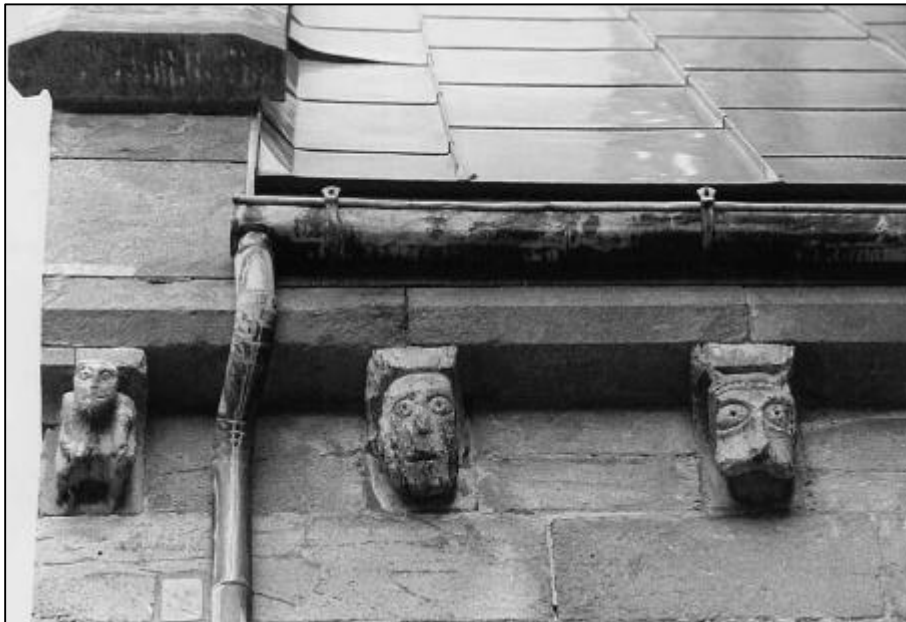
Fig. 18: Corbel heads made of Øye stone in St. Michael's chapel, Nidaros.

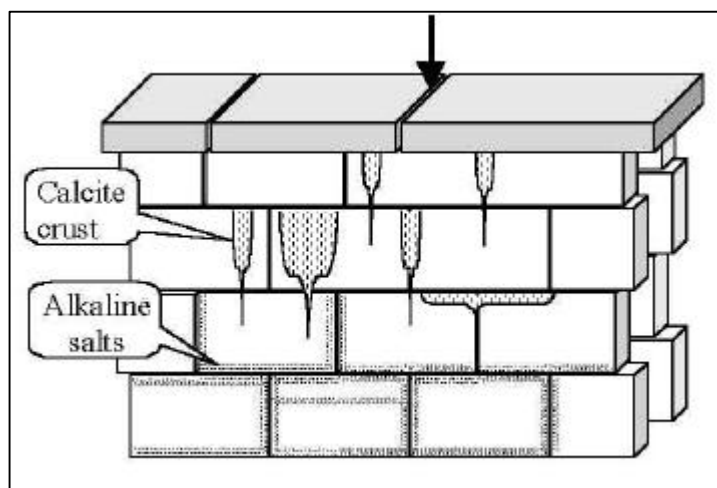
Fig. 19: Schematic representation of the carbonate salt system. The arrow indicates water leakage through open joints.

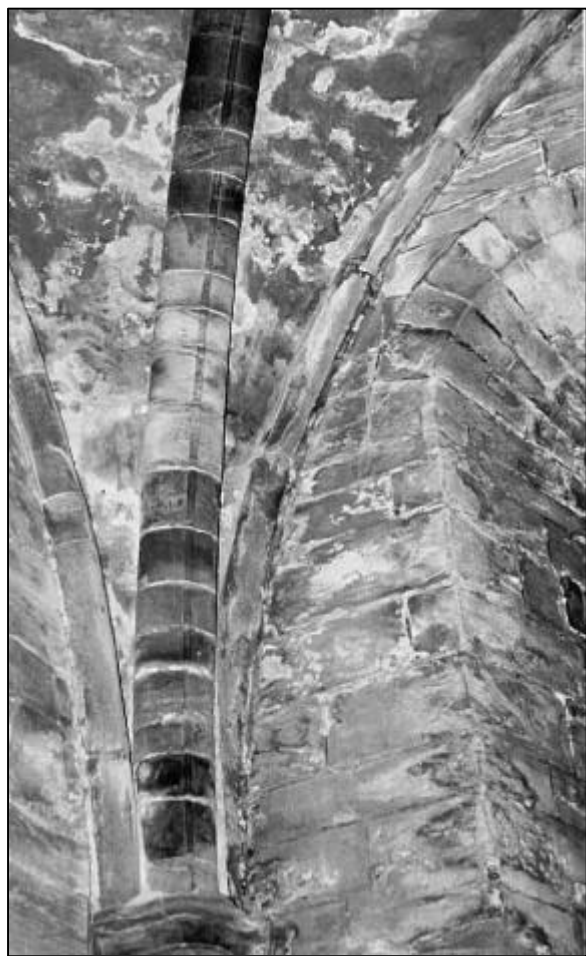
Fig. 20: West wall of the chapter house at Nidaros. The carbonate salt system consists mainly of trona and aphthitalite from cement mortars, but also some sodium sulphates can be found.

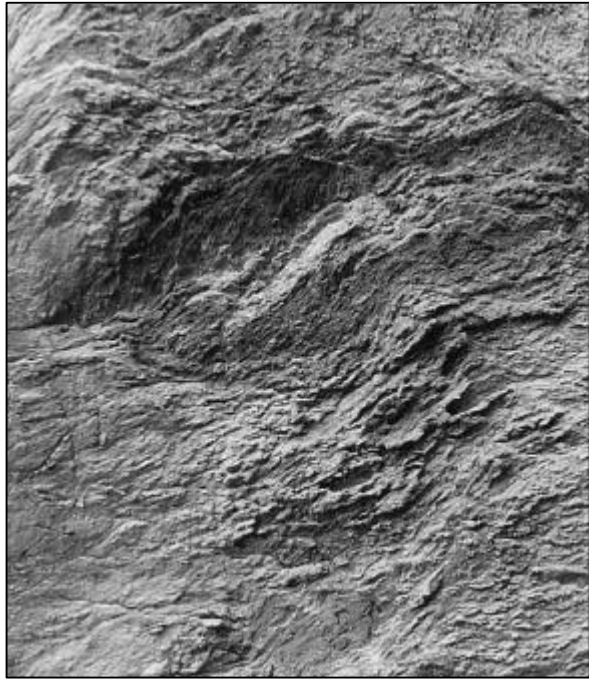
Fig. 21: Flaking and delamination at a sheltered rock face in the Øye quarry. Gypsum seems to be responsible for the weathering. Note pyrite aggregate (light/yellow).

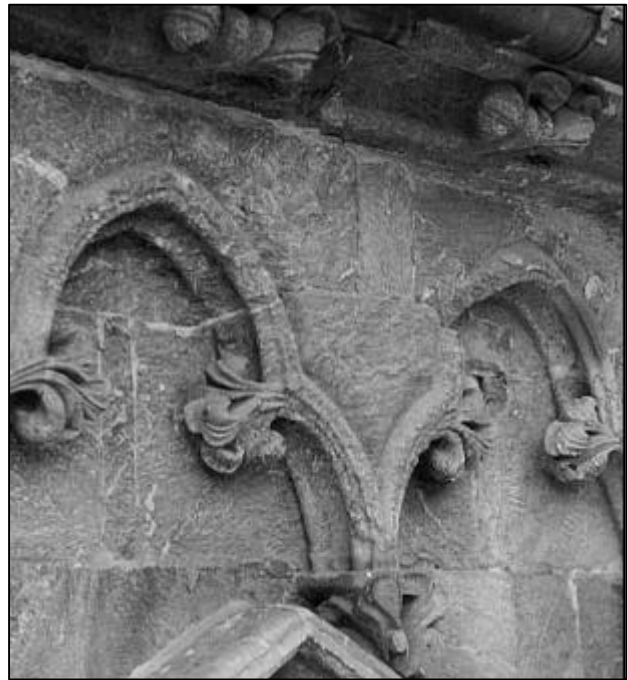
Fig. 22: Granular disintegration and delamination at a sheltered part of the south wall at Stavanger Cathedral. Former leaks may have brought large amounts of gypsum into the stonework.

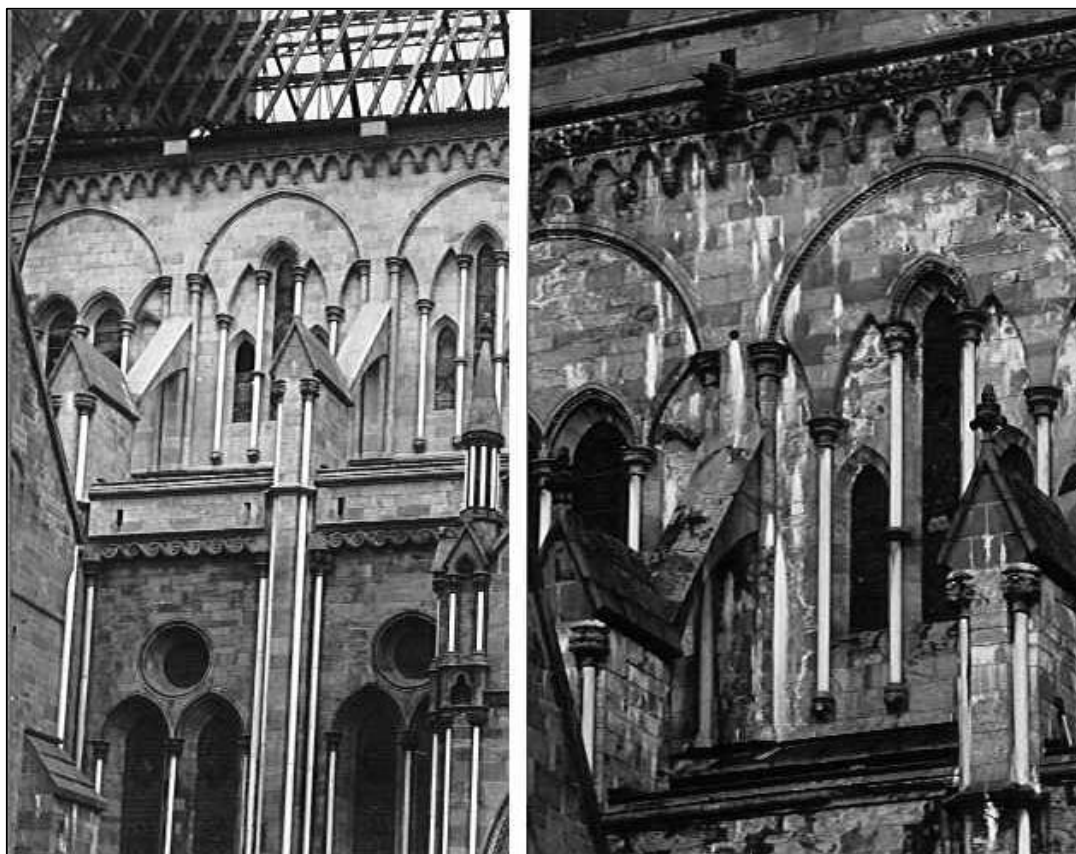
Fig. 23: The choir at Nidaros cathedral. Reconstructed in the 1880s (left), the choir today exhibits severe salt weathering (right). Salts present include calcite crusts, some sodium carbonates, but first of all gypsum, magnesium sulphates, sodium sulphates and a little chloride (secondary reaction system). The most important salt sources are Grytdal stone, brick in the inner walls and Portland cement mortars.
