Weathering and Conservation of Soapstone and Greenschist Used at Nidaros Cathedral (Norway)

Preliminary summary of results - a work document

Per Storemyr¹, Eberhard Wendler² & Konrad Zehnder³

February 2001(PDF-version August 2002)

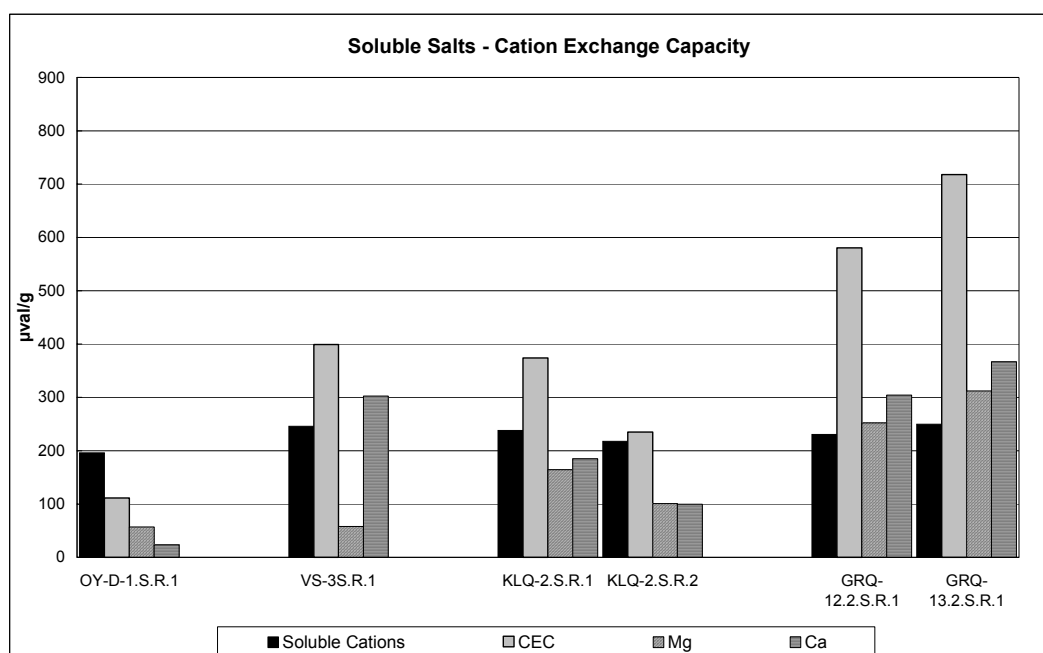
Diagram showing the amount of soluble salts and the cation exchange capacity of various stones (OY=Øye, VS=Øye, KL=Klungen, GR=Grunnes). Soluble cations means cations from salts (mostly Na), CEC means measured cation exchange capacity, and Mg and Ca means ions mobilised from the samples, in an ammonium acetate solution.

In order to try to understand the hygric dilatation of soapstone, and the behaviour when subjected to soluble salts, the cation exchange capacities (CEC) were determined. Our hypothesis was that large cations in chlorite (and talc/biotite) might be exchanged by foreign ions such as sodium. The CEC is apparently very high, much higher than in most sandstones, but since the cations *released* mostly are Mg and Ca in a c. 1:1 ratio, it seems that they represent ions *mobilised* from dolomite (in an ammonium acetate solution, which was used for determining the CEC). Thus, this probably means that there is no significant real cation exchange in the actual stones. In the figure below it can be seen that Øye greenschist behaves differently from Klungen and Grunnes. This is probably because the samples were peculiar: OY-D-1.S.R.1 was taken from a dump close to the quarry and had been buried in the earth for hundreds of years, whereas VS-3S.R.1 had been used closed to lime mortar joints at Værnes church, thereby being enriched in Ca.

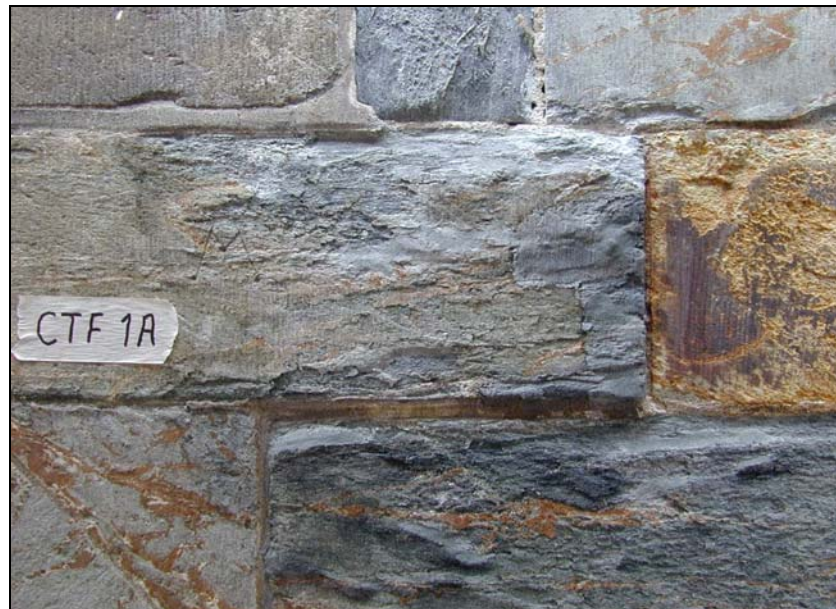
Example of documentation of test fields (field 1A at the north aisle of the choir). The upper picture shows a map of applied products, whereas the lower one shows the field after application (washes and mortars are visible on the picture)

The time passed since the establishment of the test fields (summer 2000) is of course much too short to be able to state anything about the long-term durability of the products. However, some comments on the application experiences can be made:

- Many test field were salt laden, and although visible salts (as well as loose material) were removed mechanically before application, *the use of the ethyl silicate module is risky.*
- The practical application of the products was undertaken without any significant problems (no problems with for instance injection needles becoming packed).
- Washes and especially repair mortars were much too light in order to blend with the rather dark soapstone surfaces; these products will have to be coloured before application in real situations.
- One test with washes on a very exposed stone was made already in the spring of 2000 - this wash has not shown any significant alterations yet (until February 2001)

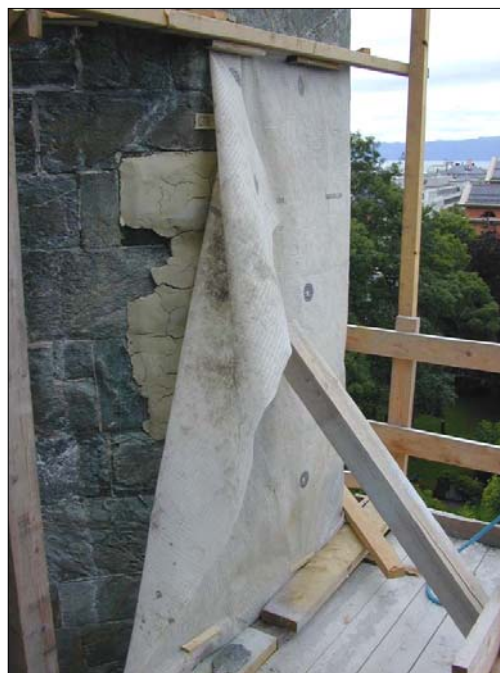
Dry two-layered desalination compress five days after application (test field 4, north turret of the choir)

The idea is that the first layer should ensure maximum contact to the stonework, while the second layer is intended for taking up the crystallising salts. Moreover, such a two-layered compress prevents the salts from re-entering the stonework after crystallising. The functioning of the compress is dependent on a decreasing moisture gradient from the stonework outwards, which means that the compress should not be completely covered by diffusion resistant materials (plastic). We utilised a simple reinforced plastic cover that was slightly open at one side, but otherwise covering the compress very well in order to prevent it from drying out too quickly.

This system has worked well at numerous sandstone buildings in Germany and the compresses have usually stayed slightly moist for 4-6 weeks, which is the minimum time required for effective desalination. In our case (see picture on the previous page), the compresses surprisingly dried out after some four-five days only. The second layer had at that time developed numerous cracks and was beginning to fall from the masonry. Moreover, the first layer had removed quite a lot of superficial stone powder from the masonry, although it had been carefully mechanically cleaned before application.

The main explanation of the rapid drying of the compress must be that soapstone is dense and thereby contains very little moisture, as compared to e.g. sandstone. Another reason might be that the cover simply was not good enough, or "promoted" too rapid drying; perhaps it is better to apply tight "Glad Pack" cover, which is said to be diffusion open. A diffusion open covering is of course a prerequisite in order for the compress to work. These possible explanations will be considered when trying to repeat the experiment. Moreover, perhaps it is better to apply such compresses in the dry Trondheim spring? At this time of year we know by experience that there is strong moisture (and salt) transport from the masonry outwards.

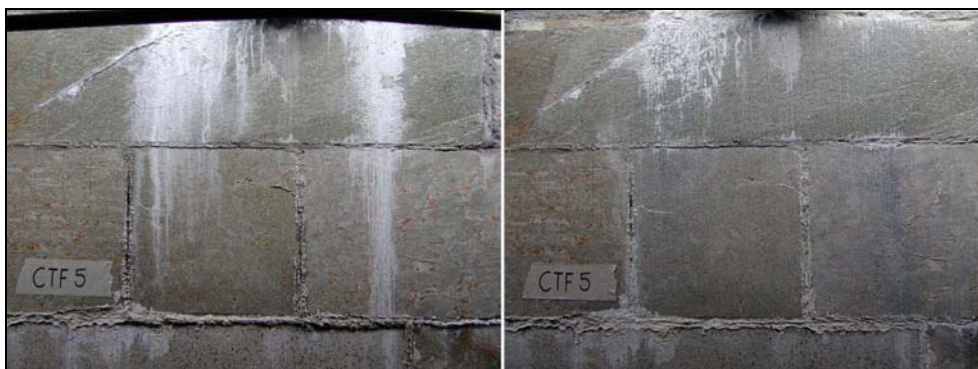
Before and after removal of calcite crusts (test field 5, south side of the choir).

Our approach was now to take away as much as possible by mechanical means and apply and ion exchange paste to remove the rest. For the paste we used cellulose (Arbocel, see <http://www.jrs.de/jrs/german/nm/arbocelt.htm>) and bentonite mixed with a weakly acidic cation exchanger (from Merck; see <http://www.merck.de/english/services/chemdat/index.htm> - 104835 Ion exchanger IV). The idea was to dissolve the crust and remove the Ca-ions without damaging the stone.

As can be seen from the picture above, the paste worked quite well for thin (up to, say 0,5 mm) calcite crusts, but it was not effective for the remaining thicker crusts. Either we will have to remove more of the crust by mechanical means or we will have to develop a "stronger" ion exchange paste (Or we can let the crusts stay!).

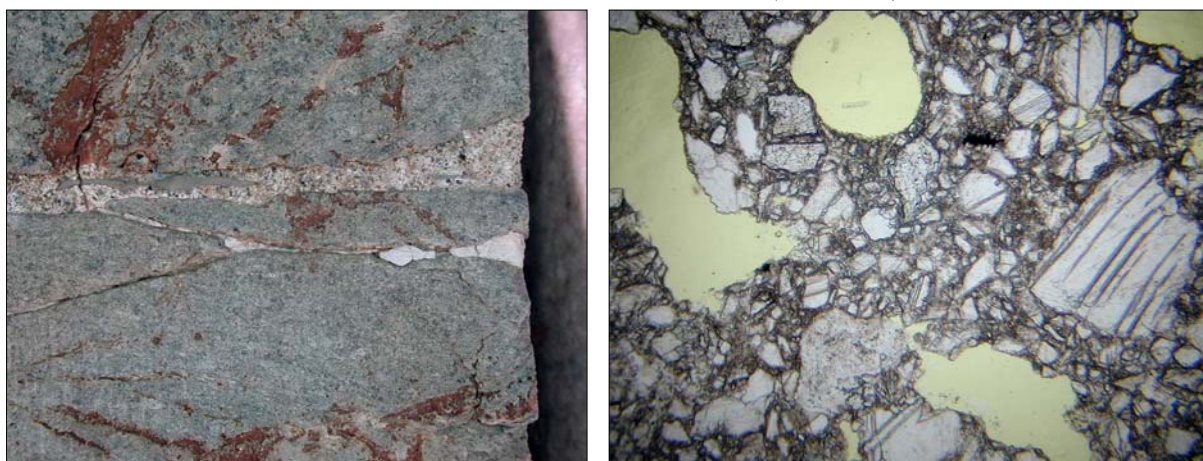
Medieval conservation mortar at the choir (south aisle).

Microphoto's width of field c. 4 mm (normal light)

During a mortar sampling campaign at the south aisle of the choir in the spring of 2000 a white, fine grained mortar used for fixing scales and cracks was discovered by Thorborg von Konow. The mortar seemed to have fulfilled its purpose and was very well preserved. von Konow made a thin-section of the mortar, which was found to largely consist of very fine grained marble aggregates and small amounts of an unknown binder (von Konow 2000).

In the summer of 2000 a mapping campaign at the south aisle was undertaken by PS. Surprisingly, the same type of mortar turned up virtually "everywhere", and by careful stratigraphical analyses it could be stated that the mortar was already used in the Middle Ages. At several places it was for instance used for "gluing" together small pieces that were obviously broken during the original building period. Thus, the mortar is highly interesting, not only as a building archaeological feature, but also because it is very well preserved after 800 years of exposure. Thus, we might be able to reproduce the mortar and use it for modern purposes.

Further analyses are in preparation, but an initial XRD recording shows that the mortar consists of calcite, dolomite and a little chlorite, mica and talc (from the surrounding stone), as well as an unknown mineral (probably a sulphate, but not gypsum or bassanite). The preliminary conclusion is that there is lime in the binder, but we cannot rule out the possibility of organic materials as well.
