Fribourg (CH) 3 – 4 septembre 2009

## Knocking off fragments of damaged stone as a preventive measure? The case of rusticated masonry at the Dreilinden estate in Lucerne

Per Storemyr and Christine Bläuer  
CSC Conservation Science Consulting Sàrl  
Fribourg, Switzerland

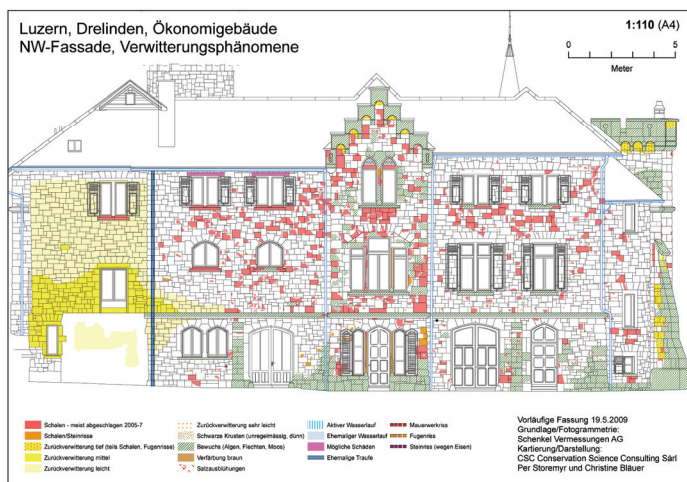
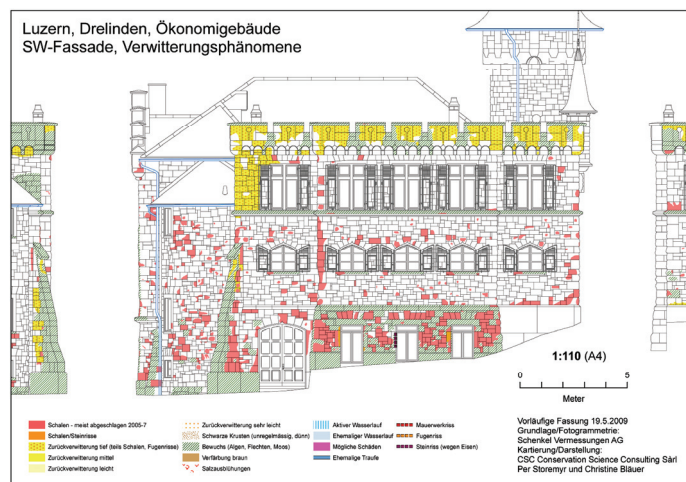
**Below: Maps of weathering phenomena at the NW and SW façades. Knocked-off stone fragments are marked with red. Maps produced using GIS.**

Very few damages can be observed on photos from 1926 and 1975, yet it is likely that minute scales and fissures started to develop relatively early. Though no close calls have been recorded, by the mid 1990s it was believed that partially loose stone fragments, some of which had already fallen off, presented a risk to passers-by. A programme of knocking off pieces started and was intensified by 2005. Perhaps as a result of the slightly more hazardous situation at the nearby main building of the estate, at this stage the programme involved removing virtually every stone surface displaying scales and fissures, whether posing a risk to passers-by or not. More than 1000 stones at the two most exposed façades were affected. They lost 40 m<sup>2</sup> or almost 10% of their surface.
