Baker Memorial Lecture 2017: Nidaros – The Portland cement cathedral

The legacy of Portland cement at Nidaros Cathedral

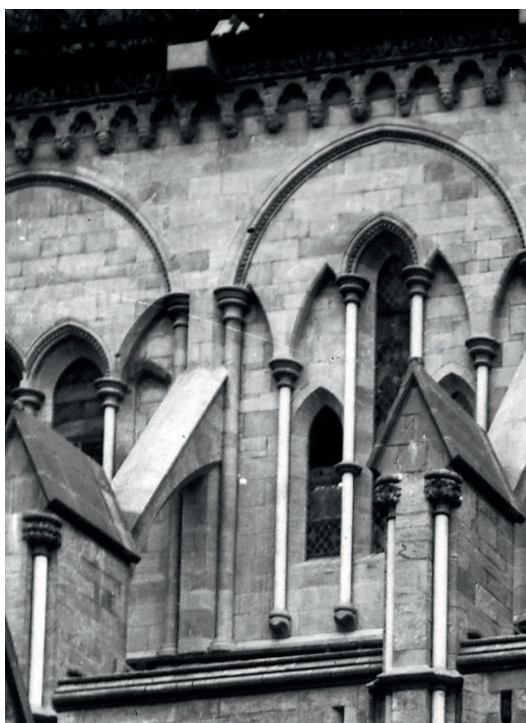
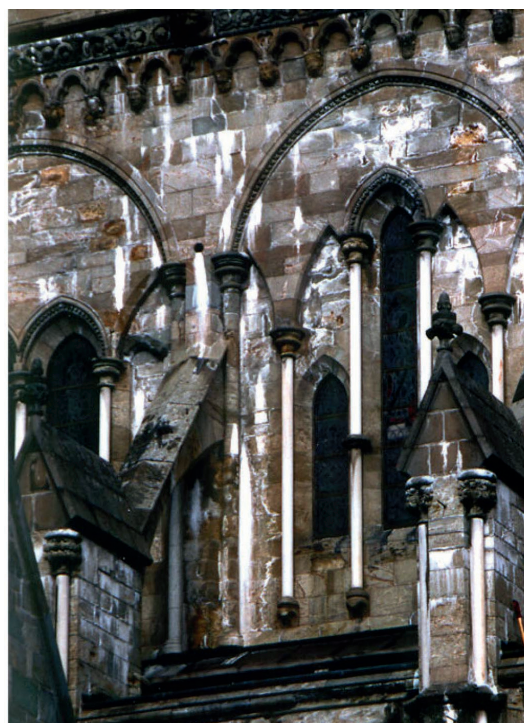
Figs. 2 and 3

The choir at Nidaros Cathedral just after reconstruction in the 1880s (left) and in 1994 (right), before the last restoration in the early 2000s. The white calcite crusts and salt efflorescence are a result of leaching of calcium hydroxide and sodium from Portland cement used in the 1880s, and particularly during a restoration prior to 1920. (Credit: Fig. 2 Nidaros Cathedral Restoration Workshop; Fig. 3 Per Storemyr)

And it is a cement with a major problem: it has a very high component of alkaline salts – sodium carbonates to be more precise – which has been disastrous for the cathedral. These cement salts effectively 'eat up' the stone fabric, in addition to the more general cement problems of cracking, water penetration and frost damage.

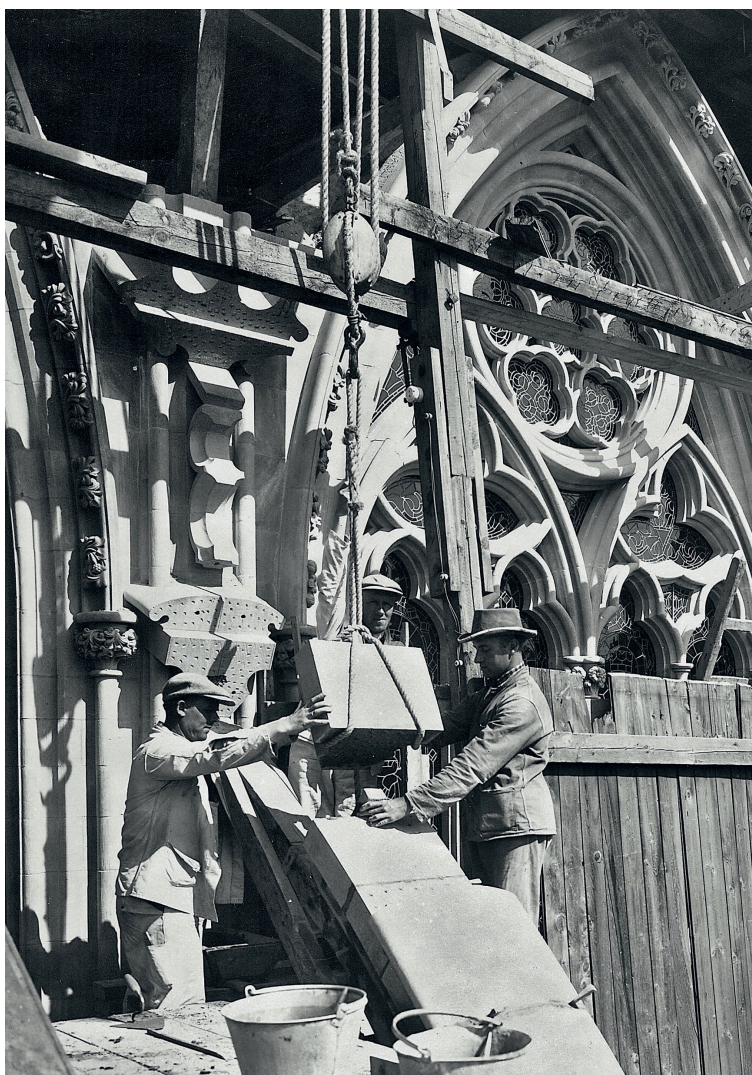
Fig. 4 Nidaros Cathedral was under reconstruction by 1930. In the foreground is the brickworks at Bakklandet, which also delivered traditional lime during the early stages of the restoration from 1869. (Credit: Nidaros Cathedral Restoration Workshop)

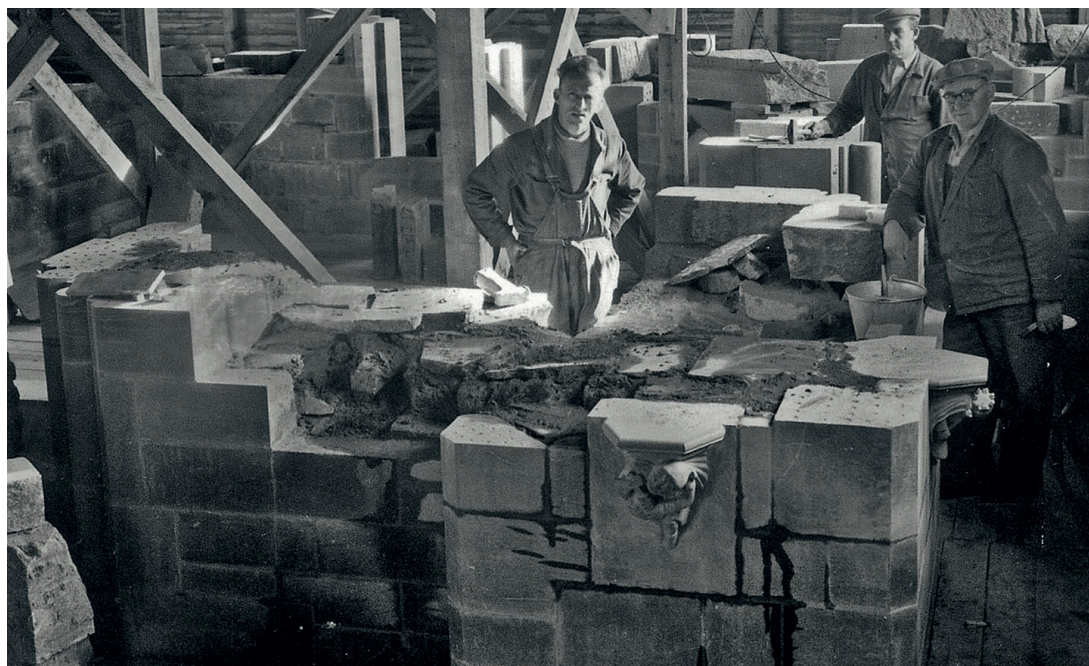
Fig. 6 Building the belfry of the southern west tower in the 1950s, using Portland cement mortars in both cores and joints. (Credit: Nidaros Cathedral Restoration Workshop)
