## ACOUSTIC ANISOTROPY OF DETERIORATED SOAPSTONE FROM THE NIDAROS CATHEDRAL, TRONDHEIM, NORWAY

RUNE M. HOLT<sup>1</sup>, ANNE SKJÆRSTEIN<sup>1</sup> AND PER STOREMYR<sup>2</sup>

### ABSTRACT

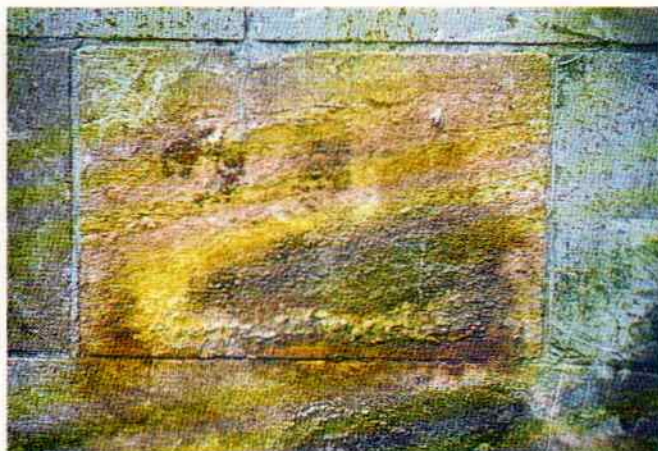
Fig. 2. Colour contrast between heavily deteriorated (brown/red/yellow) and less deteriorated (grey) soapstone on the outside wall of the Nidaros Cathedral. The intact (not deteriorated) soapstone is black in colour.

Today, through knowledge obtained during a continuing restoration effort, it has become evident that severe deterioration has occurred (see Figure 2) in sculptures, in the facades and in flying buttresses. Some of these elements are load-bearing structures. The main building stone of the cathedral is soapstone and it is in one particular type of this rock that the damage is significant.

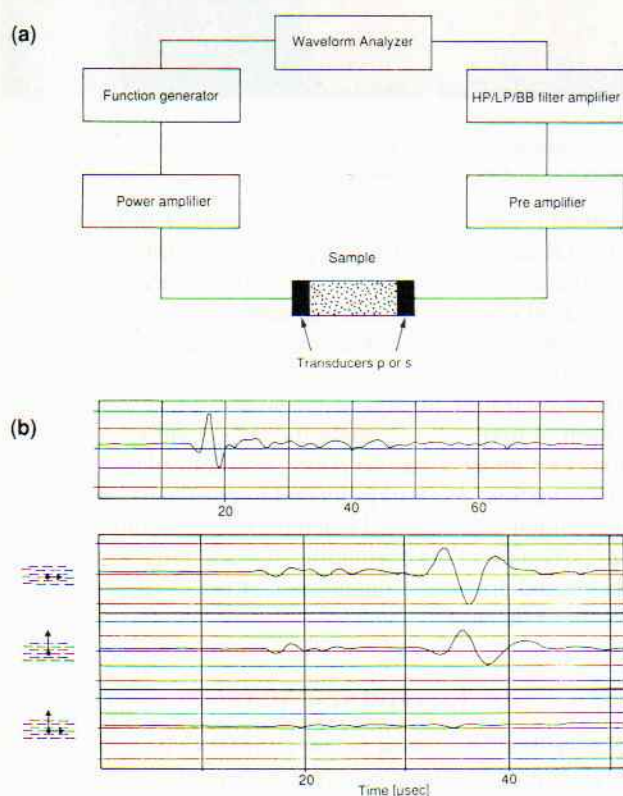
**Fig. 4.** (a) Sketch of the acoustic instrumentation set-up. The signals are generated by a WAVETEK function generator, fed through an ENI power amplifier into the transmitting PANAMETRICS transducer. After travelling through the sample as an acoustic wave, the pulse is converted to an electrical signal by an identical receiving transducer. It is then amplified by a PANAMETRICS preamplifier and further amplified and filtered by an adjustable highpass (HP)/lowpass (LP)/broadband (BB) WAVETEK filter-amplifier. Finally, the signal is recorded by a DATA 6000 waveform analyzer, which is also triggered by the function generator. (b) Typical waveforms obtained by transmission through a soapstone sample. Upper trace: *P*-wave signal; 2nd and 3rd trace: *S*-wave signals with orthogonal polarization and the same transmission path; bottom trace: *S*-wave signal with cross-polarized transducers (indicating sample homogeneity) (notice that the time scales on the *P*- and *S*-wave traces are different).

Acoustic velocity measurements were performed by clamping two Panametrics broadband ultrasonic transducers (100-500 kHz frequency range) to opposite sides of the samples using a thin layer of glue (syrup) as a bonding agent. Both *P*- and polarized *S*-wave transducers were used. Figure 4a shows the experimental set-up, while Figure 4b shows examples of recorded wave trains. The measurement uncertainty depends on several factors including the length of sample determination, parallelism, reproducibility of the gluing process and the force applied on the transducers to obtain good acoustic contact. In addition, the accuracy in picking arrival times, especially for shear waves, presents a problem. Normally, absolute values of velocities are

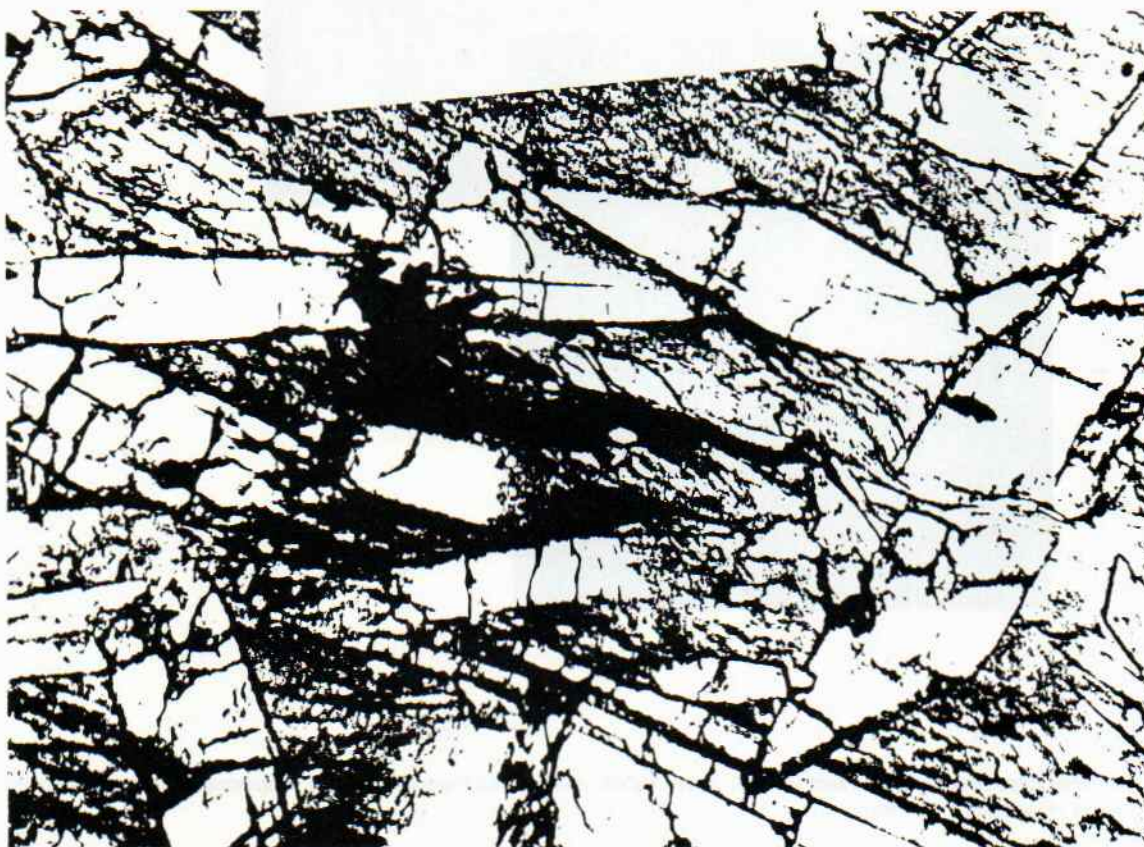
Fig. 7. Thin-section photograph from a deteriorated Grytdal soapstone sampled at the Nidaros Cathedral. Notice the cracks penetrating the amphibole grains.

A first assumption in our study was that the deterioration cracks are primarily *parallel* to the amphiboles/foliation, which represents a plane of weakness. Figure 7 shows a photograph from a thin section of a strongly deteriorated soapstone. Microcracks can easily be seen to have formed also *across* the amphiboles. Fluorescence microscopy analysis (Figure 8) seems to confirm the existence of two major orthogonal crack sets. Unfortunately, this technique could not be applied to all the samples. Also, no three-dimensional analysis was performed to check the full symmetry.

However, thin-section analysis (Figure 7), fluorescence microscopy (Figure 8) and acoustic-velocity measurements with a strongly deteriorated specimen indicated that two predominantly orthogonal crack sets are developed, one inside the soft matrix and the other through the hard inclusions. The symmetry of the medium is thus changed from transversely isotropic to orthorhombic. Clearly, in a more complete study, the full three-dimensional symmetry of the samples should be checked, both for the intact and the more deteriorated samples. The lack of truly intact samples of the Grytdal soapstone prevented this from being done here.

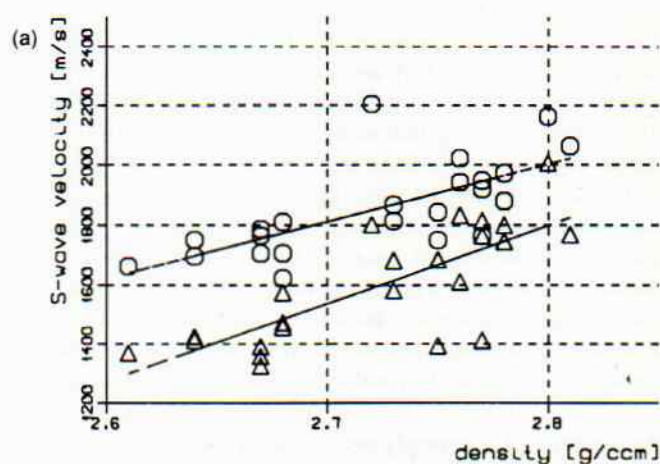
Fig. 11. (a)  $S$ -wave velocities vs. bulk density for propagation parallel to the apparent symmetry plane (in the  $y$  direction), polarized parallel ( $x$ ) and perpendicular ( $z$ ) to the same plane.  $o = S$ -wave parallel ( $v_{syx}$ );  $\Delta = S$ -wave perpendicular ( $v_{syz}$ ). (b)  $S$ -wave splitting ( $v_{syx} - v_{syz}$ ) /  $v_{syx}$  vs. bulk density.

amphiboles only serve as markers of the symmetry. Lack of truly intact (nondeteriorated) samples prevented this assumption from being verified. By observing the preferred orientation of the amphiboles, the assumed symmetry could be identified visually, in particular for deteriorated samples (see Figure 3). Sound velocity measurements were therefore performed with waves propagating in the assumed-symmetry ( $xy$ -) plane as well as at oblique angles to it. It was observed that the velocities of  $P$ - and  $S$ -waves propagating in the symmetry plane decreased with an increasing degree of deterioration (Figures 10, 11a). It was also observed that the velocities of two  $S$ -waves both propagating in the symmetry plane but with particle motions in (e.g.,  $S_{yx}$ ) and out (e.g.,  $S_{yz}$ ) of the plane were different. This is an example of shear-wave splitting or birefringence (Crampin, 1985). These two velocities are reduced an unequal amount with increased deterioration (Figure 11). It implies that the cracks formed during the deterioration process to a large extent have a preferred orientation. The in-plane polarized  $S$ -wave is always faster than that polarized out of the symmetry plane. The  $S$ -wave splitting observed here (Figure 11b) ranges from ~5 to 25%.

In Figures 10 and 11 the measured velocities were shown vs. density. In Figure 12, the water absorption is used as the deterioration parameter (for the samples where it was measured). The trend of decreasing velocity with increased deterioration seems more evident in this plot than in Figures 10 and 11, indicating that water absorption is probably a better measure of deterioration than density.

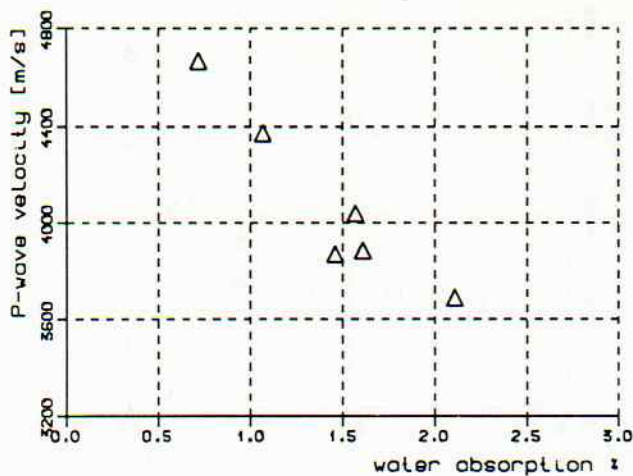
Fig. 12. *P*-wave velocity parallel to apparent symmetry plane vs. water absorption.

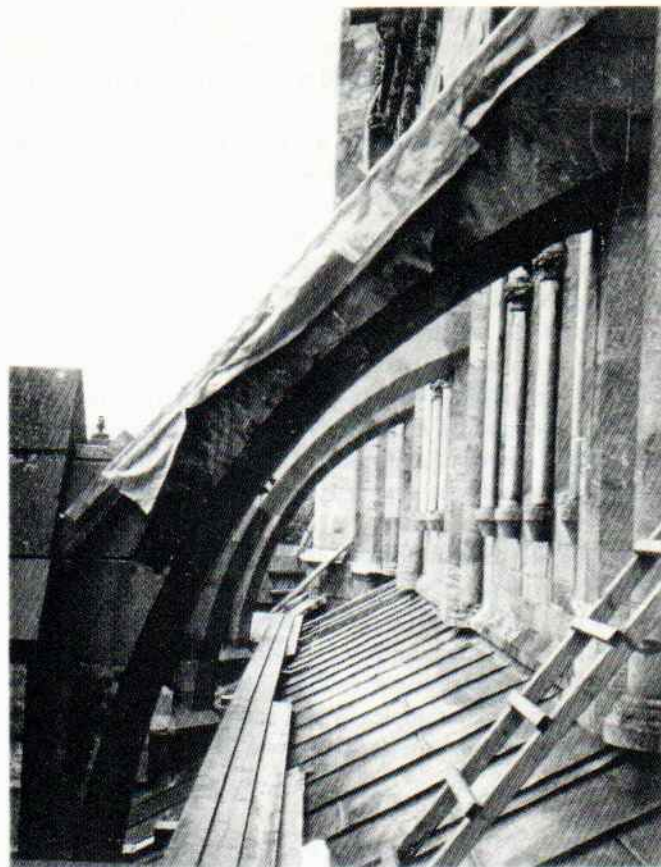
Fig. 15. Flying buttress from the Nidaros Cathedral showing a variety of deterioration states.

A flying buttress (Figure 15) has been studied in particular, since in this case the constituent blocks could be approached from more than one surface. This permitted measurements of  $P$ -wave velocities in transmission. The data could be integrated directly into a geological classification map of the cathedral.

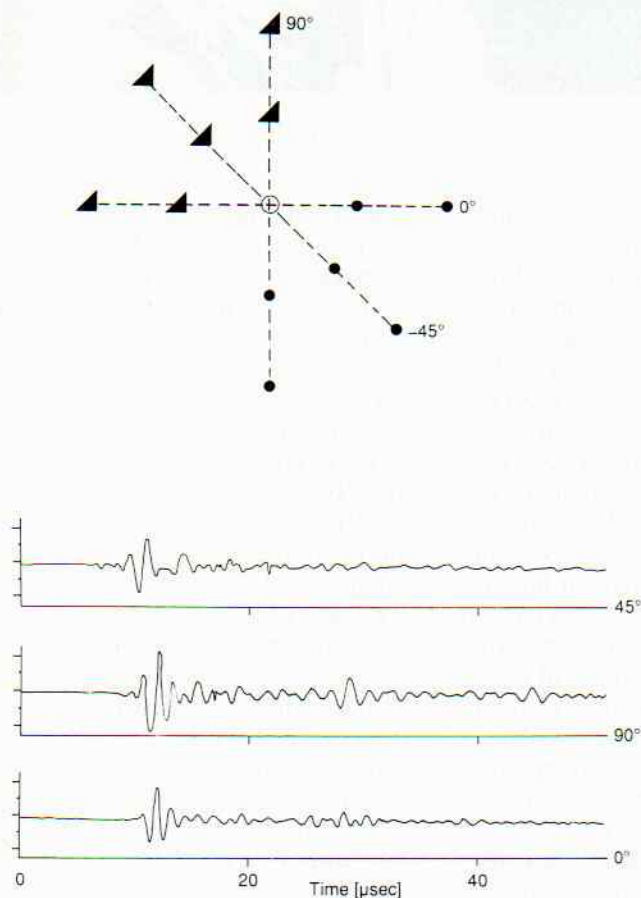
Fig. 16. Above: measurement configuration on a surface of a block on the Nidaros Cathedral. Triangles denote transmitters and circles are receiver positions. Spacings vary from 10 - 20 cm. Below: waveforms recorded for 10-cm propagation paths in 3 different directions, indicating anisotropy.

For surface-wave excitation, a standard *P*-wave transducer was used with a wedge of a low-velocity material causing critical reflection of bulk *P*- and *S*-waves and (in principle) propagation only of the surface wave. Normally, measurements were taken with one source and 2-4 receiver positions along a given direction, with source-receiver distances varying from 10-25 cm. In order to map the anisotropy, similar measurements were performed in 2 or 3 additional directions. The result is a rosette of sound-velocity determinations, as exemplified in Figure 16. This measurement indicates a high degree of anisotropy. One complicating factor in the analysis is that the symmetry is unknown and can not be obtained by any independent means when only the rock surface is exposed. Introductory studies of the surface-wave velocity frequency dependence in a relatively narrow frequency range (30-50 kHz) did not indicate a strong variation of deterioration with depth (for this frequency range ~ 3 - 5 cm). Unfortunately, there was no independent means of checking this, since samples at this stage of the study could not be taken from the site for further study in the laboratory.

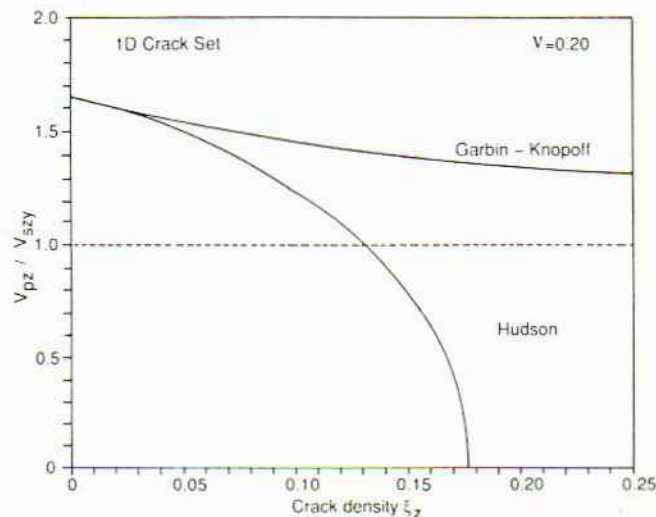
Fig. A1. The ratio of  $P$ - and  $S$ -wave velocities vs. crack density for propagation parallel to the crack normals for one single plane of cracks, according to Hudson's and Garbin and Knopoff's theories. Poisson's ratio of the intact solid  $\nu = 0.20$ .

Neither of the theories are self-consistent, so they can not be expected to be valid for high-crack densities. Nevertheless, if we evaluate the ratio  $C_{33}/C_{44}$  ( $= v_{pz}^2/v_{szy}^2$ ) for an initially isotropic solid (with Poisson's ratio  $\nu = 0.20$ ) as the crack density is increased, we find (Figure A1) that Hudson's theory predicts  $C_{33} < C_{44}$  for a critical crack density  $\epsilon_c$  ( $\approx 0.13$ ). Hudson's theory however leads to instability (imaginary values of the sound velocity) if the crack density is increased further. This limiting crack density is  $\approx 0.165$  for the case shown in Figure A1. Figure A2 illustrates how the two limiting crack densities depend on Poisson's ratio of the solid matrix. Garbin and Knopoff's theory can never lead to such an instability but will not predict  $P$ -waves to travel slower than  $S$ -waves. Only for crack densities below 0.04 do the two theories predict the same behaviour.
