# Weathering of soapstone in a historical perspective

Per Storemyr\*

## Abstract

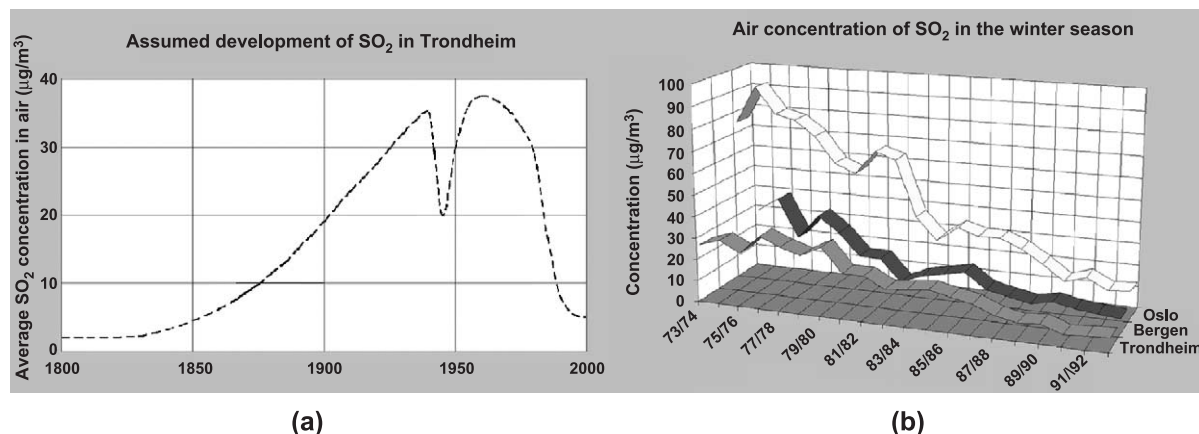
Fig. 1. Development of average  $\text{SO}_2$  concentration in the winter season. (a) Estimate for Trondheim since 1800 [4]. (b) Measurements since 1973 [9].

locally produced pollutants has had the major impact on buildings. Situated in the south of Norway, both Stavanger and Oslo have been affected by acid rain. Generally, these cities, as well as Bergen on the west coast, have been more polluted also with regard to local air pollution (Fig. 1b) [9].

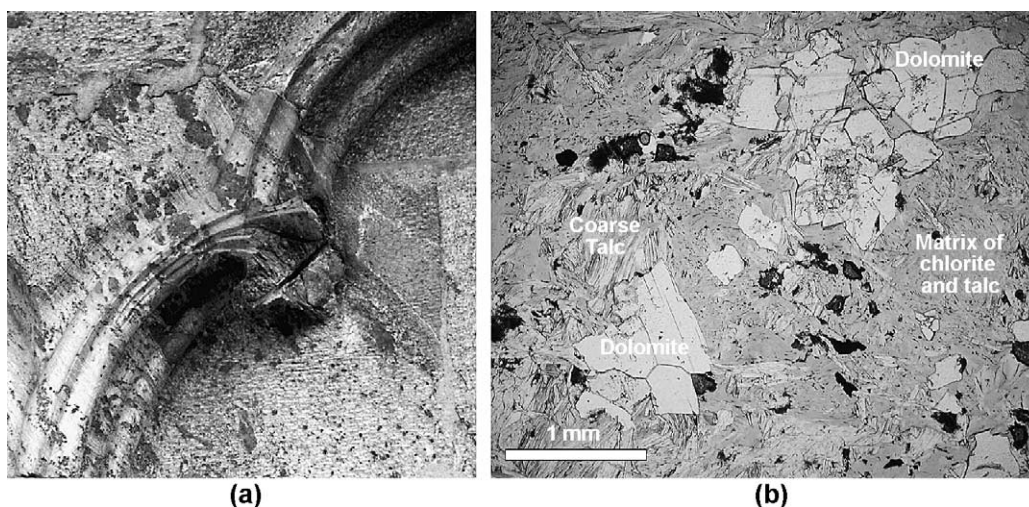
Fig. 3. Typical appearance of Caledonian, foliated soapstone (at Stavanger Cathedral). (a) Light grey areas are rich in talc and chlorite (matrix), dark grey, rich in chlorite and dark veins, are dolomite with a superficial layer of iron hydroxide, probably developed due to the leaching and oxidation of small amounts of iron in the dolomite structure. The ornament has been lost due to a rusting dowel from the 19th century. (b) Photomicrograph in normal light. Dark areas are mostly opaque minerals (magnetite, some pyrite).

in a number of soapstone deposits, especially in the Gudbrandsdalen area (eastern part of Norway), sedimentary structures can be recognized. Only one deposit derived from dolomite is yet known in Norway [1]. In addition to the primary rock source, the characteristics of soapstone deposits are strongly influenced by metamorphic grade and deformation history. The mineralogy and grain size vary with metamorphic grade, and deformation contribute to varying degrees of foliation, shear zones and cracks (Fig. 3).

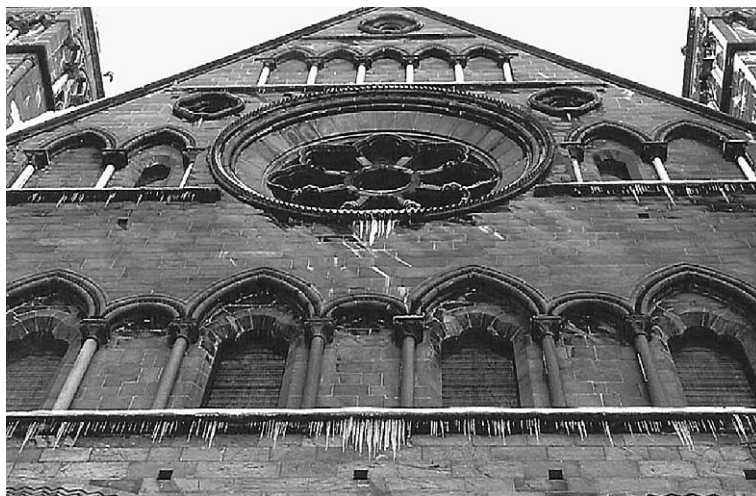
Fig. 4. Icicles and snow at the S. transept of Nidaros cathedral. The stringcourses made from Bjørnå stone have lost their moldings along the pronounced foliation in the stone. This stone has a lifetime of only 30–60 years when used at such places.

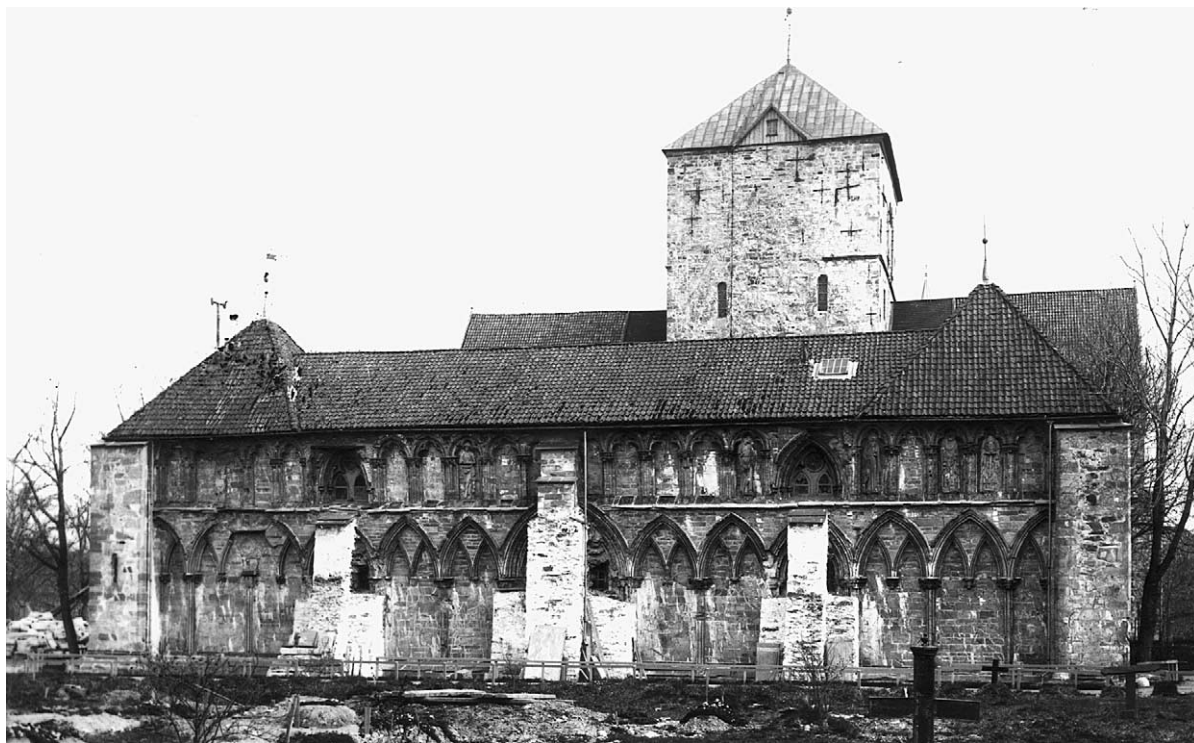
Fig. 5. The remaining two lower stories of the High Gothic west front of Nidaros cathedral by 1870. (Photograph: The Restoration Workshop of Nidaros Cathedral).

A good place to study such phenomena is at the High Gothic west front of Nidaros cathedral (Figs. 5 and 6), which has countless destroyed medieval ornaments and sculpture made from foliated but generally durable Trondheim soapstone. It can be confirmed by the study of old photographs that the damage was there already by 1870 (Fig. 6) and that it has not significantly changed since then. To understand why the damage evolved, we have to return to 1531 and the devastating fire that ruined the west front.

Because the nave in periods was used as a stone quarry, only the two lower stories remained (Fig. 5) when the structure was put under a good roof in 1739 [15]. This means that the very delicate Gothic stonework was without protection for more than 200 years. The restoration of the west front was started by 1900. First, the old masonry was dismantled and the two lower stories rebuilt, primarily using the old and weathered decorative stones and generally refraining from reconstruction. The core of the two lower stories was strengthened and thus used as a “foundation” for the new west front, which was erected on top (Figs. 5 and 6). The building of the new west front continued with new stone until its completion in 1969 [16].

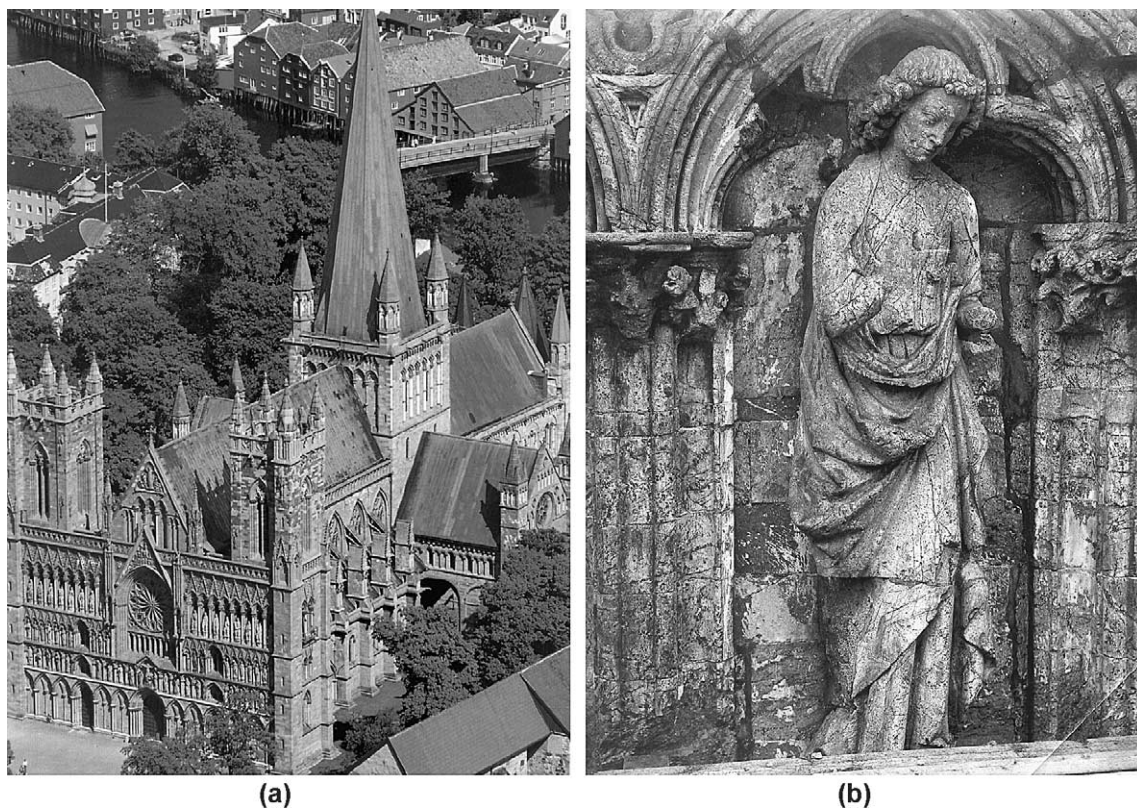
Fig. 6. (a) Nidaros cathedral today after a century of restoration. (b) St. John, one of the five remaining medieval sculptures at the west front by 1870. Note all damaged ornaments. (Photograph: The Restoration Workshop of Nidaros Cathedral).

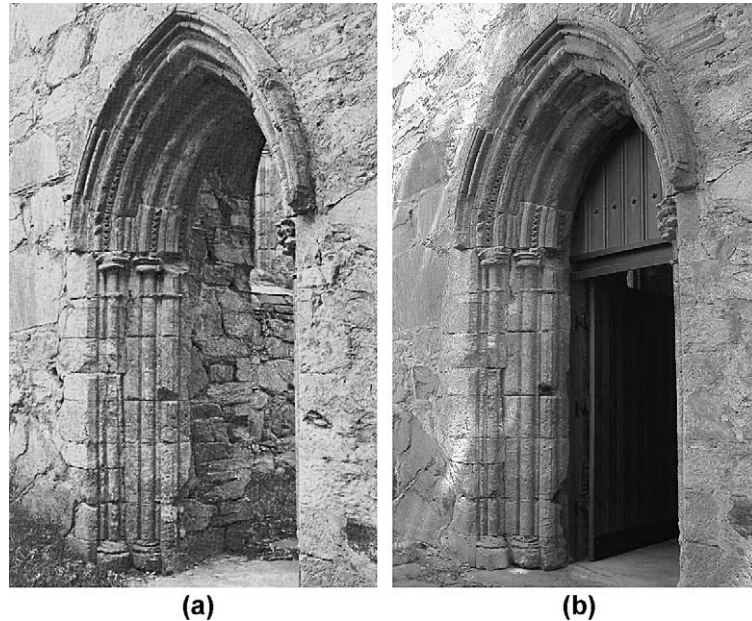
Fig. 8. The west portal of the Utstein monastery church (a) before 1965 (photograph from Ref. [19]) and (b) in 2001. Note many small damaged areas and that these damaged areas have hardly evolved.

Another example of old and worn soapstone can be found at the Gothic west portal of Utstein monastery church on an island close to Stavanger in southwest Norway (Fig. 7). Partly featuring lichen growth, the exposed flanks of the portal have numerous smaller damaged areas ranging from open joints and lost details to a rough and pitted surface, which is presently rather stable. Below the exposed and damaged, but stable, part of the arch is an inner, sheltered part, which is heavily disintegrating (Fig. 8), evidently due to salts [17]. Why do we observe this difference?

These circumstances imply that the portal was, more or less, completely exposed to the weather for more than 400 years. In this period, water infiltration and growth of bushes and moss must have played essential roles, especially in dissolving and destroying the joint system in the masonry. It is entirely possible that salt was transported to the sheltered part of the arch in this period. Gypsum is the primary salt in the arch, probably derived mainly from the building materials. Traces of chloride may stem from sea spray. Gypsum prevails in the arch until today because it cannot be washed away. It may, however, frequently dissolve and recrystallize because of condensation and minor water seepage [17].

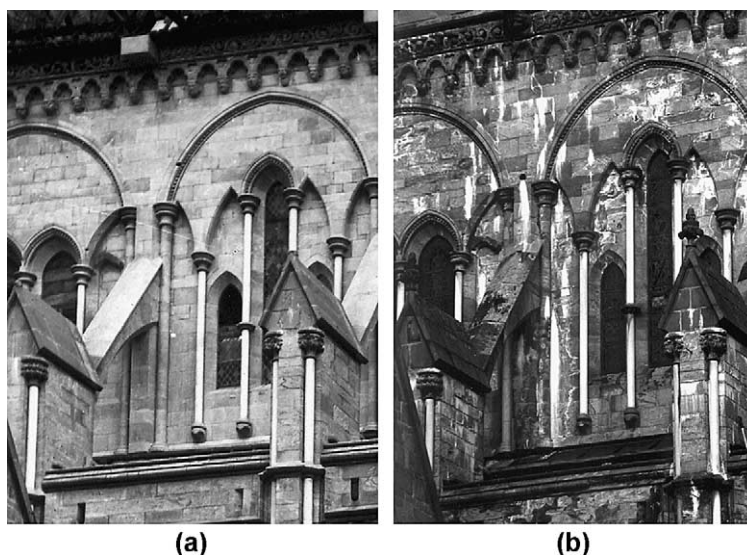
Fig. 9. (a) The choir at Nidaros cathedral was reconstructed using much Portland cement and stone rich in sulfide (Grytdal) in the 1880s. (Photograph: The Restoration Workshop of Nidaros Cathedral.) (b) One hundred years of water leaks through the masonry have produced massive calcite crusts and extreme salt weathering problems.

Portland cement (Fig. 9). Cement was introduced as the modern restoration started in 1869, first as a hydraulic additive to lime mortars, later as the “universal” mortar for large reconstruction works. Portland cement mortars have been used virtually everywhere—in strengthened foundations, along widened and repointed medieval joints, on top of wall heads and as grouts and “soups” injected in old and weak walls [4]. From old photos, it can be seen that calcite crusts (stalactites “stuck to the wall”) were not present before the restoration—they only turned up some years after various buildings parts were successively restored. This is a very good indicator of the use of Portland cement and the presence of water leaks. Upon the dissolution of calcium hydroxide present in Portland cement, calcite will form as the solution enters the surface (Fig. 9). The water leaks originate from poorly insulated parapet walks, from undersized water discharge systems and from fissures between joints in exposed building elements. The record for the choir, for example, shows 13 periods of major leaks, mostly occurring in the wintertime, between 1920 and 1995 [4].

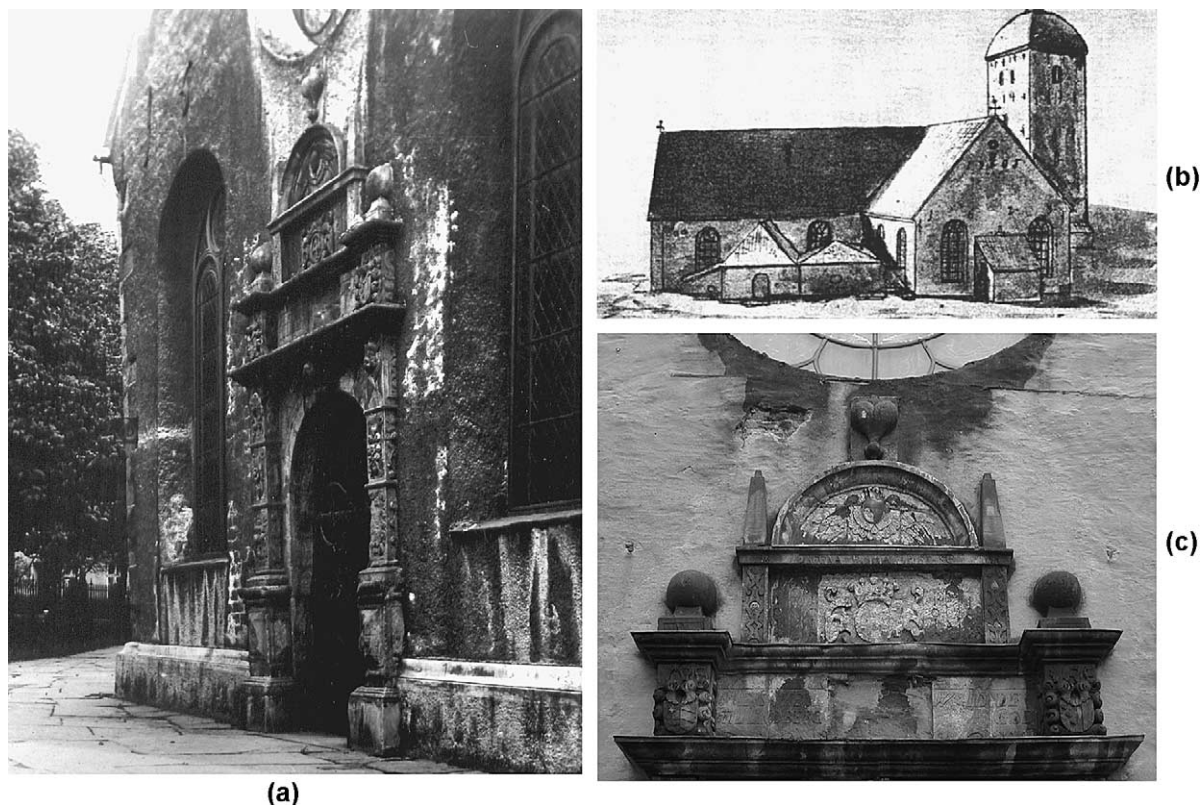
Fig. 10. Church of the Holy Cross. (a) The north portal, with much black crust by 1900. (Photograph: Directorate for Cultural Heritage.). (b) A porch in front of the portal in 1839. (Drawing by F. Bøe). (c) The upper part of the portal in 1999, showing damage where crusts formerly prevailed.

The north portal of the Church of the Holy Cross in Bergen was built in 1632. It is perhaps the finest renaissance portal in Norway and the only one so far at which traces of original polychrome painting have been documented. This masterpiece was soon in trouble, but nevertheless appears to have survived no less than three fires until 1746. Subsequently, a porch was built in front of the portal, perhaps to protect it or perhaps to conceal the damage (Fig. 10). The porch remained for a hundred years until the portal was restored in 1856–1857. It is likely that the polychromy was finally removed at this time, possibly by acid and/or lye [22]. The most important measure was not directly related to the portal, though, but to the fact that a large circular window was inserted just above it. By collecting rain and draining it directly onto the portal, this window has played a vital role in the weathering over the last 140 years. Already by 1900, the portal and the wall around had much black crust, which expanded greatly during the 1940s and 1950s. In the 1970s and 1980s, the extent had been slightly reduced, but this was mainly due to the fact that pieces had started to fall from the most damaged parts, which are essentially the somewhat sheltered areas below the upper arch and between the three architraves. Since the late 1980s, no great changes have been recorded [22].

The reasons why so much black crust could form at the portal is connected to relatively high atmospheric concentrations of SO<sub>2</sub> and particulate matter from heating and combustion processes over a long period, as well as the generally sheltered position of the north wall. The locations of the worst damage are also governed by rain and run-off from the window, which make these areas thoroughly moist, but not completely wet, like other more exposed but less damaged areas of the portal. The worst damage is located in a transition zone between dry, moist and wet—a zone in which damage related to black crusts is generally known to concentrate (valid for dense stones; [23]). In addition, gypsum in black crusts is not the only salt in

the damaged area—there is a range of other species present as well, of which halite is the most important. Halite may stem from sea spray, but perhaps more likely from acid cleaning in the 19th century. Furthermore, the foliated soapstone in the damaged area is edge bedded, a feature that makes it delaminate easily and lose the outer parts. Thus, air pollution and black crusts cannot, alone, be held responsible for the damage, but rather, a range of unfortunate circumstances starting with the “weakening” of the portal due to fires and the insertion of the circular window above the portal in the 19th century. This knowledge has important consequences for the conservation: A protective roof should be built above the portal.

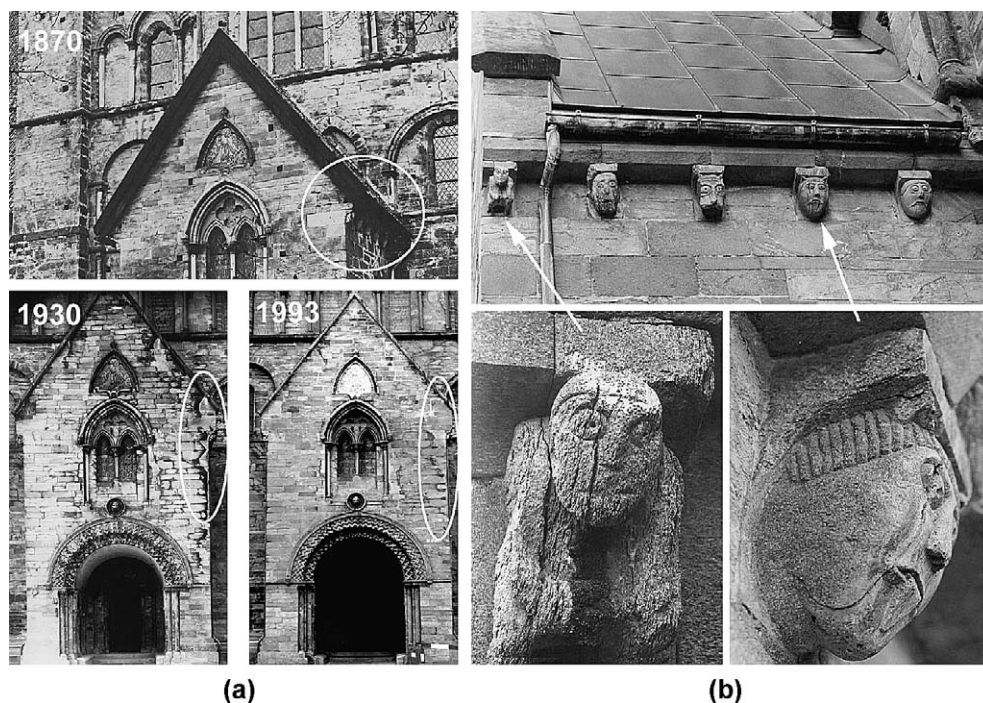
Fig. 11. The north porch at Nidaros cathedral. (a) Before and after the restoration in 1880; note the new roof and the development of black crusts. These were more widespread in 1930 than in 1993. (b) The corbel heads at the west side of the porch. (Historic photographs: The Restoration Workshop of Nidaros Cathedral).

Another example illustrating the importance of understanding former changes in architectural design can be found at the Nidaros cathedral, at the mixed Romanesque and Gothic north porch of the cathedral (Fig. 11). Probably after the fifth and last fire at the

cathedral in 1719, the porch acquired a good, traditional roof with projecting eaves, which protected the valuable Romanesque corbel heads in the cornice (Fig. 11b). A similar roof may have prevailed also before the fire. The corbels are made from chlorite schist with talc, and, according to old photos, they were in good condition before the modern restoration of the porch in the early 1880s. This restoration did not involve the corbels, which remained, more or less, untouched, but concentrated primarily on the roof, which was restored to what it might have looked like in the 13th century. A raised gable was constructed, the eaves were cut back, lead (later copper) plates were used as roofing material, and gutters and downpipes were added. Moreover, new Grytdal stone with a high content of pyrrhotite was applied in the beam directly above the corbels [4].

drastically deteriorated. The chlorite schist delaminated, and there were clear signs of black crusts in the more sheltered areas (Fig. 11). But does this mean that air pollution was responsible for the damage? There is probably no doubt that the formation of black crusts and gypsum plays a role in the weathering, but it appears to be more important that the reconstructed roof is not able to protect the corbels properly. The outermost corbel, for instance, is only half protected (cf. weathering in the transition zone between wet, moist and dry at the portal of the Church of the Holy Cross in Bergen) and influenced by water leaks and run-off from the architecturally complex 1880 cornice and the occasionally overflowing gutter. Thus, frost may be an important weathering agent as well. Moreover, gypsum from the Grytdal stones above can easily be transported to the corbels [4].
