*The Regalia Room Mural  
Paintings Conservation Project,  
Trondheim, Norway*

**Conservation Measures and  
Monitoring of Salt Weathering  
2001-2002**

18.12.2002

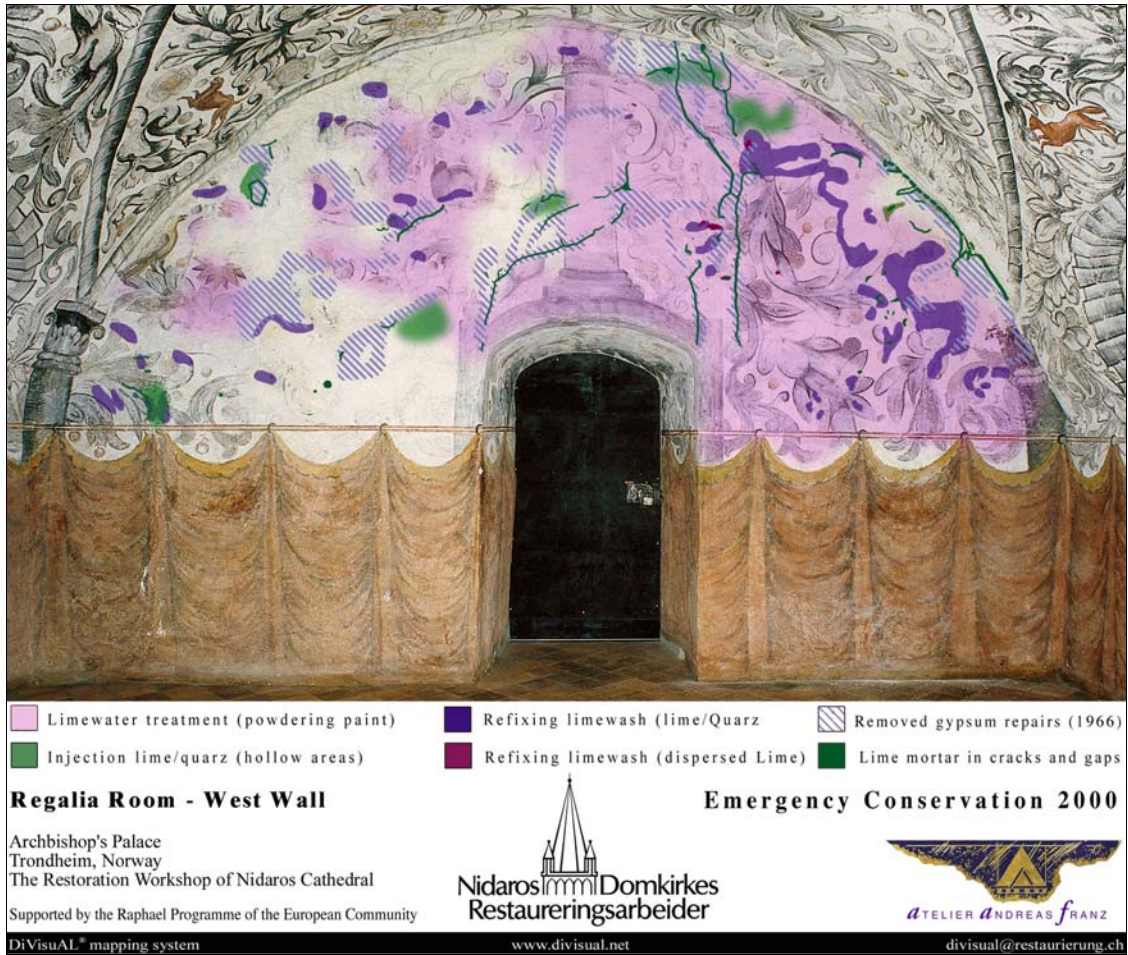
Figure 8: Emergency conservation measures 2000. Updated map.

The mortars used for the restoration are shown in table 1 and the actual measures undertaken in figure 9. Since the map of the measures carried out in 2000 contained some mistakes, a corrected version is reproduced in this report (fig. 8).

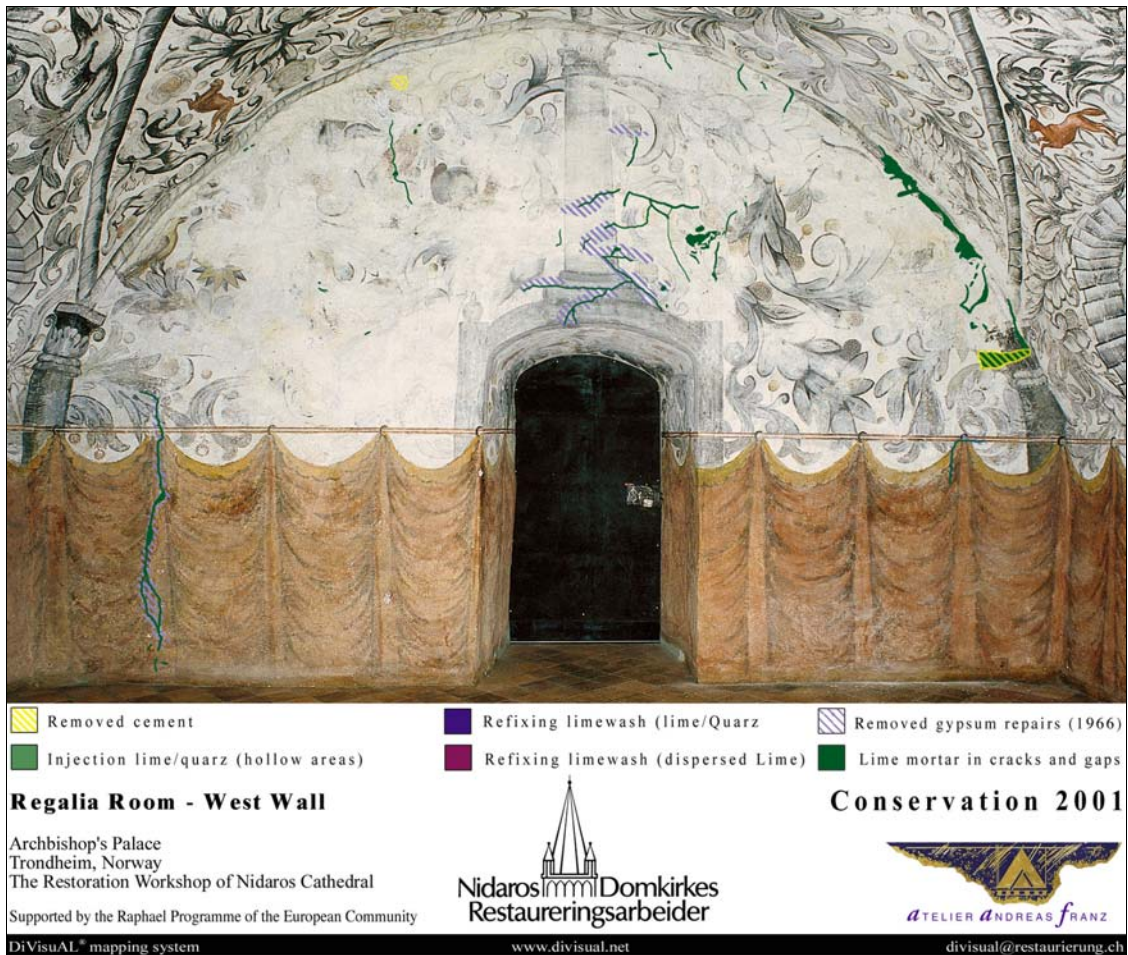
Figure 9: Measures carried out during the 2002 work

Upon removing 1966 gypsum repairs from the “column” above the door (fig. 9), it was possible to get a new view of the stratigraphy of the limewash and paint layers of the wall. Surprisingly, a formerly unknown layer (no. 2, fig. 32) turned up between the original grey paint from 1616 (no. 1) and the 1826 limewash (no. 3). It is possible that this layer corresponds to the what has been called the 2<sup>nd</sup> limewash/paint, supposedly applied in the periods between 1672 and 1826 and earlier found on the north side of the wall. However, only tiny fragments have been found earlier [2].

The actual conservation work carried out in August 2001 involved mainly closing cracks and gaps, which borders had been secured in 2000, by various types of lime mortars. The final finishing of the mortar repairs (toning etc.) was not undertaken (fig. 3-7).

Prior to some of the repairs, gypsum and cement mortars from the restoration in 1966, and not removed in 2000, were taken away (fig. 3). Originally, it was intended to remove much more cement, but as its removal in many cases poses a larger strain to the wall than leaving it, it was decided to refrain from treatment in most cases.

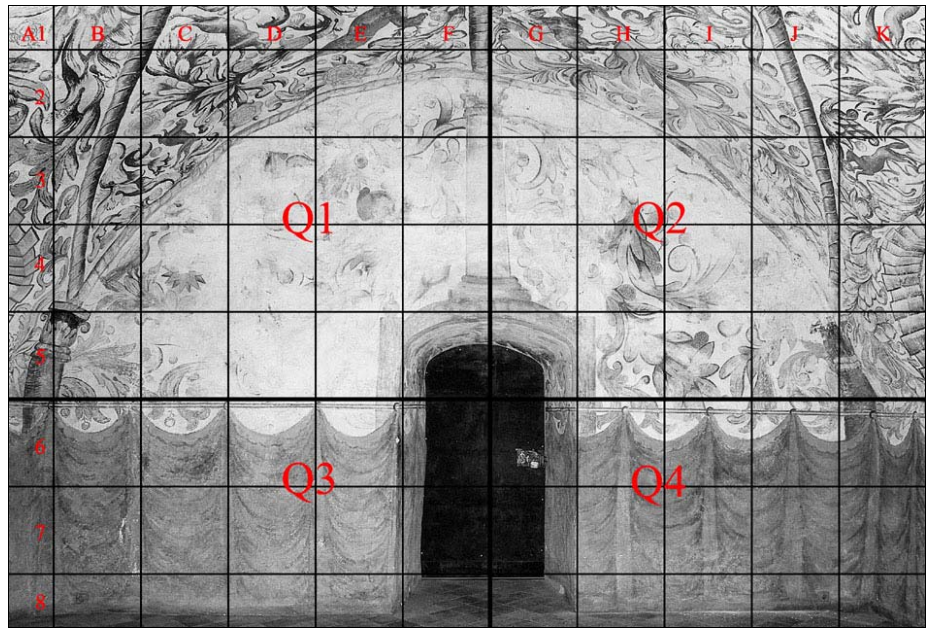
Figure 11: Grid for photo documentation of the west wall after the August 2001 conservation campaign

After the August 2001 conservation campaign, the west wall was photo documented in sections, roughly following the grid shown in fig. 11. A digital camera (Nikon Coolpix 950) and direct flash light was selected in order to easily and quickly be able to compare with future photos taken in a similar manner. Three areas (fig. 12) were also selected for in-depth documentation. All photos are digitally stored in the archives of Expert-Center für Denkmalpflege.

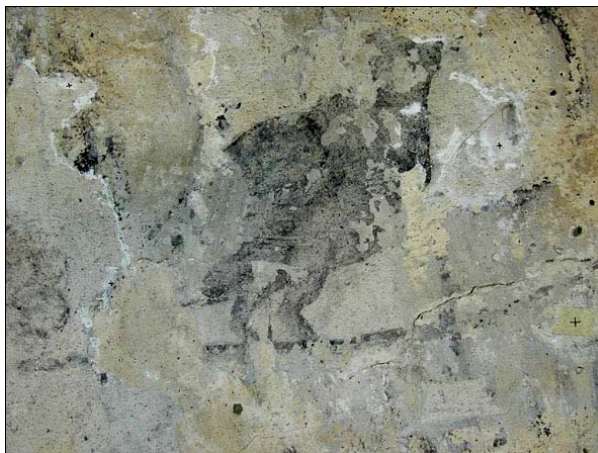
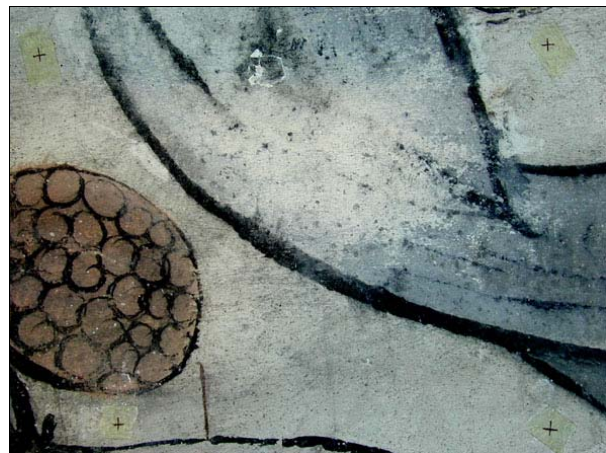
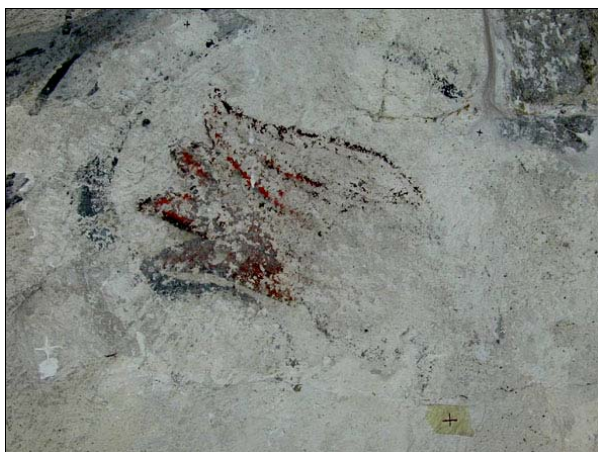
Figure 12: Areas for in-depth photo documentation: Top left: PM1 (Grid I-J4), top right: PM2 (H4), bottom left: PM3 (C3-4). All areas have 4 simple register marks for future comparisons. Camera data:

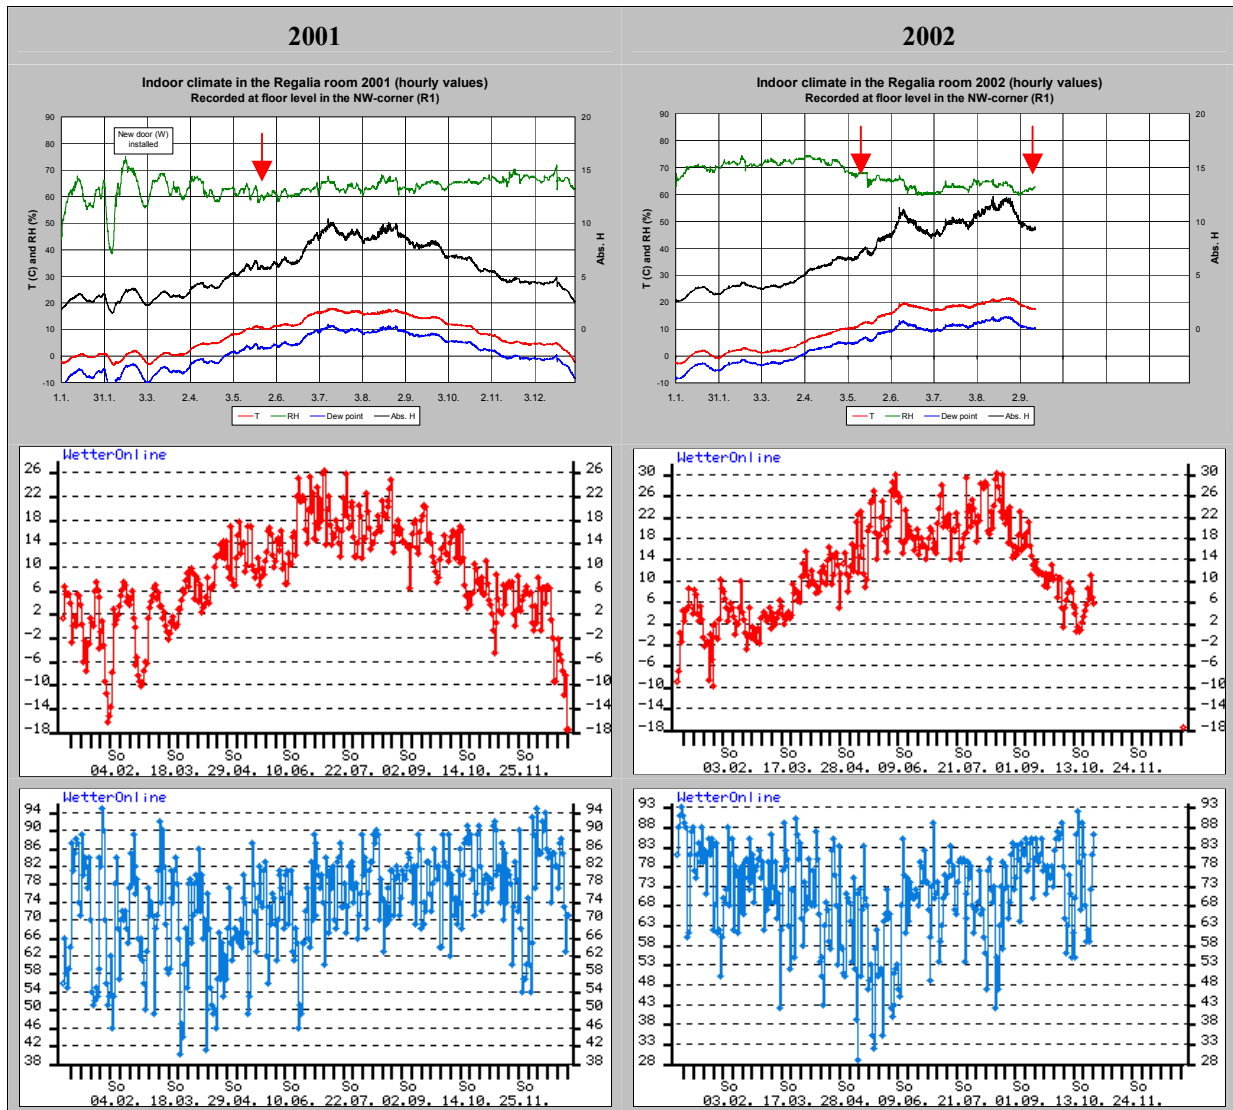
After the establishment of the climate control measures described in chapter 3 (February 2001), it can be seen that the stable indoor climate roughly follows the outside variations in temperature with a general delay of less than ca. 1 week (fig. 15, see also appendix 1). The indoor climate is strongly dependent on the outside temperature, but also the outside relative humidity plays a great role. For instance, the cold May in 2001 (arrow, fig 15) was followed by a low indoor relative humidity because the weather was

very dry. Likewise, the extremely warm and dry 2002 summer (2 arrows, fig. 15) – the warmest in Trondheim since measurements started in 1866 ([www.met.no](http://www.met.no)) – gave a stable relative humidity at 60-65% for nearly 4 months. The temperature in the same period rose to well above 20°C, which is almost 5°C higher than what has been generally measured over the last few years.

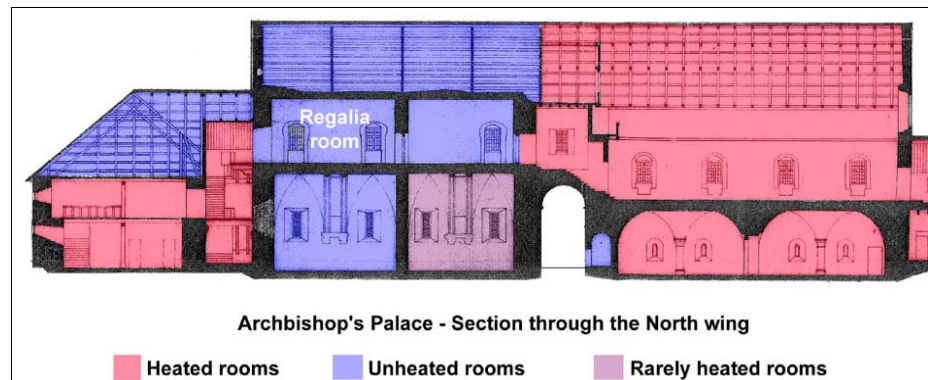
Figure 21: Heated and unheated rooms in the Archbishop's Palace. North wing, as seen from the south.

4. IR-Thermography was also undertaken on the exterior facades of the Archbishop's palace. The images in fig. 20 do not reveal anything new, but the differences between heated and unheated building parts can clearly be seen (compare fig. 20 and 21). The south façade had temperatures between 3°C (unheated) and c. 6°C (heated), whereas the north facades showed values below the freezing point (minimum -2°C). The ambient temperature was in the range between -4°C to +4°C in the actual period (overcast weather).

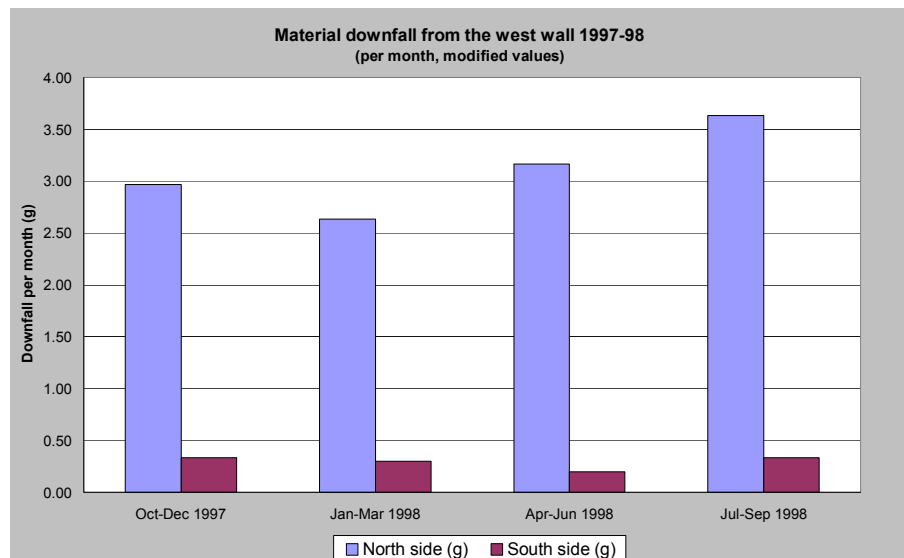
Figure 23: Material downfall from the west wall 1997-1998

Material downfall from the west wall was also recorded in the period 1996-1998, before the emergency conservation measures were undertaken in the summer of 2000 [4]. At that time the downfall was in the range of 2,5-4,5 g/month at the badly deteriorating north side of the wall and 0,2-0,4 g/month at the south side (fig. 23).<sup>1</sup> It was at that time difficult to establish relationships between the downfall, variations in the indoor climate and salt crystallisation periods. A main reason was the extremely fragile state of large amounts of exfoliating gypsum repairs from 1966 and old limewash, which implied that a few large, fallen flake could completely obscure the picture. However, it would seem that most downfall occurred in spring and autumn, during periods with the largest temperature and humidity gradients [2].

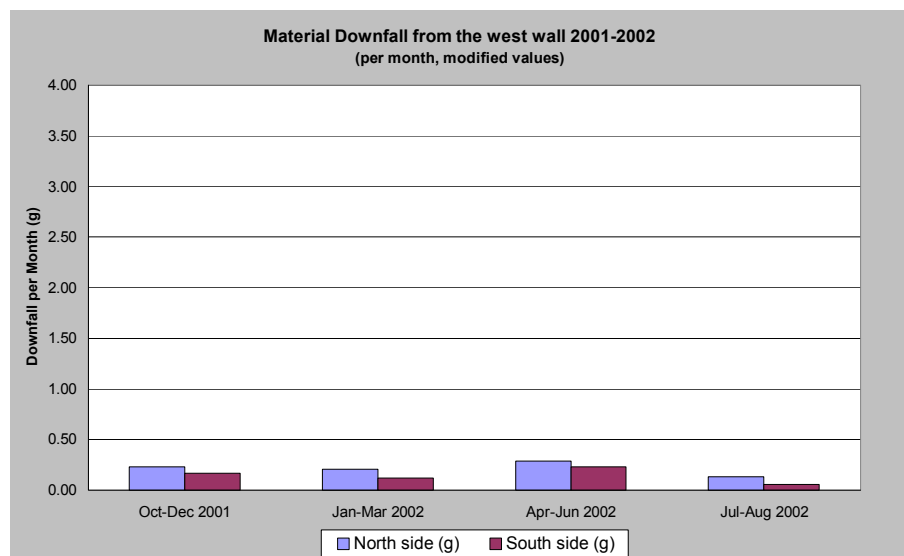
Figure 24: Material downfall from the west wall 2001-2002

After removal of most of the exfoliating gypsum repairs and preliminarily securing most of the fragile limewash flakes, the downfall has been drastically reduced. Between October 2001 and August 2002, it has been in the range of 0,1-0,3 g/month (north side) and 0,1-0,2 g/month (south side) (fig. 24). For the north side this is a reduction of 15-25 times.

Whether the climate control measures have had any influence on the positive downfall statistics is still hard to state. The amount of downfall is small and, like before the conservation measures, extremely dependent on whether a few large, fallen fragments obscure the picture. However, it is a fact that the general room climate was drier and much more variable in the period from 1996 until the installation of the preliminary door in February 2001. Recording of downfall will continue in the hope that a clearer picture will emerge after a few years.

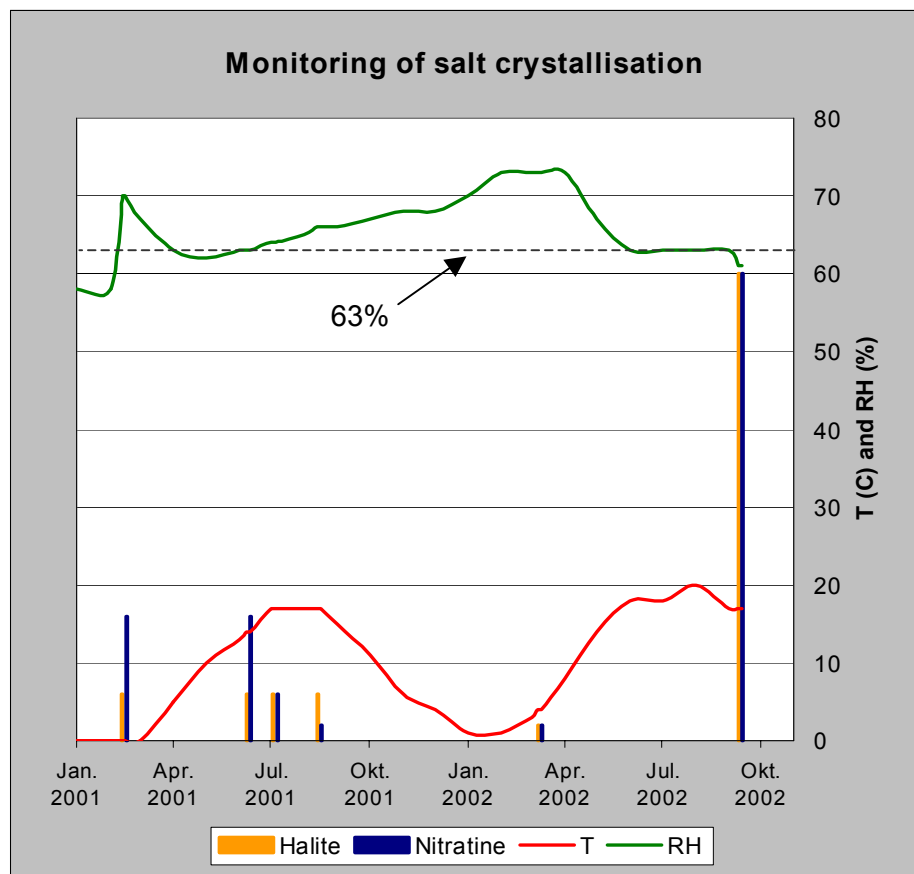
Sampling of salts was undertaken 14.2.2001, 10.6.2001, 5.7.2001, 15-17.8.2001, 9.3.2002 and 13.9.2002. The general results can be seen in fig. 25: Medium amounts of the most important salt species (halite and nitratine) could be found in February and June 2001, they subsequently almost disappeared in July and August and were also more or less absent in March 2002. In September 2002, however, after the extremely warm and dry summer, the amount of salt nearly exploded. By then it was for the first time possible to very easily see the salts, present as whiskers and cotton-like bundles of needles, with the naked eye (fig. 26-28).

Figure 25: Presence of halite (sodium chloride) and nitratine (sodium nitrate) at the time of observation as compared with the mean monthly relative humidity and temperature. The relative amount of salt is indicated by the bars. The amount of salt was roughly estimated from analyses of several samples at each time of observation.

It is still too early to draw final conclusions on the relationship between salt crystallisation periods and ambient temperature and relative humidity. However, from fig. 25 it would seem that the Equilibrium Relative Humidity (EQRH) of the actual salt mixture in the wall is in the range 63-67%. This does, however, not mean that the salts are always present below and absent above 63-67% relative humidity, as the kinetics of the salt crystallisation processes also must be considered. For instance, it would seem that the “salt explosion” in the late summer 2002 was related to the fact that the relative humidity had been stable around 63% for nearly 4 months, thus enabling the salts to build up larger whiskers and needles. It can of course not be ruled out that supply of moisture from minor water leaks also plays a role, but this is unlikely, since the summer of 2002 was so dry (see appendix 1).

Although the exact mechanisms for the strong salt crystallisation can only be supposed at the moment, it becomes clear from fig. 25 that the relative humidity in the Regalia room is too low, thus enabling salts to crystallise. From the figure it would seem that the *safe lower limit* of the relative humidity has to be raised to about 70% (year-round) in order to avoid crystallisation. Whether this can be done by “low-tech” means or if one has to install humidifiers in certain dry periods remains an important open question. It should, however, not be forgotten that the summer of 2002 was exceptional – and on the other hand: exceptional climatic events appear to become more frequent.

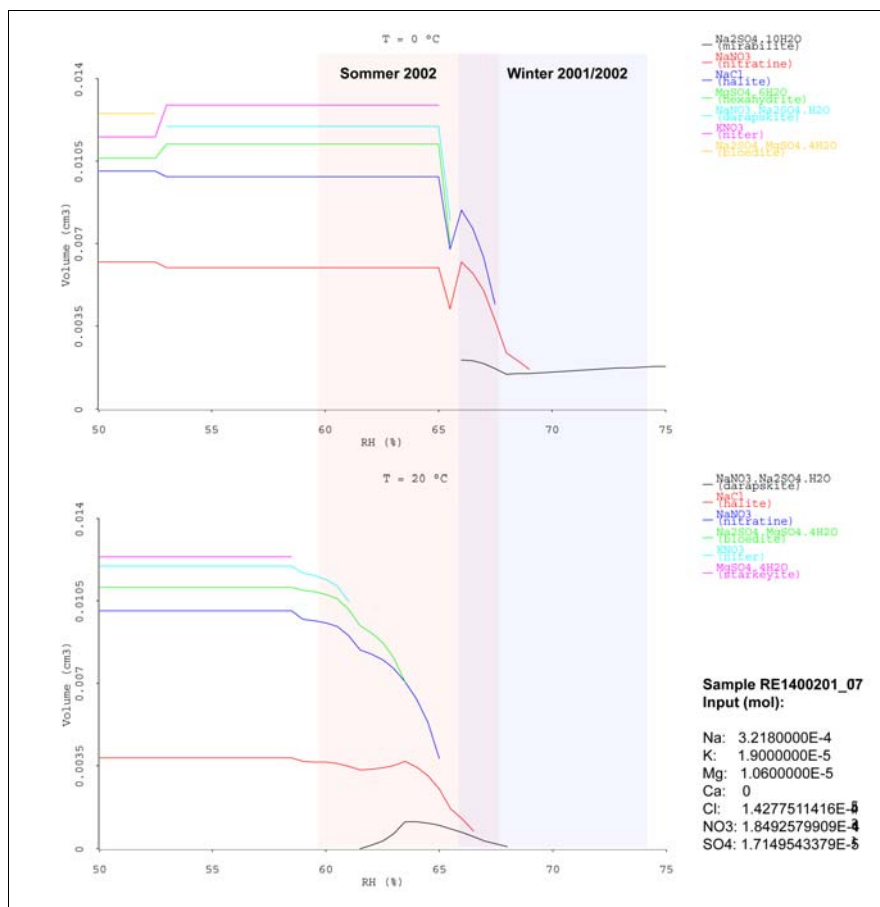
As can be seen, these results correspond roughly with the observations in the Regalia room (chapter 6), although the observed Equilibrium Relative Humidity (EQRH) might be slightly lower (towards 63-67% rather than 67-70%). A most important feature is also that in summertime the EQRH of the salt mixture is slightly reduced. However, the summer of 2002 was still dry enough for the salts to strongly crystallise in the Regalia room (lower part of fig. 29). In the wintertime, however, even if the EQRH is raised to some 70%, the relative humidity in the Regalia room was high enough for the salts to generally stay in solution in 2001-2002 (upper part of fig. 29).

Figure 29: Computer modelling of sample RE140201\_07 with removal of calcium to facilitate the analysis. Upper part: Graph by 0°C. Lower part: Graph by 20°C. The pink and light blue fields show the relative humidity range in the summer of 2002 and the winter of 2001-2002, respectively.

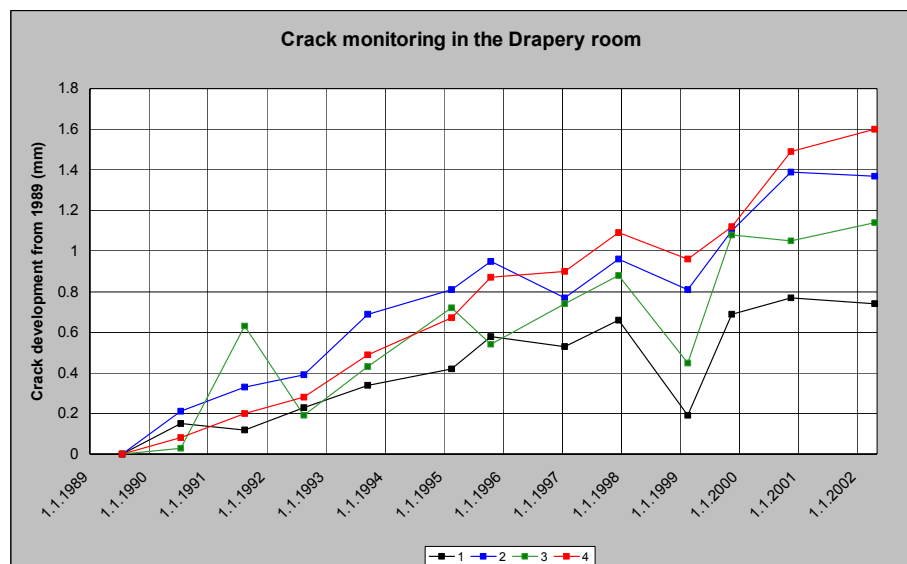
Crack monitoring in the north wing of the Archbishop's Palace has been carried out since 1989 and is thoroughly described in [4]. The most recent measurements, undertaken in the spring of 2002 by Kristin Bjørlykke of the Restoration Workshop of Nidaros Cathedral, in the Drapery room just to the east of the Regalia room showed very small changes since 2001. Although it might seem that the cracks are not significantly widening at the moment, one should bear in mind that their behaviour is probably dependent on ground water level changes, as shown by the measurements in 1999 when the cracks contracted after an extremely wet period (fig. 30).

Figure 30: Crack monitoring in the Drapery room to the east of the Regalia room. 1-4 means various measurement spots as described in [7].

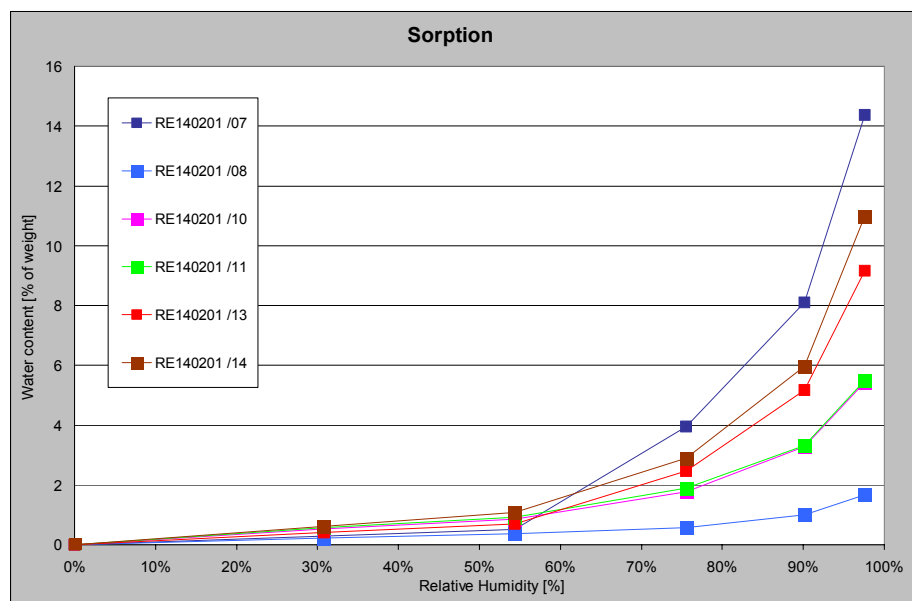
The sorption and desorption characteristics of the samples taken appear to be more or less completely dependent on their actual salt content (fig. 31). As the relative humidity rises above 60-70%, the samples quickly starts to pick up moisture; the higher the salt content (e.g. sample RE140201\_07), the higher the absorbed moisture.

Figure 31: Sorption curves for the mortar samples at 20°C. Diagram from [6]. Sample RE140201\_07 has the highest amount of salts (2.7%); sample RE140201\_14 the lowest (0.3%).

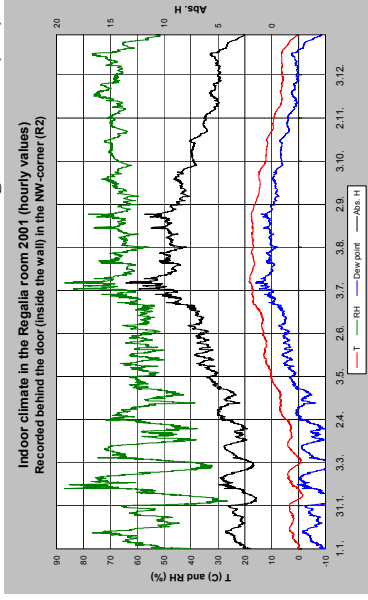
2002

Closed niche, "inside" W-wall Regalia room (R2)
