Andreas Franz and Per Storemyr

The 17th Century Mural Paintings in the Regalia Room, Archbishop's Palace, Trondheim, Norway

History, Paint Technology and Weathering of the West Wall

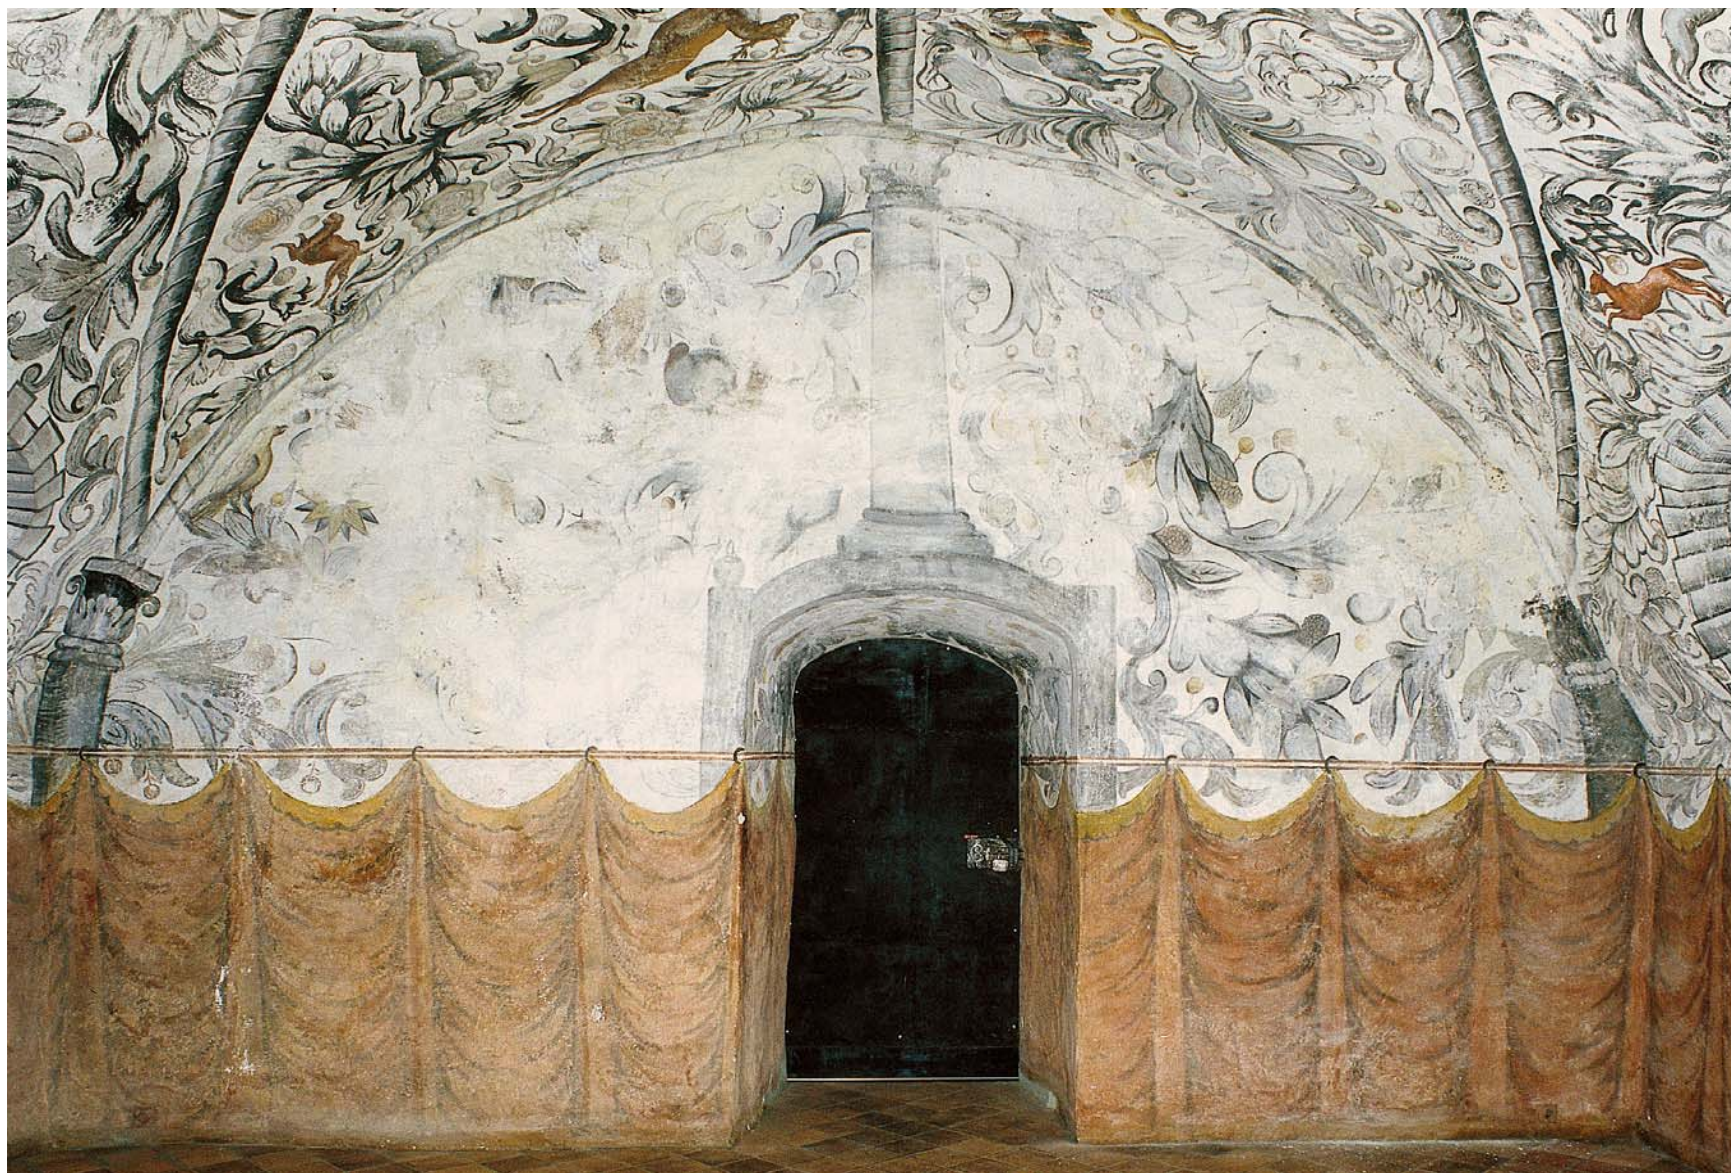
The weathered west wall of the Regalia room in the spring of 1999 (Photo: Kjartan Proven Hauglid)

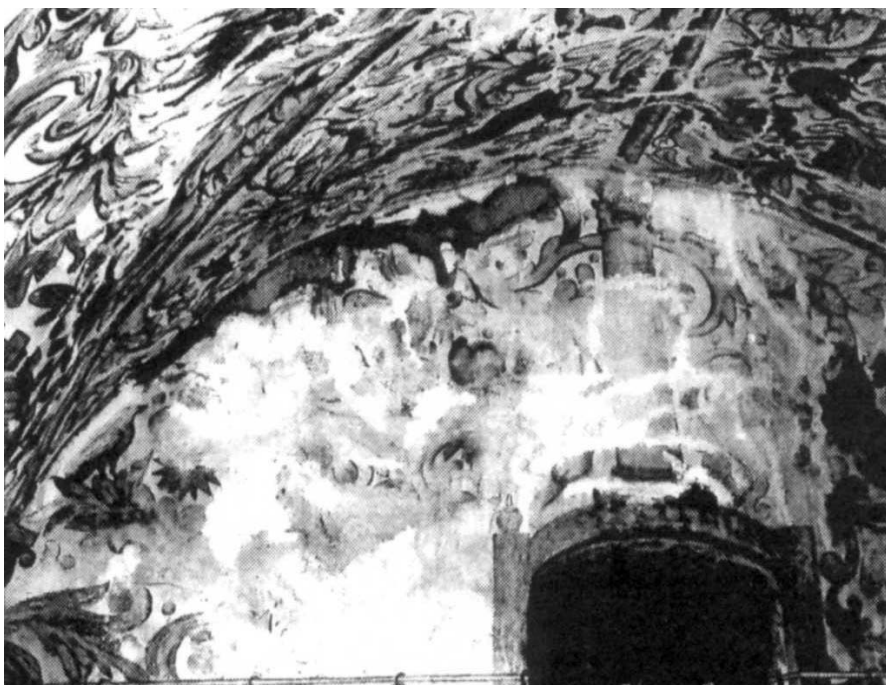
*The west wall of the Regalia room under restoration in 1966. Note grey cement repairs
(Photo: Archives of the Directorate for Cultural Heritage, Oslo)*

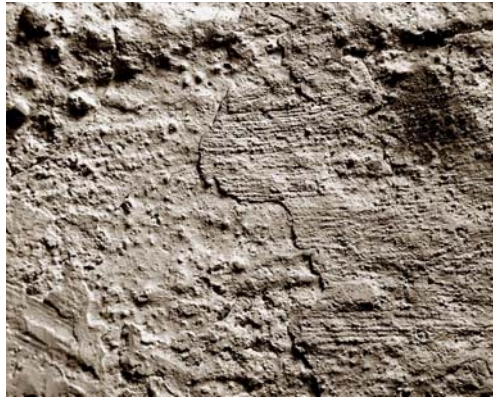
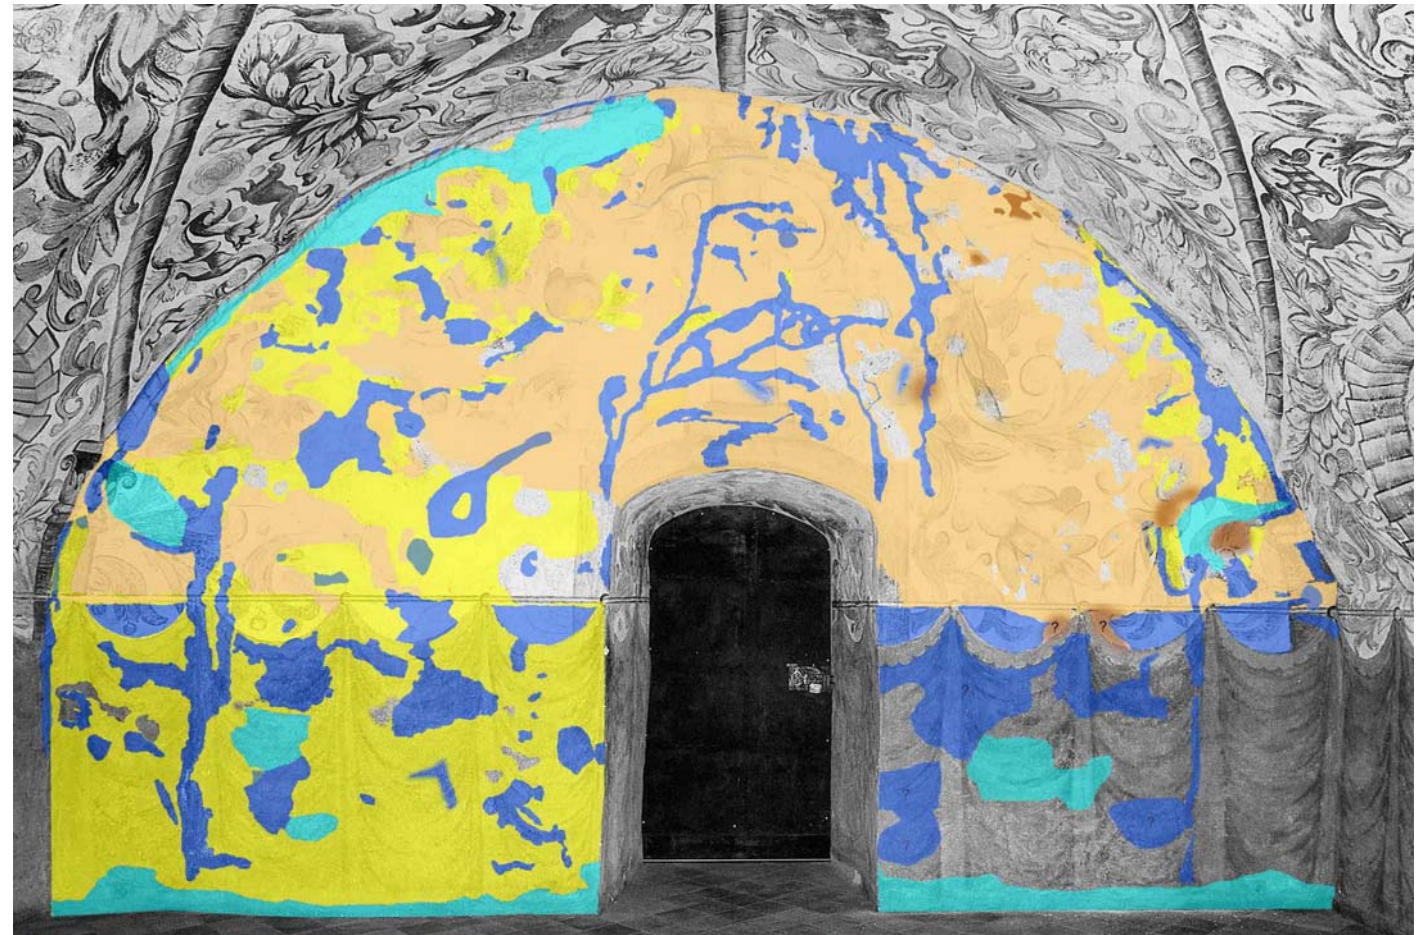
Limewash stratigraphy on the west wall. The picture shows the difference between the 1st (left) and the 3rd limewash (right). The 1st is characterised by its coarse, soft structure, while the 3rd has a "sandy" surface and closely-spaced brush marks

This limewash, with aggregate sizes up to 1 mm, was applied on the whole upper half of the wall, but interestingly, not in the drapery area. It can be easily identified by its coarse, sandy surface texture and sharp brush marks (much sharper than the 1st limewash). Its poor adhesion to the wall suggests that the ground was not pre-moistened before painting.

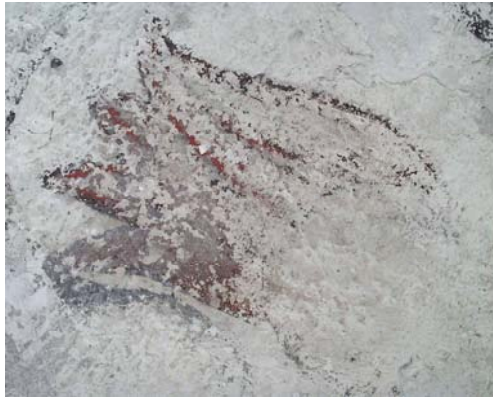
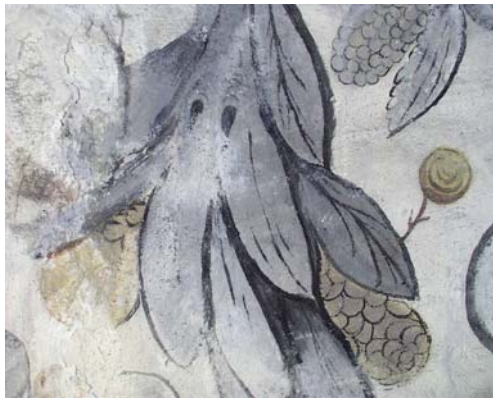
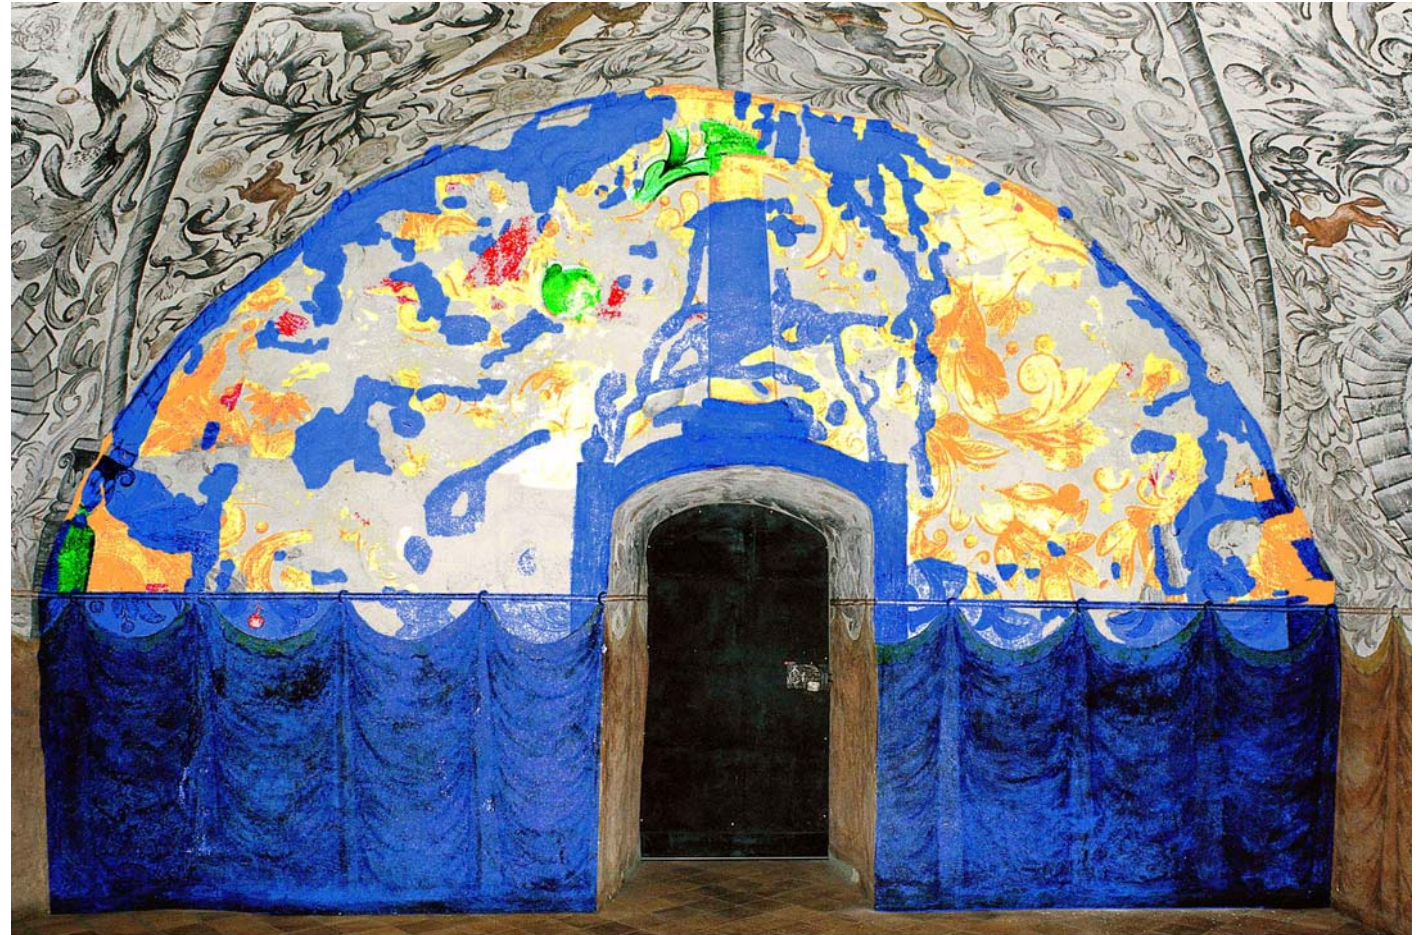
Paint stratigraphy on the west wall. The pictures show the 1st paint layer (above - tulip in Q1) and the 3rd paint layer (below - tendrils in Q2)

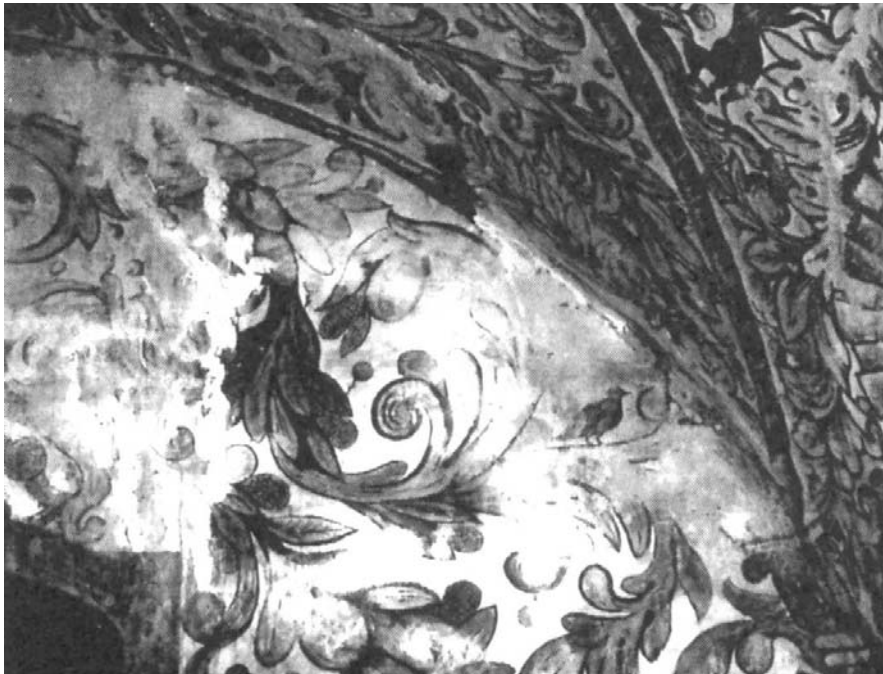
- Limewash in damaged areas was often knocked off and replaced by gypsum or cement
- Cement mortar was used to consolidate badly damaged areas and fix loose plaster
- Gypsum mortar was used to fix smaller cracks and exfoliated areas
- Large parts of the murals, especially the drapery, was overpainted, but relatively few reconstruction measures were undertaken (see also Odén 1999)
- Steel brushes were used to give patina to many overpainted areas

The west wall under restoration in 1966. Note all the white fields; many of these are gypsum repairs. (Photo: Archives of the Directorate for Cultural Heritage, Oslo)

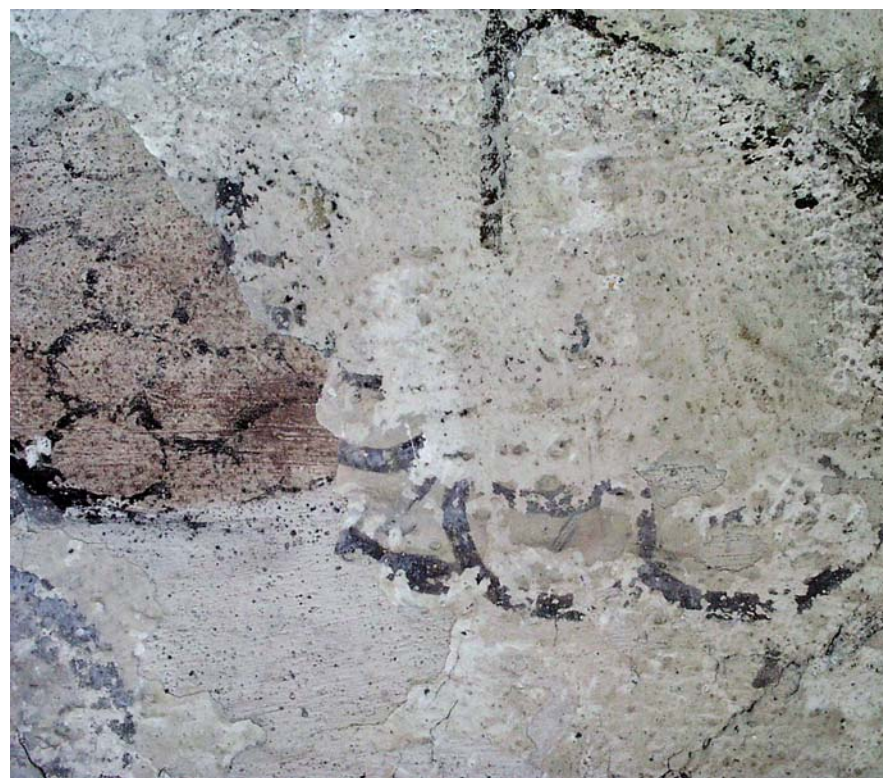
Typical appearance of the 3rd (1826 - red berry) and 1st (1616 - grey lines) paintlayers in Q1

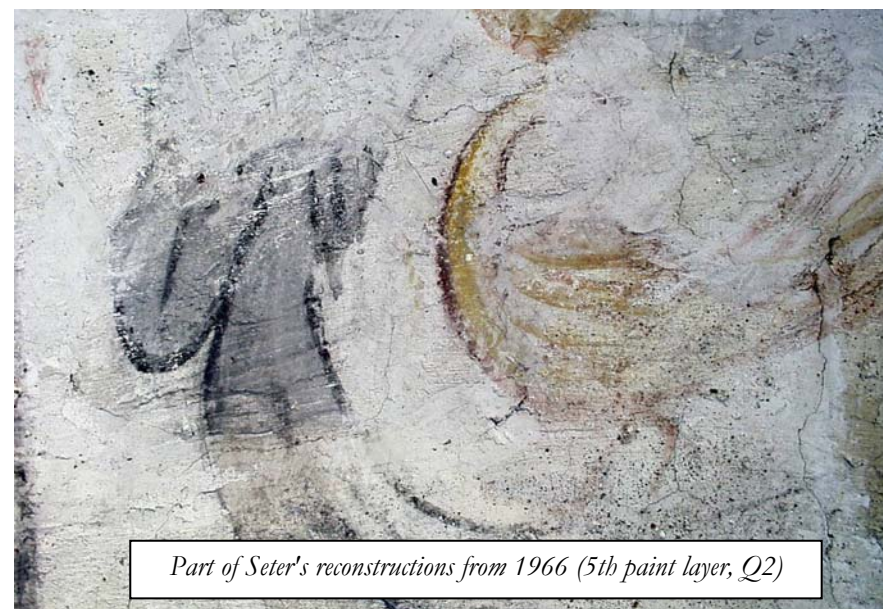
Part of Seter's reconstructions from 1966 (5th paint layer, Q2)

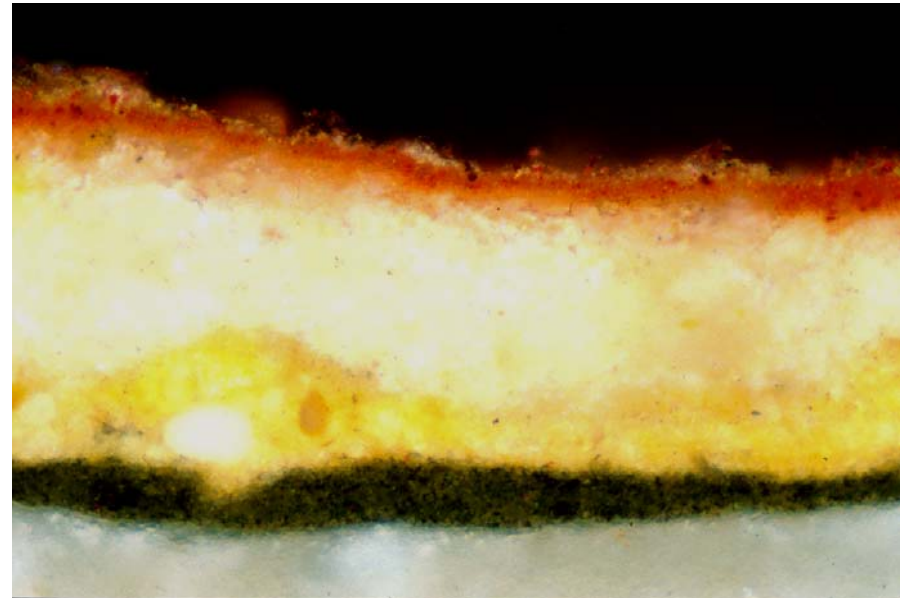
Mechanical damage at the south edge of the main door opening. On the "bottom" it is possible to observe a plaster from before 1616. The uppermost paint stratigraphy can be seen on the picture to the right.

Microphoto of the uppermost part of the stratigraphy in the damaged area to the left. From the bottom: white lime mortar/limewash, green/dark paint from 1826, a light brown/-yellow layer (unknown date), a light gypsum repair (1966) and the red paint/glazing from 1966. Sample P15, see appendix 1 for details. Width of field c. 0,8 mm

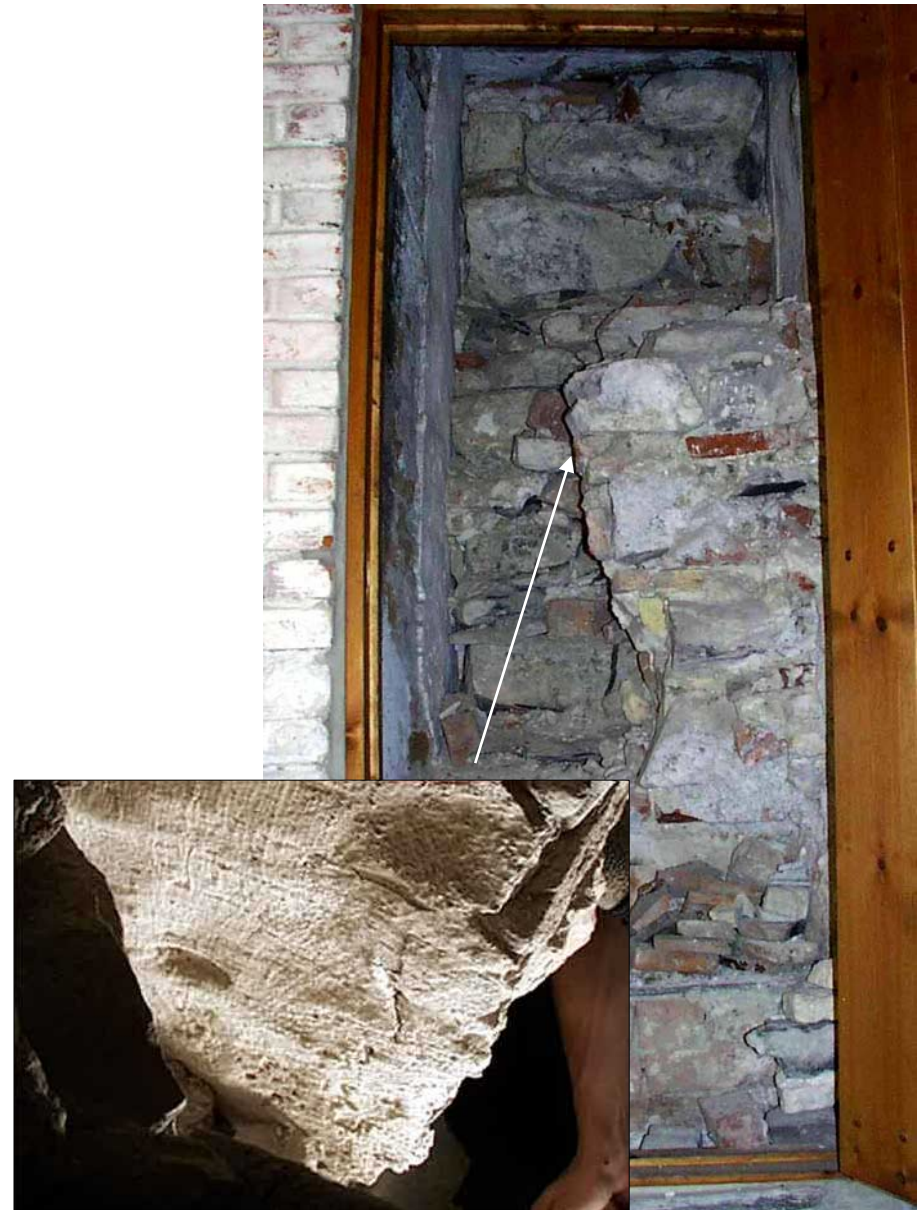
The rear of the presently closed opening in the north-west corner of the west wall was briefly investigated in order to evaluate the former theory stating that it was completely open until 1826 (cf. Odén 1999). Our findings indicate that the opening was closed already in 1616, but used as a niche until 1826. The reason for this theory is that there is a remaining "piece" of masonry in the middle of the opening, which must have formerly blocked the whole passage. Towards the Regalia room, this "piece" of masonry has an upper layer of smooth limewash which is more or less identical to the limewash used as ground for the 1st paint layer (1616). There is no trace of weathered-away limewash above this smooth limewash. Perhaps the niche was used for

Views of the niche at the rear of the north-west corner of the west wall. Right: Overview showing the masonry at the rear of the blocked door that may formerly have led to a "toilet". Inserted: The backside of the "piece" of masonry in the middle has limewash which seems identical to the 1616-limewash in the Regalia room.

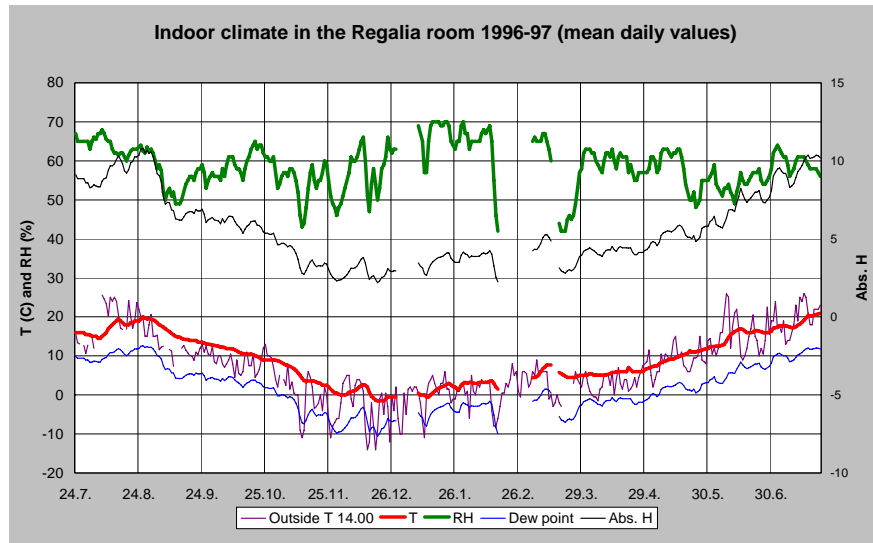
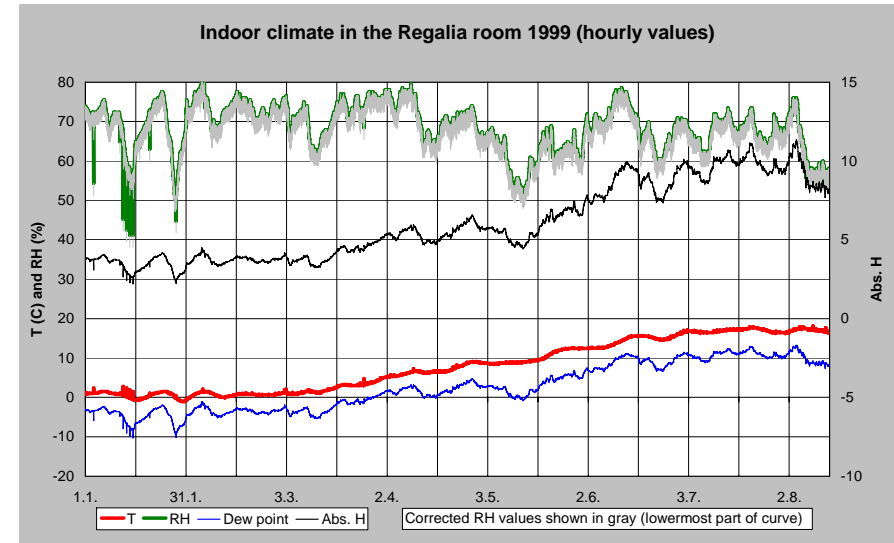
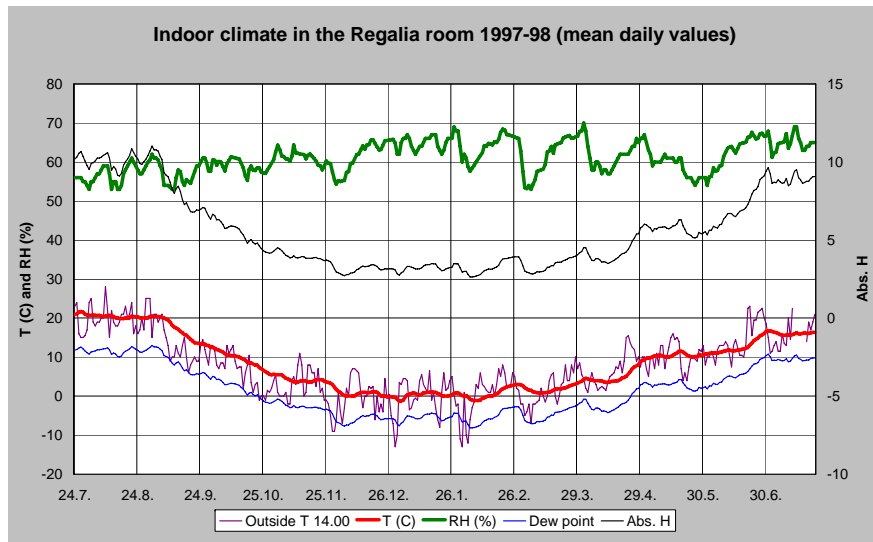
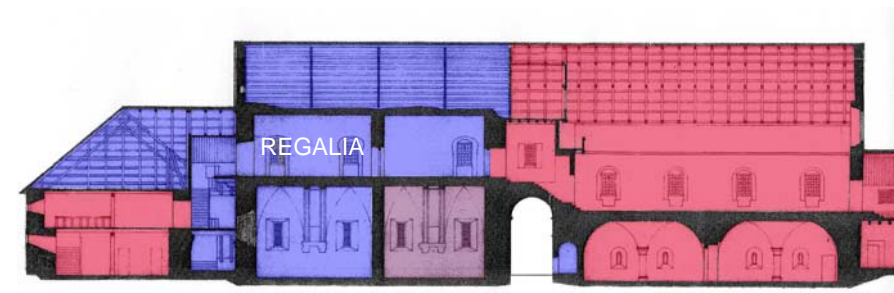
Diagrams showing the indoor climate in the Regalia room 1996-99.

As can be seen from the diagrams, the indoor temperature varies between just below 0°C in the deepest winter to about 20°C in high summer (average $8-9^\circ\text{C}$). RH varies from c. 40% during cold winter periods to more than 70% in mild winter periods, as well as during humid summer days (average c. 60%). As expected, the indoor RH is extremely dependent on the outside temperature: Rapid temperature changes outside are very quickly reflected in the indoor RH.

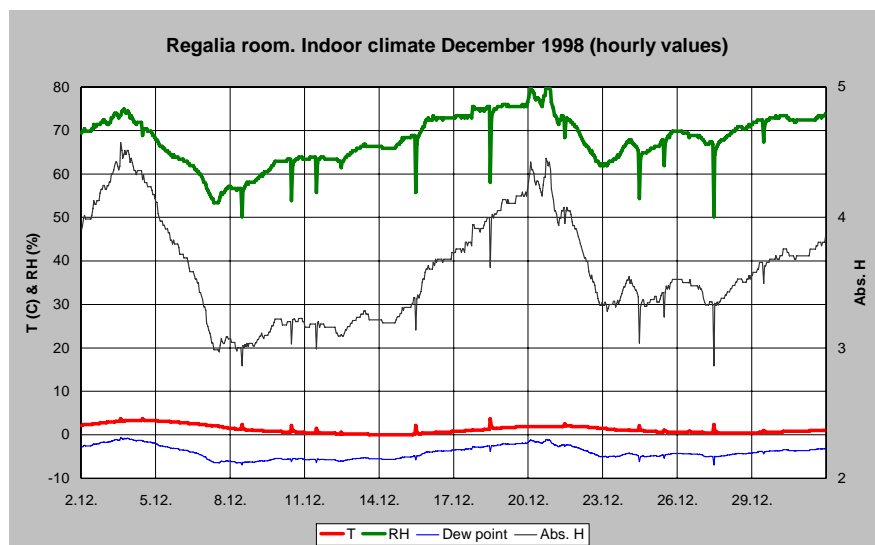
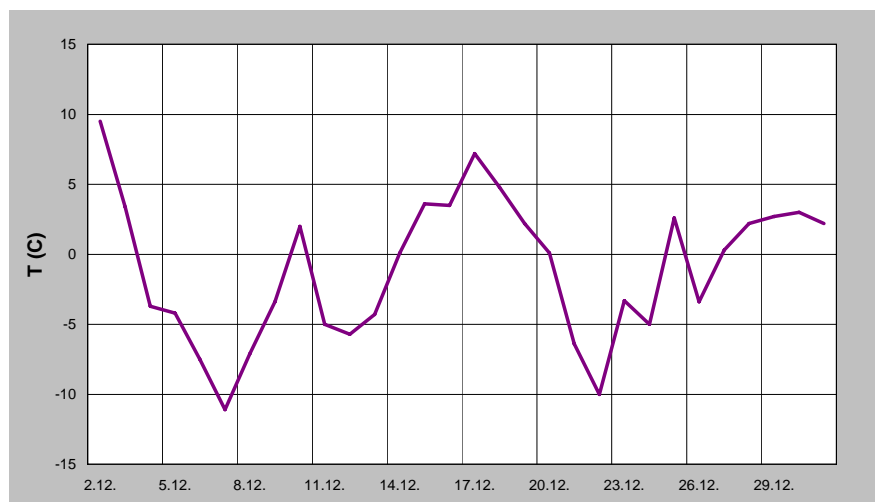
Indoor climate in the Regalia room in Dec. 1998 showing rapid changes at midday.

Below: Compare with outside temperature at Værnes (30 km east of Trondheim)

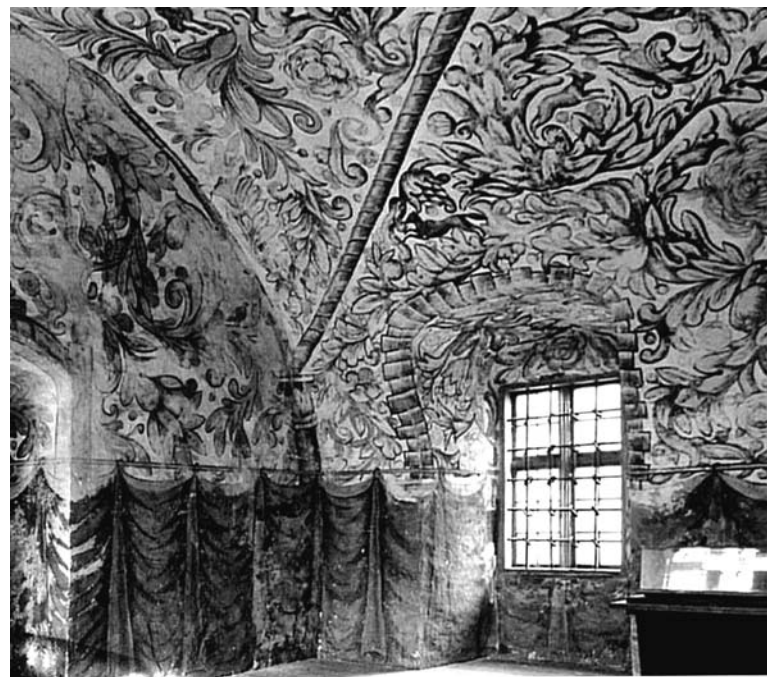
From 1960 there is only one photo of the north part of the wall. It is not known whether this photo was taken before or after the extensive restoration of the exterior face of the west wall, and before concrete and iron beams/anchors were installed. It is, however, probable that these interventions were undertaken before the photo was taken, otherwise it is difficult to explain the fact that the weathering pattern in the northwest corner appears just like today, although less extensive. In this interpretation it is assumed that the mentioned interventions are at least partly responsible for

The north-west corner of the Regalia room 1960 (Photo: Schröder)
