The Restoration Workshop of Nidaros Cathedral

**CONSERVATION OF  
MURAL PAINTINGS IN THE  
REGALIA ROOM,  
ARCHBISHOP'S PALACE,  
TRONDHEIM, NORWAY  
1999-2005**

**Emergency Conservation of the West Wall  
and Scientific Investigations 2000**

*NDR 1/2001*

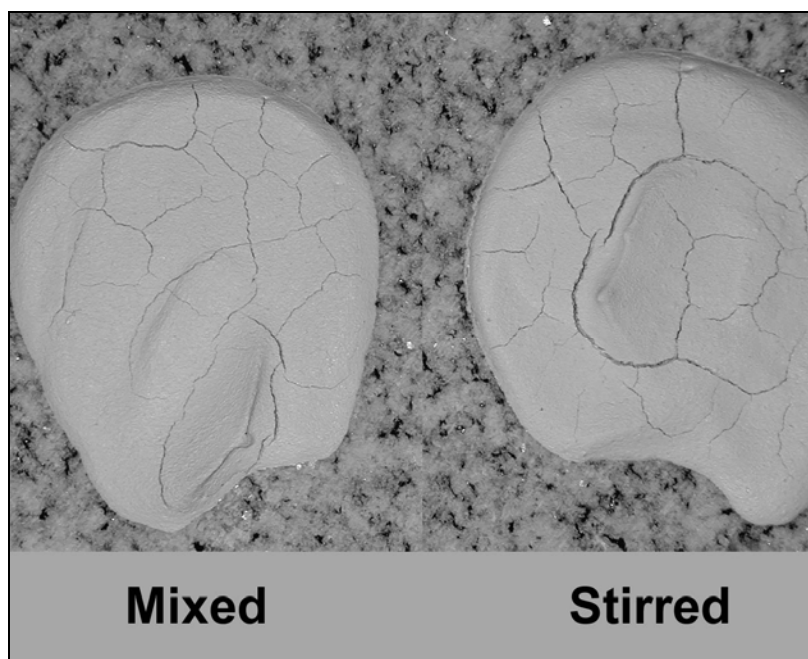
*Mixed (at 12.000 RPM) and stirred (with spatulas) pure lime after one day of hardening. The mixed lime show somewhat less cracks than stirred*

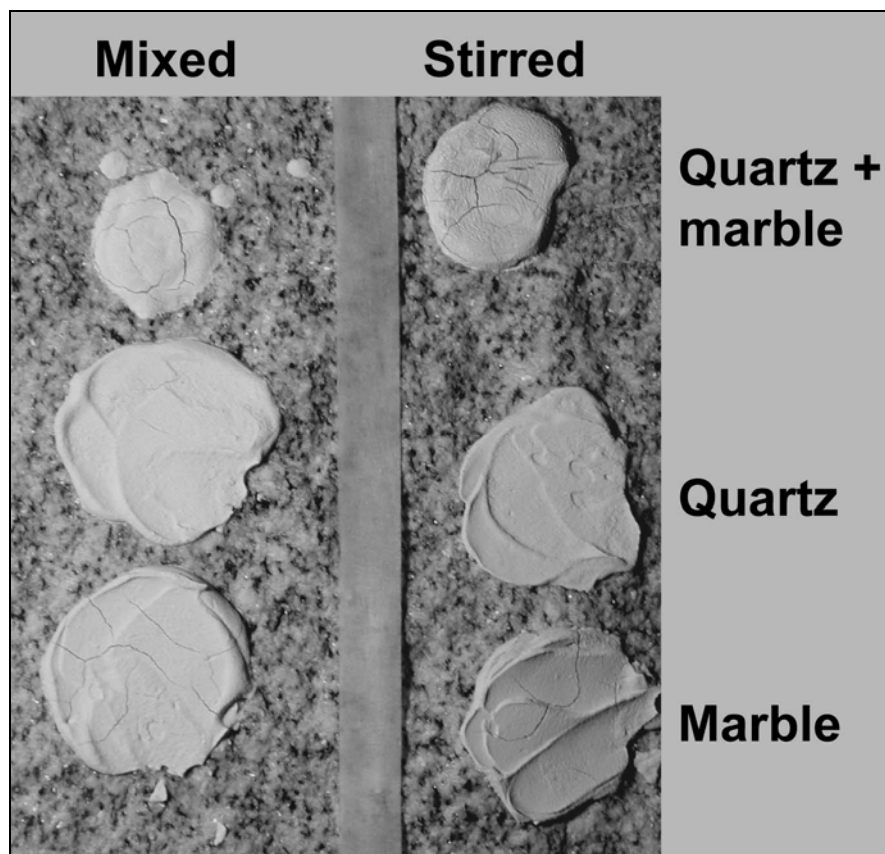
*Mortar mixes 1, 2 and 3 (see table on previous page) after 2 days of hardening. Note that the mortars with quartz have no cracks at all*

Summarised, mixing lime based injection mortars with quartz as aggregate has a very positive effect on shrinkage and flow. We therefore decided to use such mortars for the emergency conservation of the west wall.

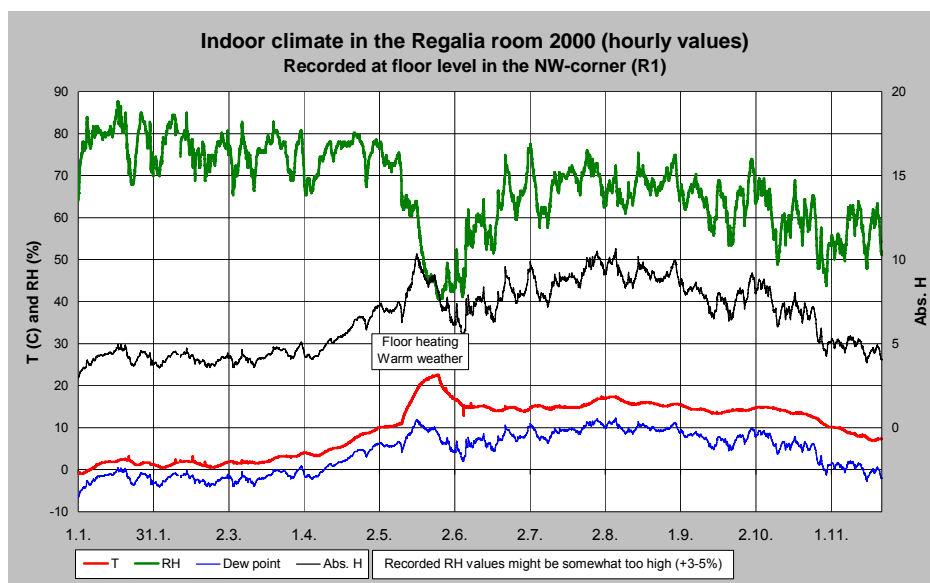
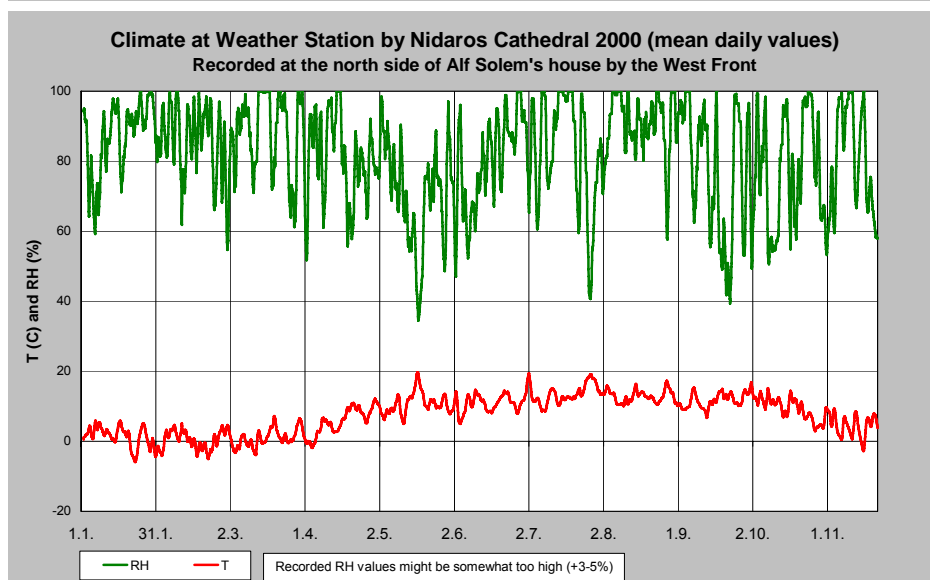
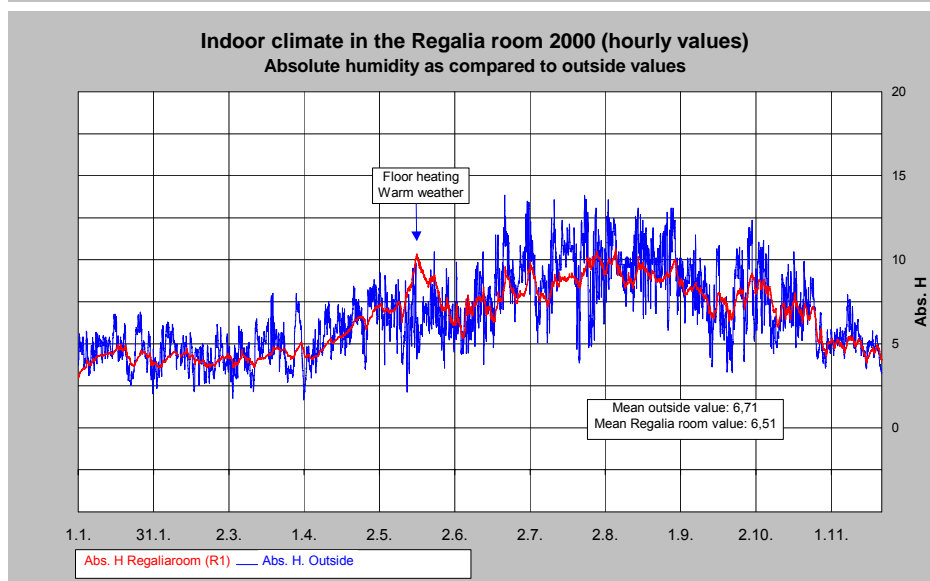
The indoor climate in the Regalia room in 2000 shows a couple of interesting features. First, the winter climate was relatively humid (70-85% RH), which corresponds to a mild exterior weather with few very cold days. Second, the temperature rose sharply in May (from 10 to 22°C within two weeks), with a

*Indoor climate in the Regalia room 2000 (top) as compared to the outside weather (middle). The bottom image compares absolute humidity inside and outside (g/kg air).*

corresponding drastic decrease in RH (75-40%). This unusual event occurred because the floor heating in the room was turned on accidentally for some two weeks. The drastic rise of T and drop in RH also reflect a warm and dry outside weather in May. Third, the summer climate in the room was cool and humid (15C, 60-75% RH), whereas the autumn brought about exceptionally dry weather, implying that the RH dropped to 50-65%. For a general description of the 2000 weather, see [http://www.dnmi.no/klima/veret\\_i\\_2000/veret\\_i\\_2000.html](http://www.dnmi.no/klima/veret_i_2000/veret_i_2000.html)

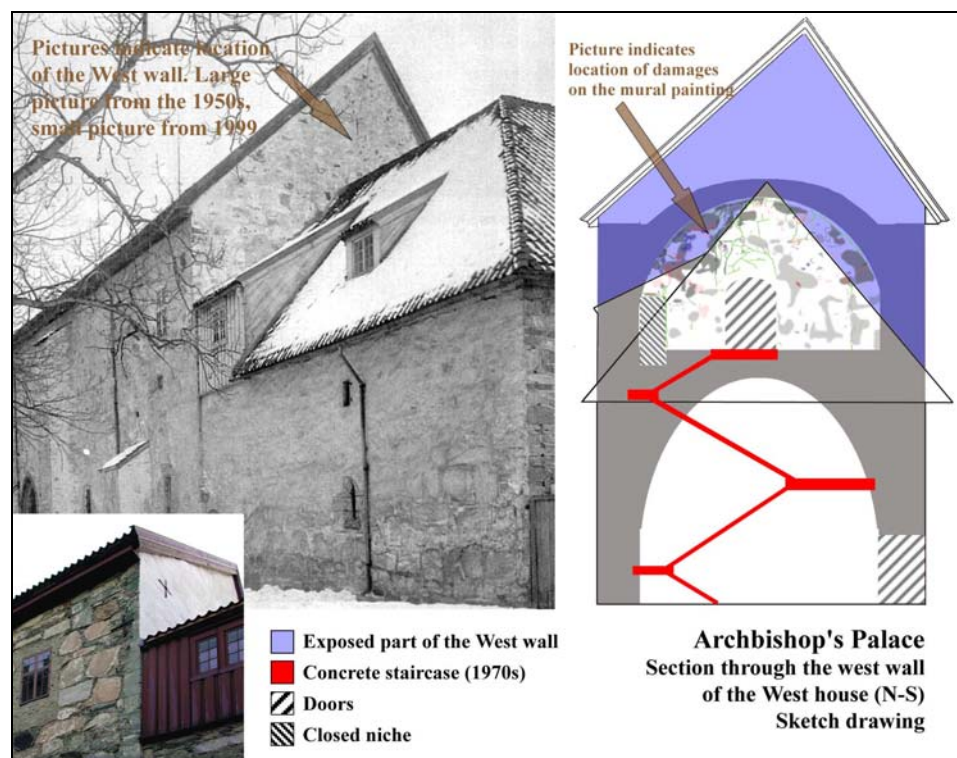
At last it should be pointed out that the condition of the murals on the west wall is extremely dependent on the state of the exterior gable wall. When this wall is in order (no water leaks), large-scale damages will not develop, as in the past (Franz & Storemyr 2000:45f). This means that regular maintenance of the exterior wall is of utmost importance. And if this is not enough, one has to think in terms of installing an extra protective wall.

*Section through the west wall showing which parts of the wall that are directly exposed to rain, as well as location of staircase and doors.*

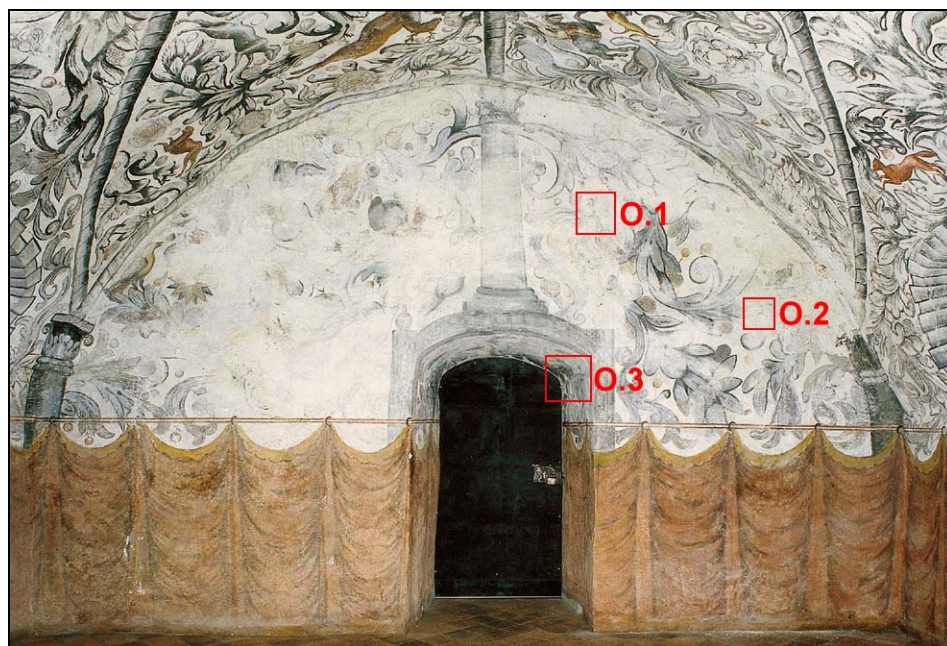
In order to be able to follow the behaviour of the hard-to-see salts on the west wall, three observation spots were established in June 2000. The spots chosen are located on the photo below. Samples were taken from all spots before the wall was moistened with lime water.

*Location of observation spots for salts on the west wall*

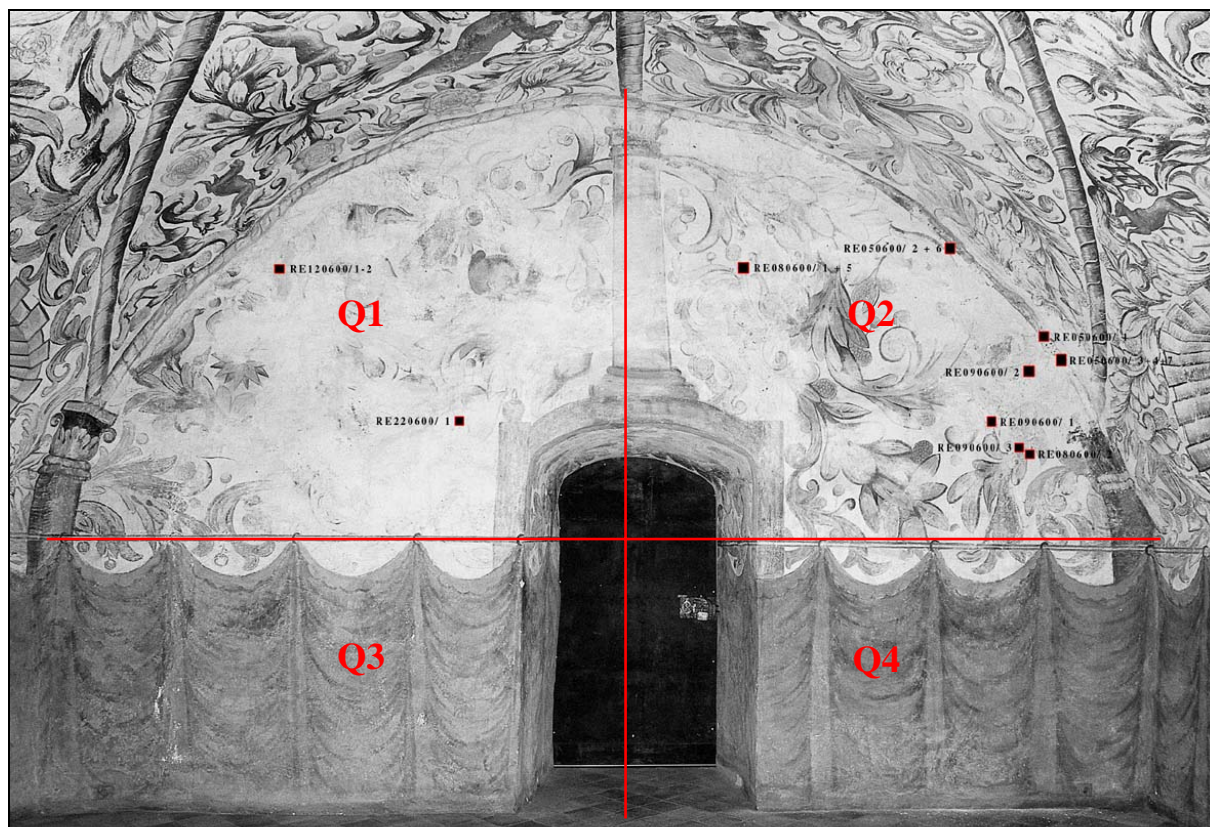
### Regalia Room - West Wall

RE080600/2	Q2	Powder of green/gray injection mortar from 1966. Check with XRD (done by NGU, file no. 20010033 (doc & xls): Quartz (much) Chlorite (medium) Mica (little) Plagioclase (little) Amphibole (little) Sodium nitrate (little) Halite (little) Traces of clay minerals???? NO lime (calcite)
RE090600/1	Q2	Limewash. Mostly <b>lime</b> , a few <b>sodium nitrate</b> grains
RE090600/2	Q2	Salt efflorescences in a small depression in the limewash. Large <b>halite</b> whiskers and crystals.
RE090600/3	Q2	Gray, probably intermediate paint/limewash layer. Mostly <b>lime</b> , a few <b>sodium nitrate</b> grains
RE120600/1	Q1	Salt efflorescences after injection of lime mortar. <b>Mirabilite</b>

RE120600/2	Q1	Salt efflorescences after injection of lime mortar. <b>Mirabilite</b>
RE220600/1	Q1	Salt efflorescences after injection of lime mortar. <b>Mirabilite</b>
