WEATHERING OF SOAPSTONE IN A HISTORICAL PERSPECTIVE

Per Storemyr

Abstract

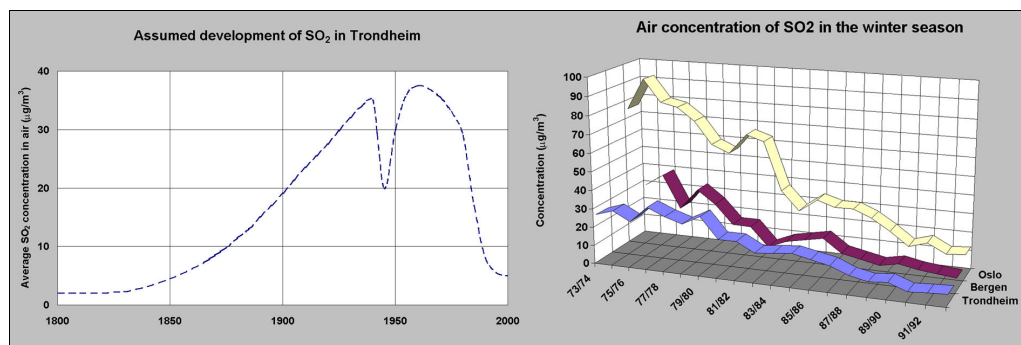
Figure 2: Development of average SO₂ concentration in the winter season. Left: Estimate for Trondheim since 1800 [4]. Right: Measurements since 1973 [9].

Compared to UK and places on the European Continent [8], local air pollution came late to Norway and has rarely reached extreme concentrations. The history of air pollution in for instance Trondheim started in the early 19th century when heating with coal commenced and small industrial enterprises were established. SO₂-concentrations increased towards 1900, and on the basis of population increase, heating fuel statistics, industrial development and observations of black crust development on facades (from photos, see Figure 11), it has been estimated that average concentrations in the cold season hardly exceeded 40 µg/m³ between 1920 and the late 1970s [4]. Since then there has been a drastic decrease to 5 µg/m³ or

below at present (Figure 2). Emission of NO_x and suspended particulate matter from traffic has increased during the last decades and the concentration of NO_x is at present in the range of $40\text{--}60\text{ }\mu\text{g}/\text{m}^3$ in the cold season (Hagen [9]). Nevertheless, Trondheim is and has been a relatively "clean" city. Moreover, it has hardly been affected by acid rain from the European Continent and UK, implying that dry deposition of locally produced pollutants has had the major impact on buildings. Situated in the south of Norway, both Stavanger and Oslo have been affected by acid rain. Generally, these cities, as well as Bergen on the west coast, have been more polluted also with regard to local air pollution (Figure 2) [9].

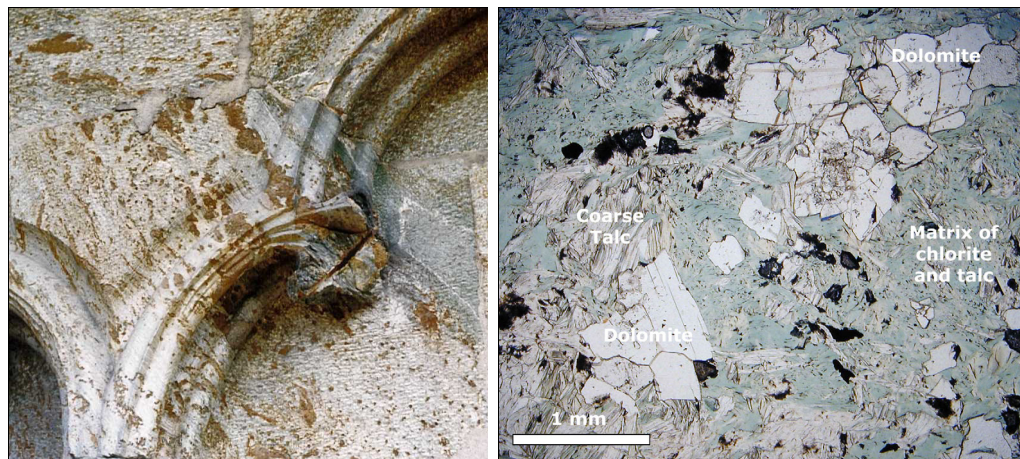
Figure 3: Typical appearance of Caledonian, foliated soapstone (at Stavanger Cathedral). Left: Light grey areas are rich in talc and chlorite (matrix), green rich in chlorite and brown areas are dolomite with a superficial layer of iron hydroxide, probably developed due to leaching and oxidation of small amounts of iron in the dolomite structure. The ornament has been lost due to a rusting dowel from the 19th century. Right: Photomicrograph in normal light. Dark areas are mostly opaque minerals (magnetite, some pyrite).

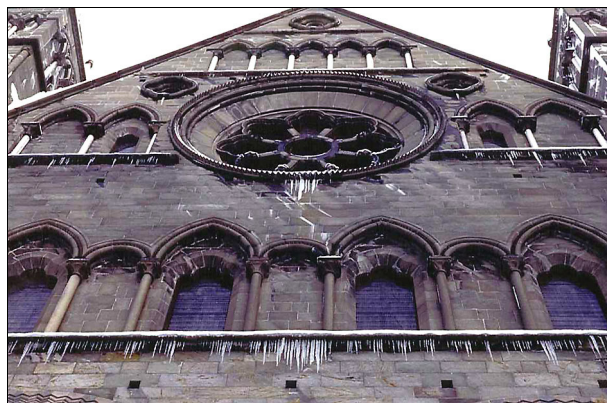
Figure 4: Icicles and snow at the S. transept of Nidaros cathedral. The stringcourses made from Bjørnå stone have lost their mouldings along the pronounced foliation in the stone. This stone has a lifetime of only 30-60 years when used at such places.

The typical weathering forms on soapstone are strongly dependent on exposure conditions and do not differ essentially from other stone [4]. *Spalling and cracking* involving loss of smaller and larger pieces usually occur at places strongly exposed to precipitation (rain, snow, ice), such as cornices and capstones, as well as at exposed ornaments and sculpture. This weathering form is clearly related to soapstone structure, usually following the foliation or thin talc and carbonate veins. Strongly foliated stone may show *delamination* at exposed places, implying that the stone structure opens along the foliation, but that loss of pieces are not necessarily involved. This weathering form also occurs in transition zones between rain-exposed and sheltered parts of walls, especially where salt and black crusts can accumulate. At moderately exposed places and in transition zones, flaking, meaning development of tiny fissures parallel to the stone surface and subsequent loss of mm to cm-large "flat" pieces, tend to occur. This weathering form may sometimes develop into *contour scaling*. *Granular disintegration*, implying loosening of individual (flaky) mineral grains, occurs almost exclusively in rather sheltered locations and is normally followed by various types of salt. Only extremely few soapstones, to date only three types out of several dozen investigated, show this weathering form at places exposed to rain, snow and ice, thus it is a form strongly indicating salt weathering processes. When exposed to rain, soapstone always show slight dissolution of carbonate veins and aggregates, usually followed by oxidation of traces of iron in the carbonate structure. As a result of complex exposure conditions and varying stone properties, *combinations* of the typical weathering forms occur at most monuments.

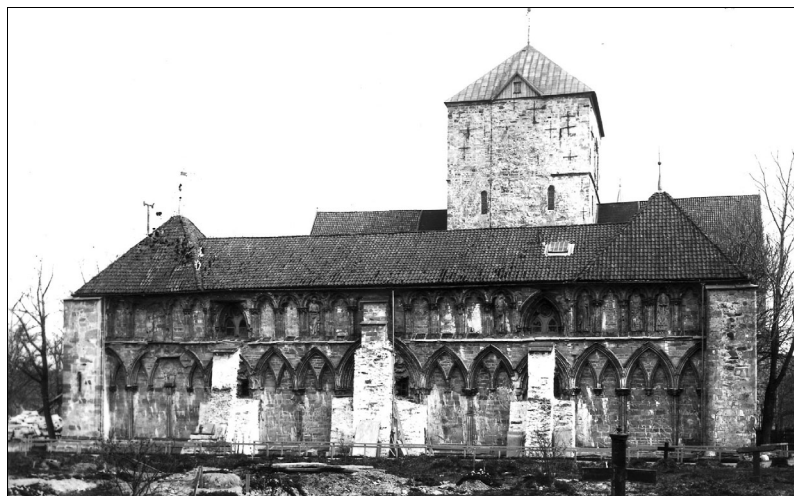
Figure 5: The remaining two lower storeys of the High Gothic west front of Nidaros cathedral by 1870. (Photo: The Restoration Workshop of Nidaros Cathedral.)

A good place to study such phenomena is at the High Gothic west front of Nidaros cathedral (Figures 5, 6), which has countless destroyed medieval ornaments and sculpture made from foliated, but generally durable Trondheim soapstone. It can be confirmed by the study of old photos that the damages were there already by 1870 (Figure 6) and that they have not significantly changed since then. In order to understand why the damages evolved, we have to return to 1531 and the devastating fire that ruined the west front.

Since the nave in periods was used as a stone quarry, only the two lower storeys remained (Figure 5) when the structure was put under a good roof in 1739 (Lysaker [15]). This means that very delicate Gothic stonework was without protection for more than 200 years. The restoration of the west front started by 1900; first the old masonry was dismantled and the two lower storeys rebuilt, primarily using the old and weathered decorative stones, and generally refraining from reconstruction. The core of the two lower storeys were strengthened and thus used as a "foundation" for the new west front, which was erected on top (Figures 5, 6). The building of the new west front continued with new stone until its completion in 1969 (Fischer [16]).

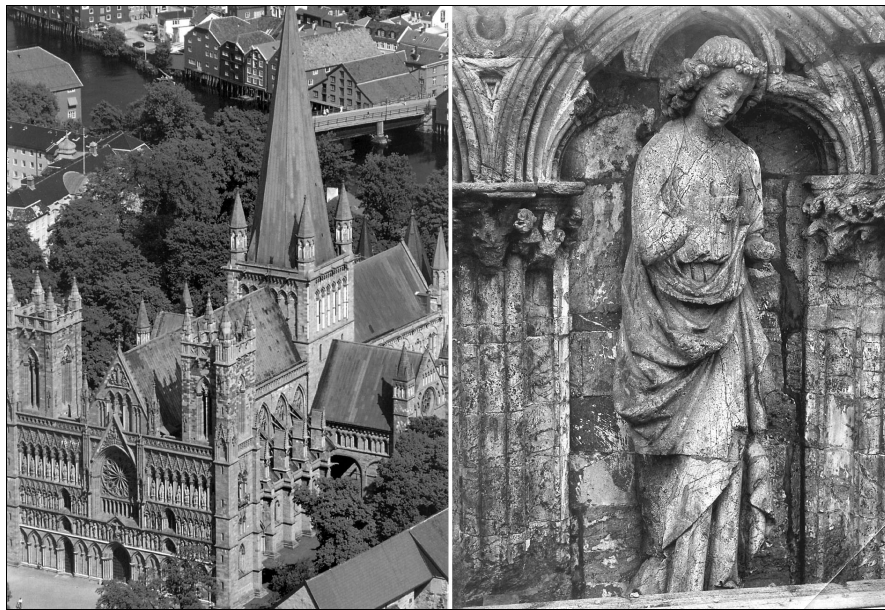
Figure 6: Left: Nidaros cathedral today after a century of restoration. Right: St. John, one of the five remaining medieval sculptures at the west front by 1870. Note all damaged ornaments. (Photo: The Restoration Workshop of Nidaros Cathedral.)

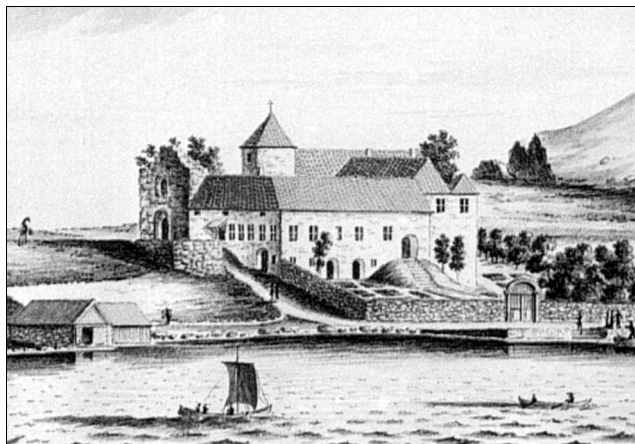
Figure 7: Utstein monastery. The Gothic west portal is situated to the left in the ruined gable wall of the church. (Painting by Dreyer 1822.)

Another example of "old and worn" soapstone can be found at the Gothic west portal of Utstein monastery church on an island close to Stavanger in southwest Norway (Figure 7). Partly featuring lichen growth, the exposed flanks of the portal have numerous smaller damages ranging from open joints and lost details to a rough and pitted surface, which is presently rather stable. Below the exposed and damaged, but stable part of the arch is an inner, sheltered part, which is heavily disintegrating (Figure 8), evidently due to salts (Storemyr [17]). Why do we observe this difference?

The main reason is that also Utstein church fell into ruin after the Middle Ages (Figure 7). It was sacked in the 16th century and the wall heads were not covered until 1865. This preliminary protection remained another 100 years and in 1965 the church was partially reconstructed and put under permanent roofing (Lexow [18], Fischer [19]). The portal was to some extent repaired (mainly the joints) and it still is one of the most authentic Gothic portals in Norway.

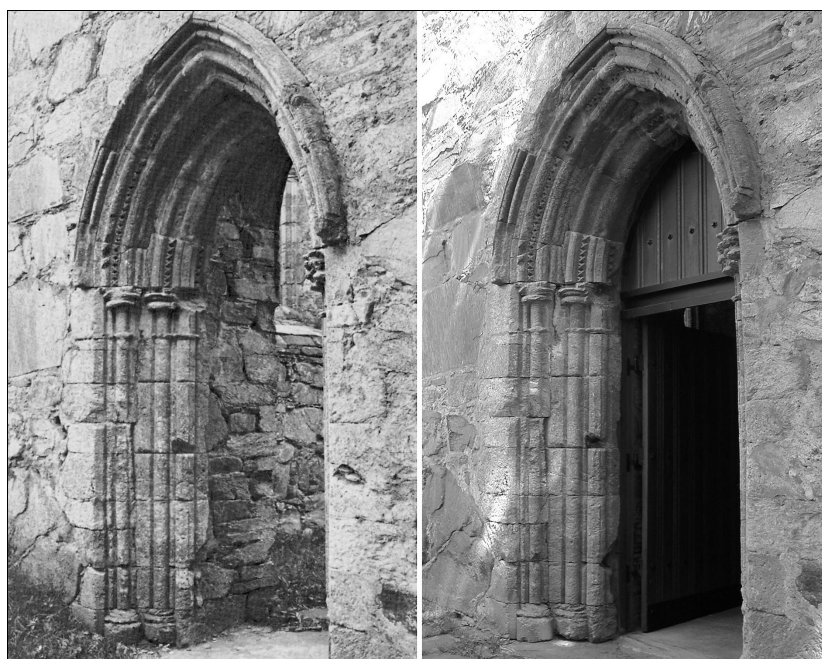
Figure 8: The west portal of Utstein monastery church before 1965 (Photo from [19]) and in 2001. Note many small damages and that the damages have hardly evolved.

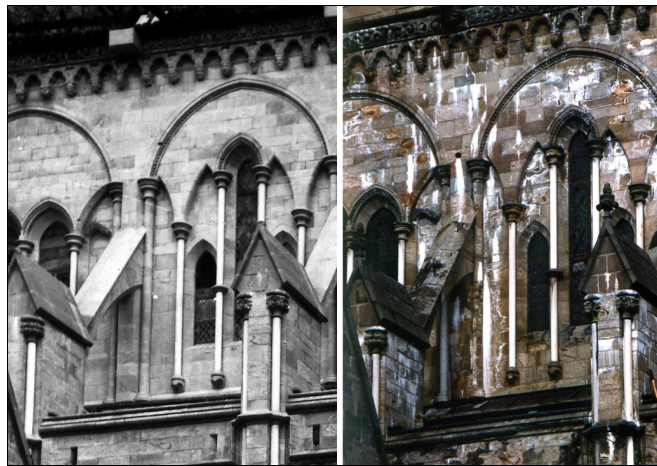
Figure 9: Left: The choir at Nidaros cathedral was reconstructed using much Portland cement and stone rich in sulphide (Grytdal) in the 1880s. (Photo: The Restoration Workshop of Nidaros Cathedral.) Right: 100 years of water leaks through the masonry have given massive calcite crusts and extreme salt weathering problems.

Nidaros cathedral is probably the medieval monument in Norway most heavily affected by Portland cement (Figure 9). Cement was introduced as the modern restoration started in 1869, first as a hydraulic additive to lime mortars, later as the "universal" mortar for large reconstruction works. Portland cement mortars have been used virtually everywhere – in strengthened foundations, along widened and repointed medieval joints, on top of wall heads and as grouts and "soups" injected in old and weak walls [4]. From old photos it can be seen that calcite crusts (stalactites "stuck to the wall") were not present before the restoration – they only turned up some years after various buildings parts were successively restored. This is a very good indicator of the use of Portland cement and the presence of water leaks. Upon dissolution of calcium hydroxide present in Portland cement, calcite will form as the solution enters the surface (Figure 9). The water leaks originates from poorly insulated parapet walks, from undersized water discharge systems and from fissures between joints in exposed building elements. The record for the choir shows e.g. 13 periods of major leaks, mostly occurring in the wintertime, between 1920 and 1995 [4].

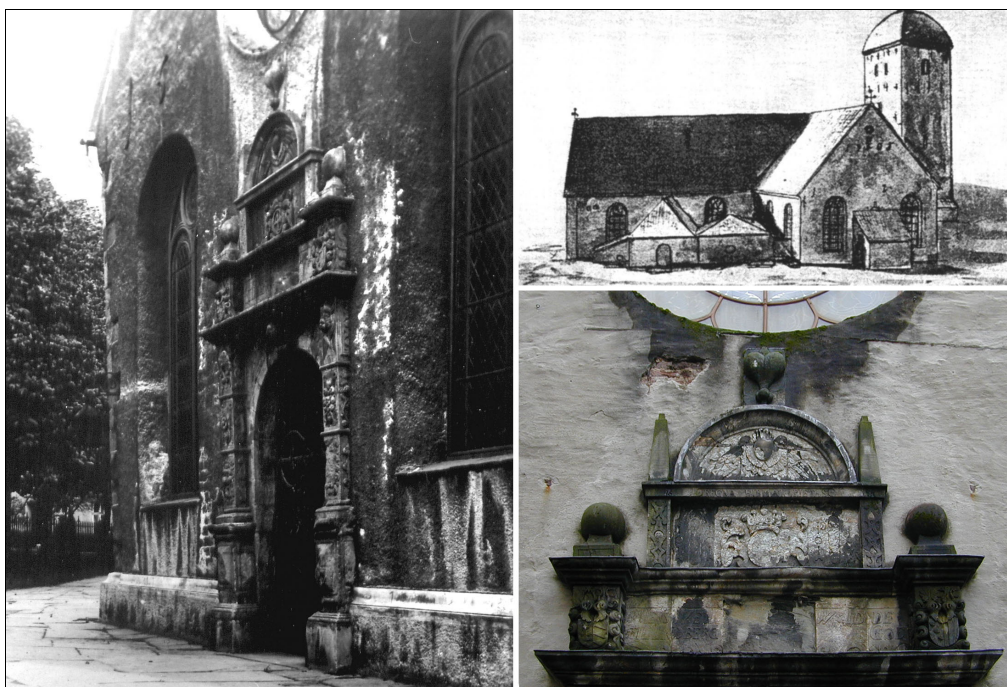
Figure 10: Church of the Holy Cross. Left: The north portal with much black crust by 1900. (Photo: Directorate for Cultural Heritage.). Top right: A porch in front of the portal in 1839. (Drawing by F. Bøe). Bottom right: The upper part of the portal in 1999, showing damages where crusts formerly prevailed.

The north portal of the Church of the Holy Cross in Bergen was built in 1632. It is perhaps the finest renaissance portal in Norway and the only one so far at which traces of original polychrome painting has been documented. This masterpiece soon got into trouble, but nevertheless appears to have survived no less than three fires until 1746. Subsequently, a porch was built in front of the portal, perhaps to protect it or perhaps to conceal damages (Figure 10). The porch remained for a hundred years until the portal was restored in 1856-57. It is likely that the polychromy was finally removed at this time, possibly by acid and/or lye (Moe [22]). The most important measure was not directly related to the portal, though, but to the fact that a large circular window was inserted just above. By collecting rain and draining it directly onto the portal, this window has played a vital role in the weathering over the last 140

years. Already by 1900 the portal and the wall around had much black crusts, which expanded greatly towards the 1940s and 50s. In the 1970s and 80s their extensiveness had been slightly reduced, but this was mainly due to the fact that pieces had started to fall from the most damaged parts, which is essentially the somewhat sheltered areas below the upper arch and between the three architraves. Since the late 1980s no great changes have been recorded [22].

The reasons why so much black crusts could form at the portal is connected to relatively high atmospheric concentrations of SO_2 and particulate matter from heating and combustion processes over a long period, as well as the generally sheltered position of the north wall. The location of the worst damages are also governed by rain and run-off from the window, which make these areas thoroughly moist, but not completely wet, like other, *more* exposed, but *less* damaged areas of the portal. The worst damages are located in a transition zone between dry, moist and wet – a zone, in which damages related to black crusts are generally known to concentrate (valid for dense stones) (Arnold [23]). In addition, gypsum in black crusts is not the only salt in the damaged area – there is a range of other species present as well, of which halite is the most important. Halite may stem from sea spray, but perhaps more likely from acid cleaning in the 19th century. Furthermore, the foliated soapstone in the damaged area is edge-bedded – a feature that easily makes it delaminate and lose the outer parts. Thus, air pollution and black crusts cannot alone be held responsible for

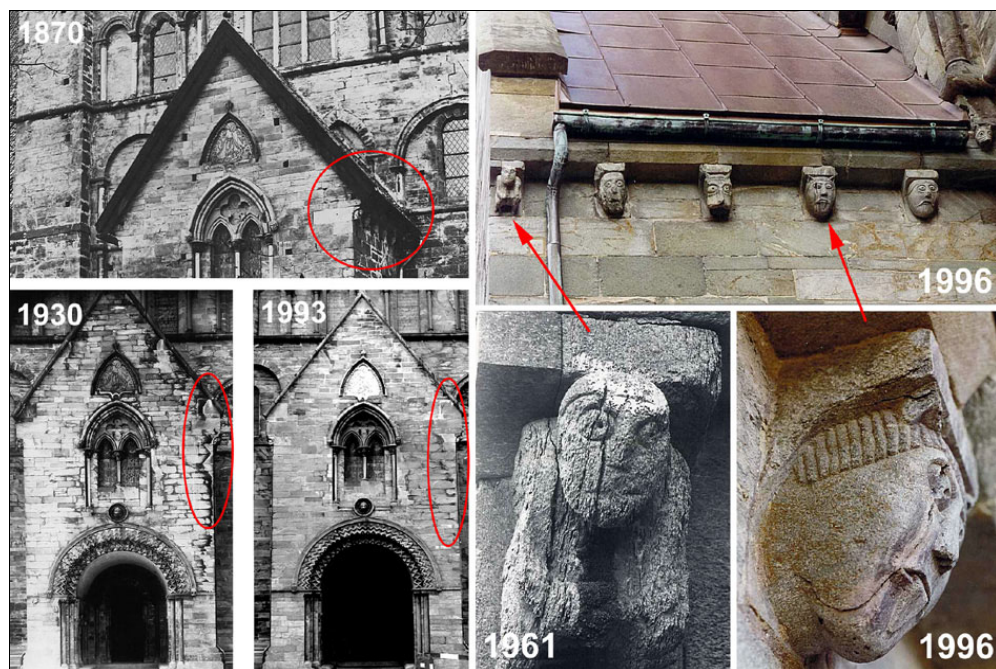
Figure 11: The north porch at Nidaros cathedral. Left: Before and after the restoration in 1880; note the new roof and the development of black crusts. These were more widespread in 1930 than in 1993. Right: The corbel heads at the west side of the porch. (Historic photos: The Restoration Workshop of Nidaros Cathedral.)

Another example illustrating the importance of understanding former changes in architectural design can be found at Nidaros cathedral – at the mixed Romanesque and Gothic north porch of the cathedral (Figure 11). Probably after the fifth and last fire at the cathedral in 1719 the porch got a good, traditional roof with projecting eaves, which protected the valuable Romanesque corbel heads in the cornice (Figure 11). A similar roof may have prevailed also before the fire. The corbels are made from chlorite schist with talc and according to old photos they were in good condition before the modern restoration of the porch in the early 1880s. This restoration did consequently not involve the corbels, which remained more or less untouched, but primarily concentrated on the roof, which was restored to what it might have looked like in the 13th century. A raised gable was constructed, the eaves were cut back, lead (later copper) plates were used as roofing material and gutters and downpipes were added. Moreover, new Grytdal stone with a high content of pyrrhotite was applied in the beam directly above the corbels [4].

Towards the 1950s and 60s the condition of the outermost corbels at the west side of the porch were drastically deteriorated. The chlorite schist delaminated and

there were clear signs of black crusts in the more sheltered areas (Figure 11). But does this mean that air pollution was responsible for the damages? There is probably no doubt that the formation of black crusts and gypsum plays a role in the weathering, but it appears to be more important that the reconstructed roof is not able to protect the corbels properly. The outermost corbel is for instance only half-protected (cf. weathering in the transition zone between wet, moist and dry at the portal of the Church of the Holy Cross in Bergen) and influenced by water leaks and run-off from the architecturally complex 1880-cornice and the occasionally overflowing gutter. Thus, frost may be an important weathering agent as well. Moreover, gypsum from the Grytdal stones above can easily be transported to the corbels [4].
